Underground Storage Tank  
Closure Report

Fulmer's Garage  
Chestnut St. & Buckeye Rd.  
Emmaus, Pa. 18049

Boyko Petroleum Service  
4171 Chestnut St.  
Whitehall, PA. 18052  
Comp. Cert. # 566  
Cert. Inst. # 255  
John Kokolus

June 1993

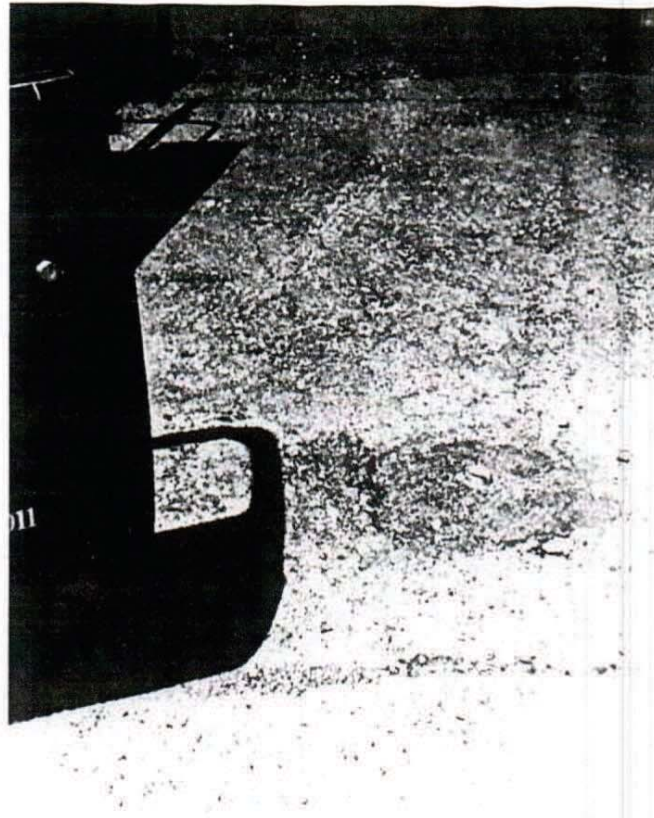
Above: Tank area before excavation

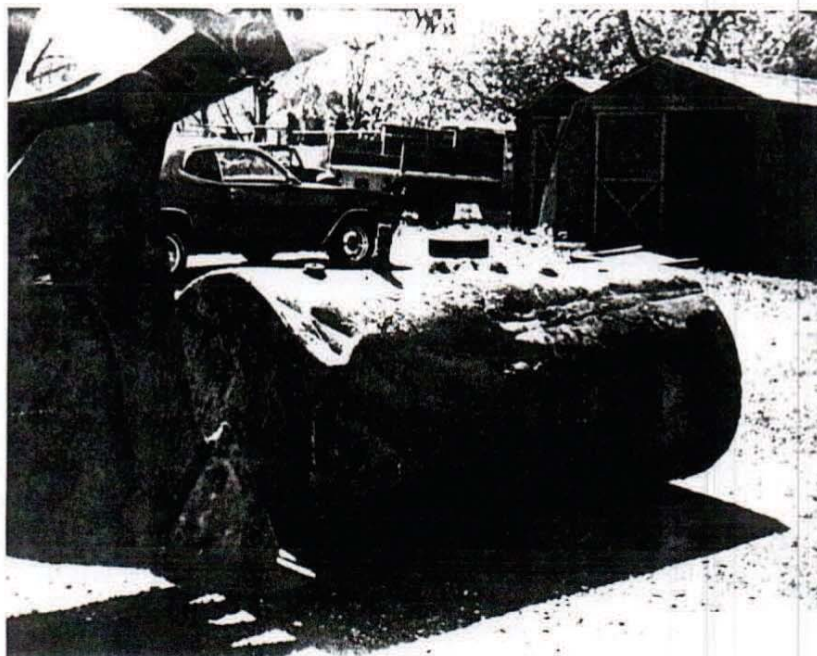
Below: 1,000 tank after removal

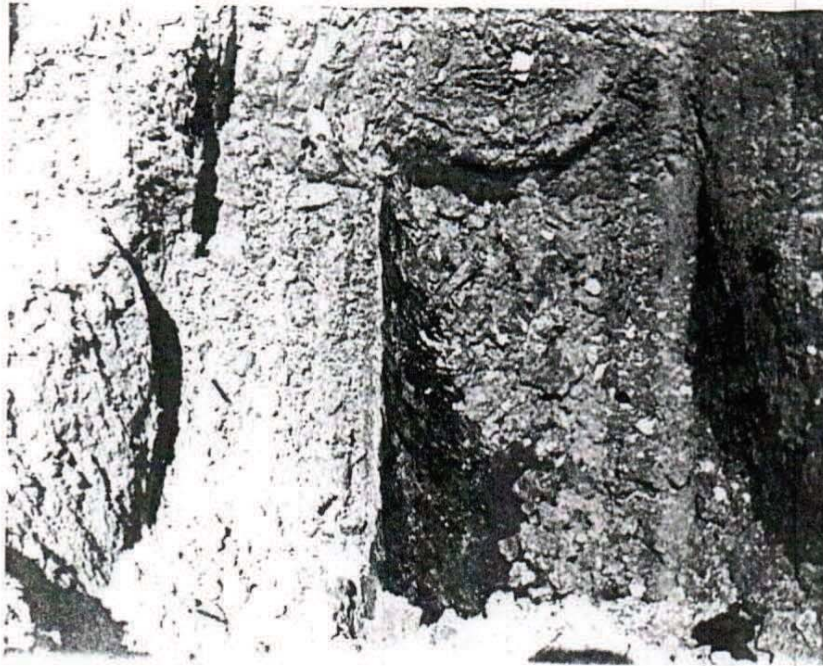
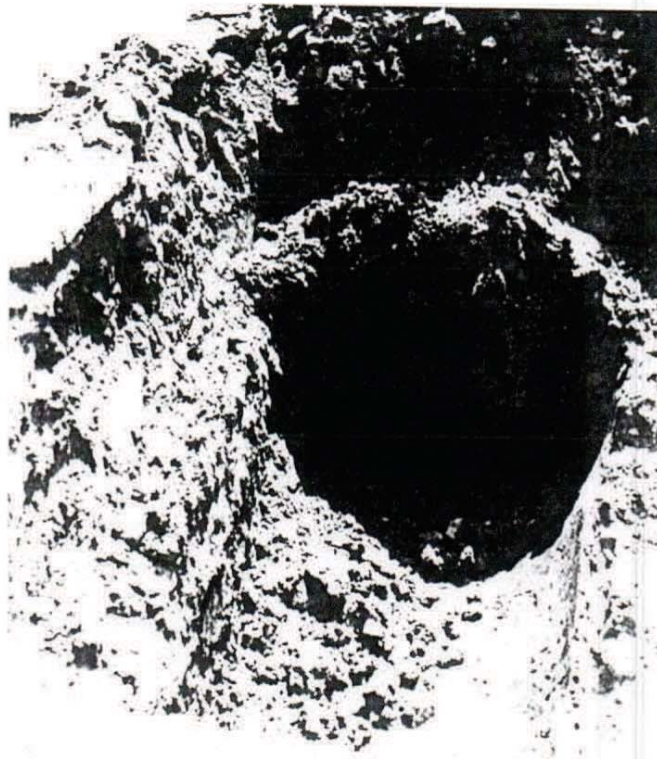
Above & Below: Excavation after 1,000  
tank removed

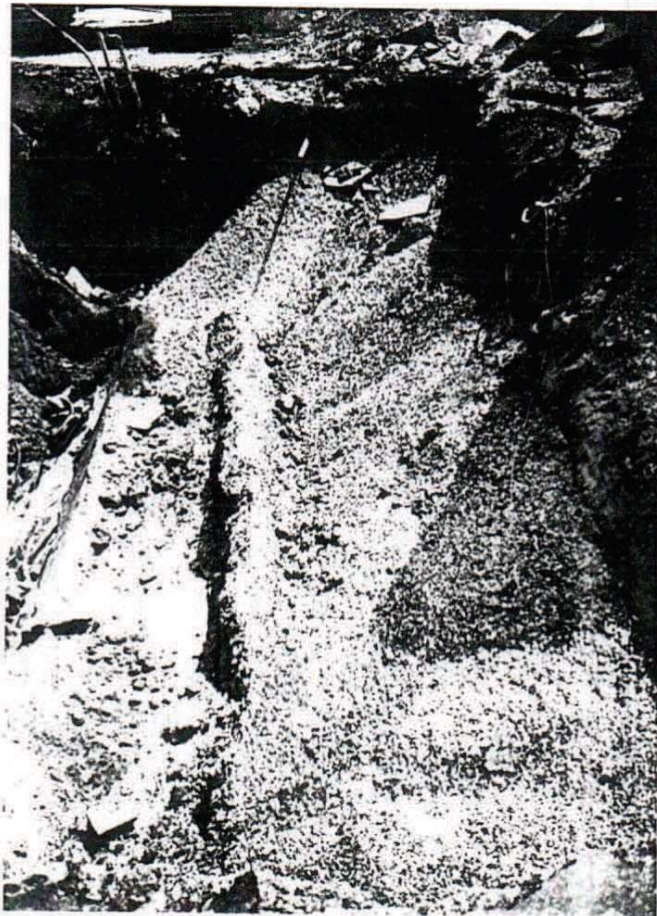
Above: Excavation after 4,000 & 6,000 tanks removed

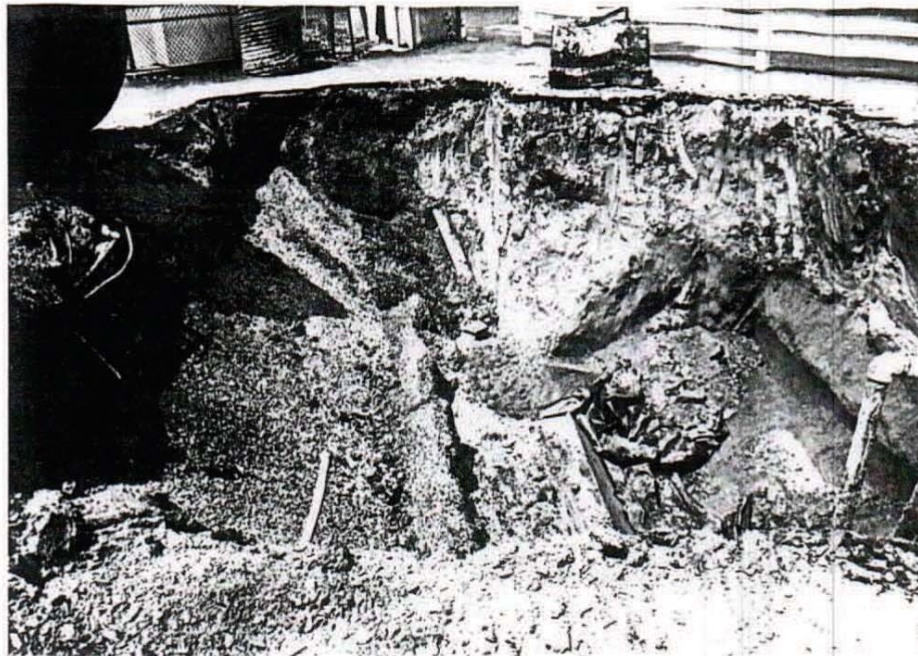
Below: Excavation after remediation and prepared for new tank installation
