SITE CHARACTERIZATION REPORT

Seneca Mini Mart
3390 State Route 257,
Seneca, Venango County, Pennsylvania
PADEP Facility ID # 61-18854

September 13, 2017

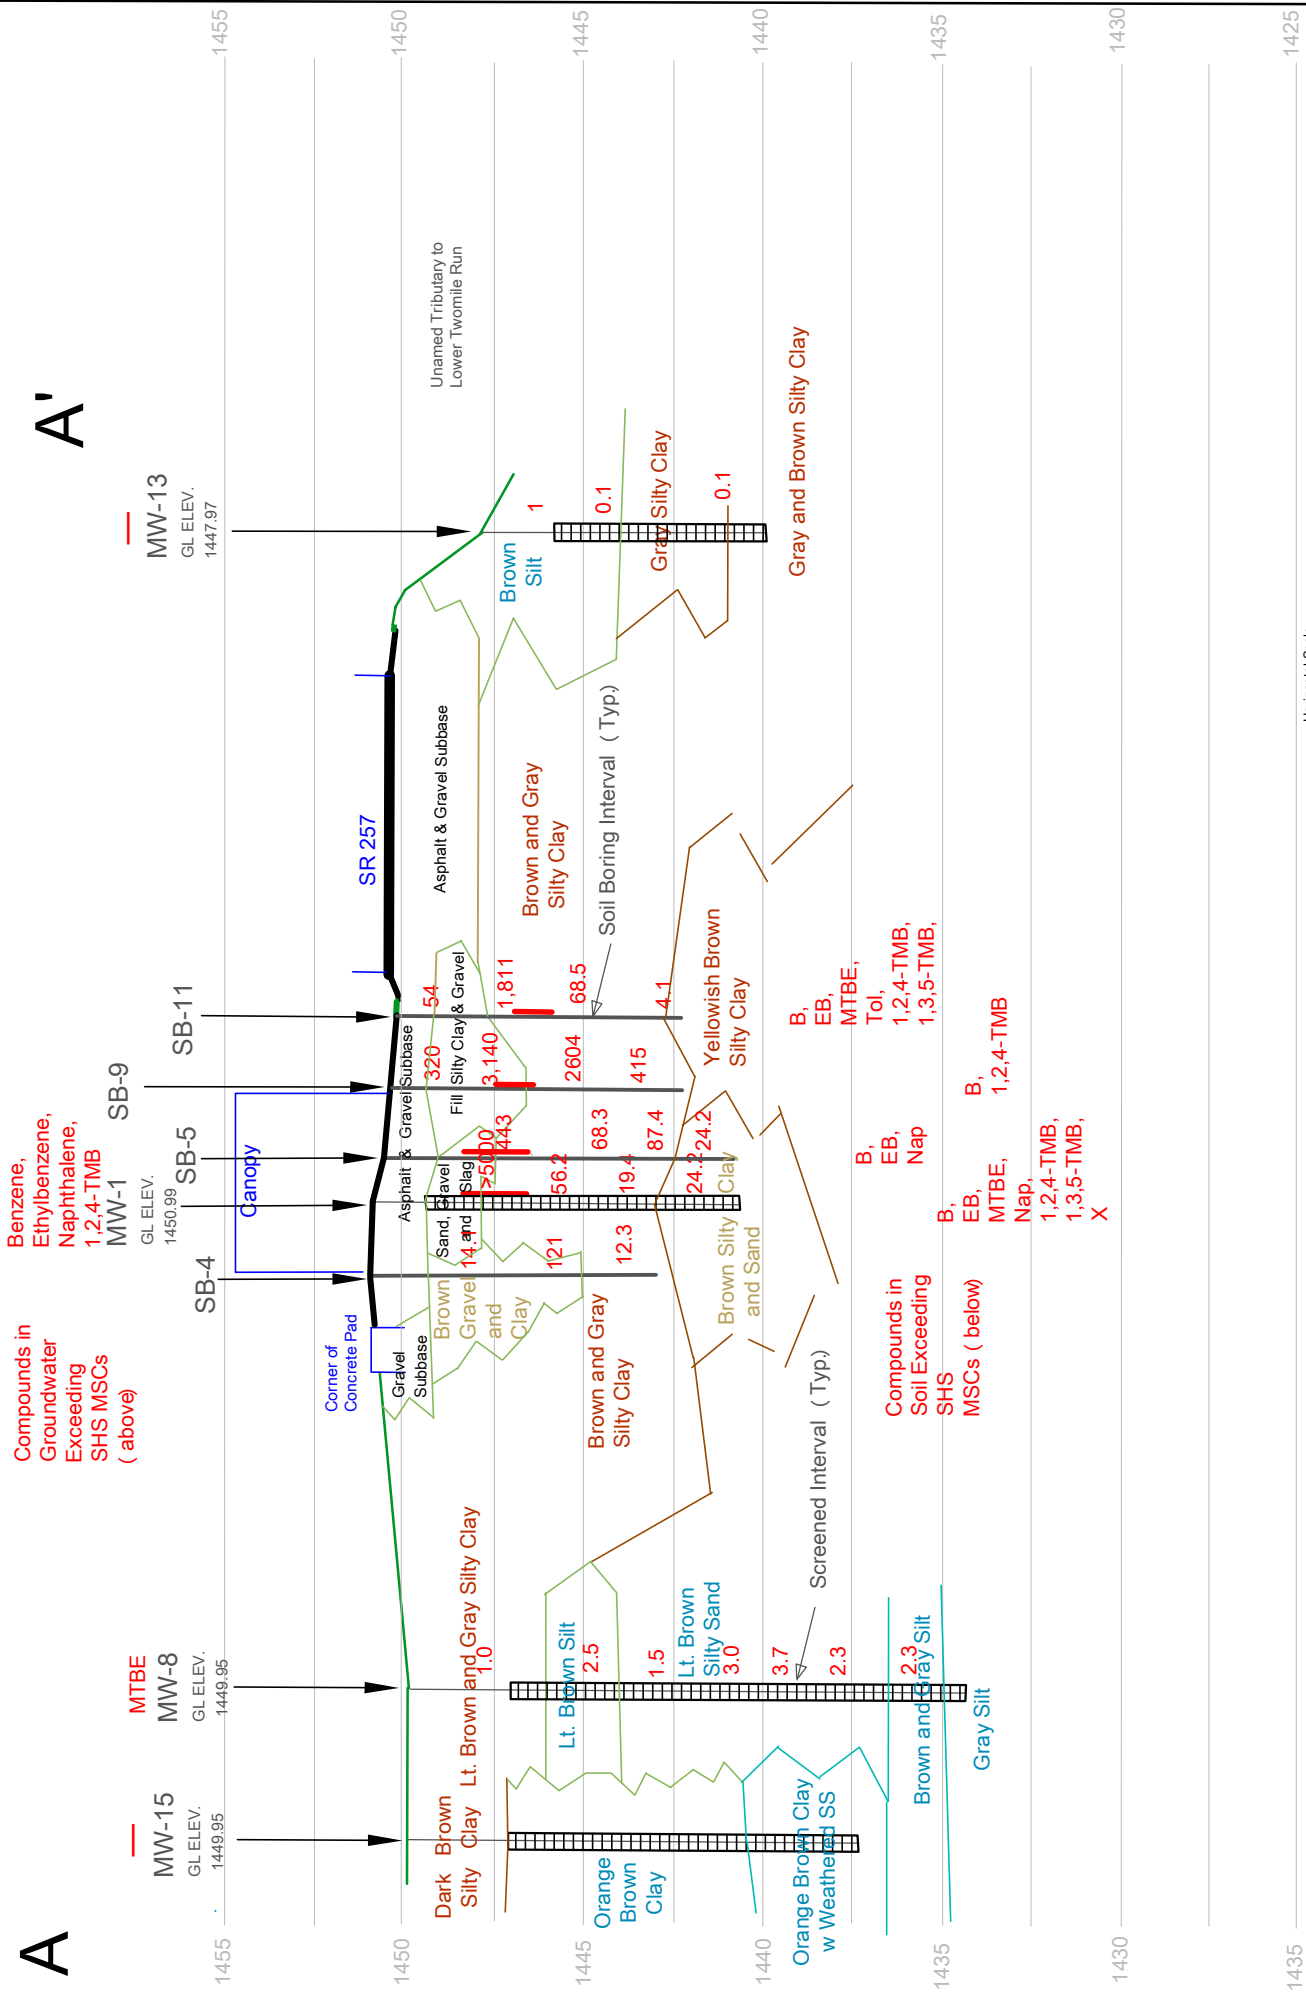
FIGURE 9

Cross Section A - A'

PID Values Listed Beside Interval in ppm

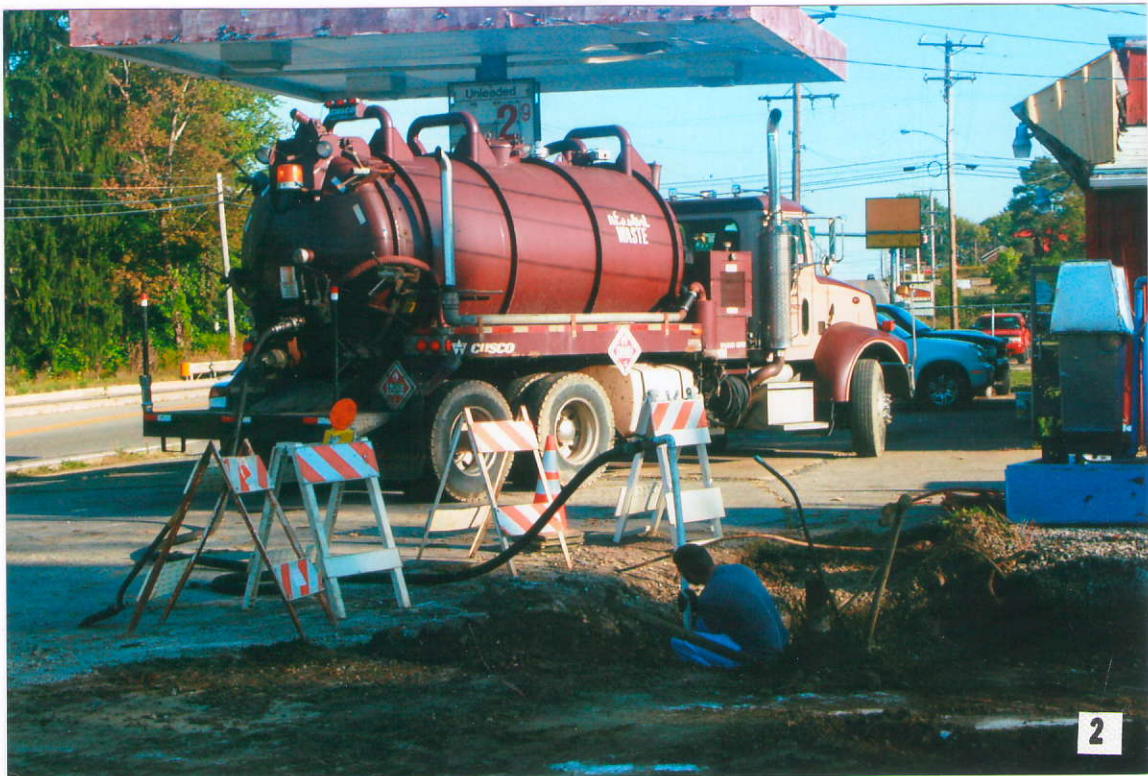
Photograph #1 – Removal of product from tanks

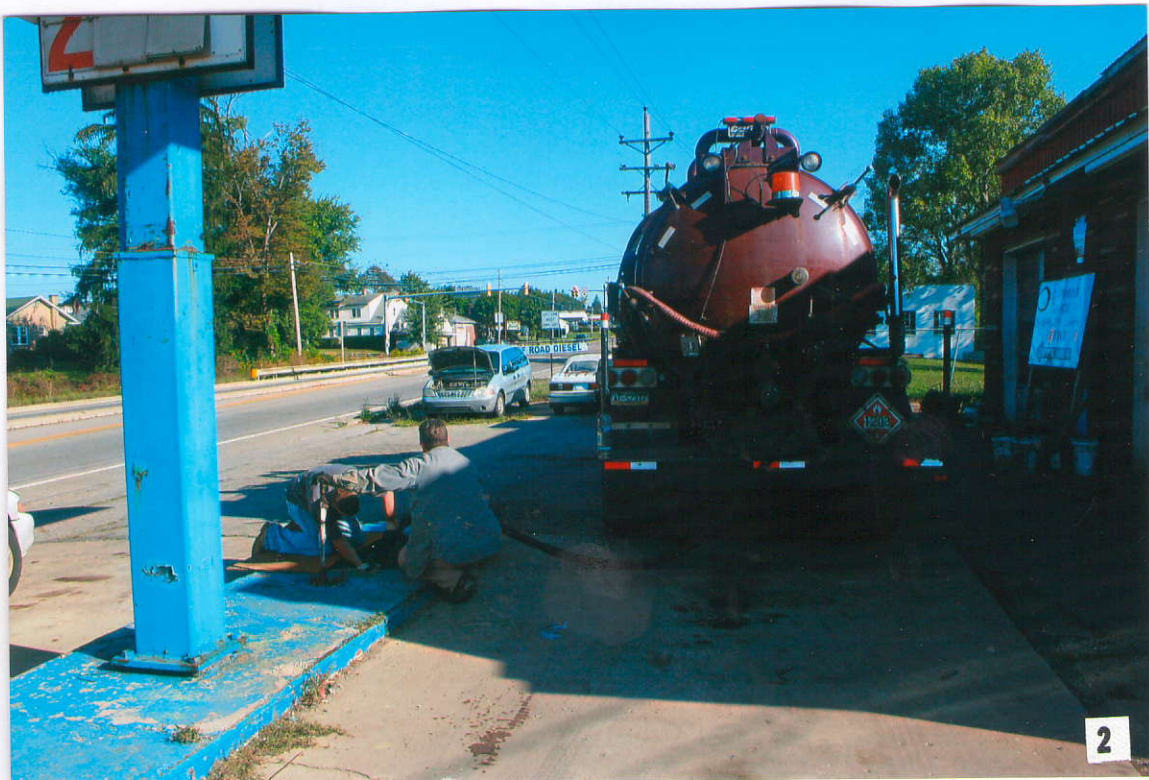
Photograph #2 – Removal product from lines

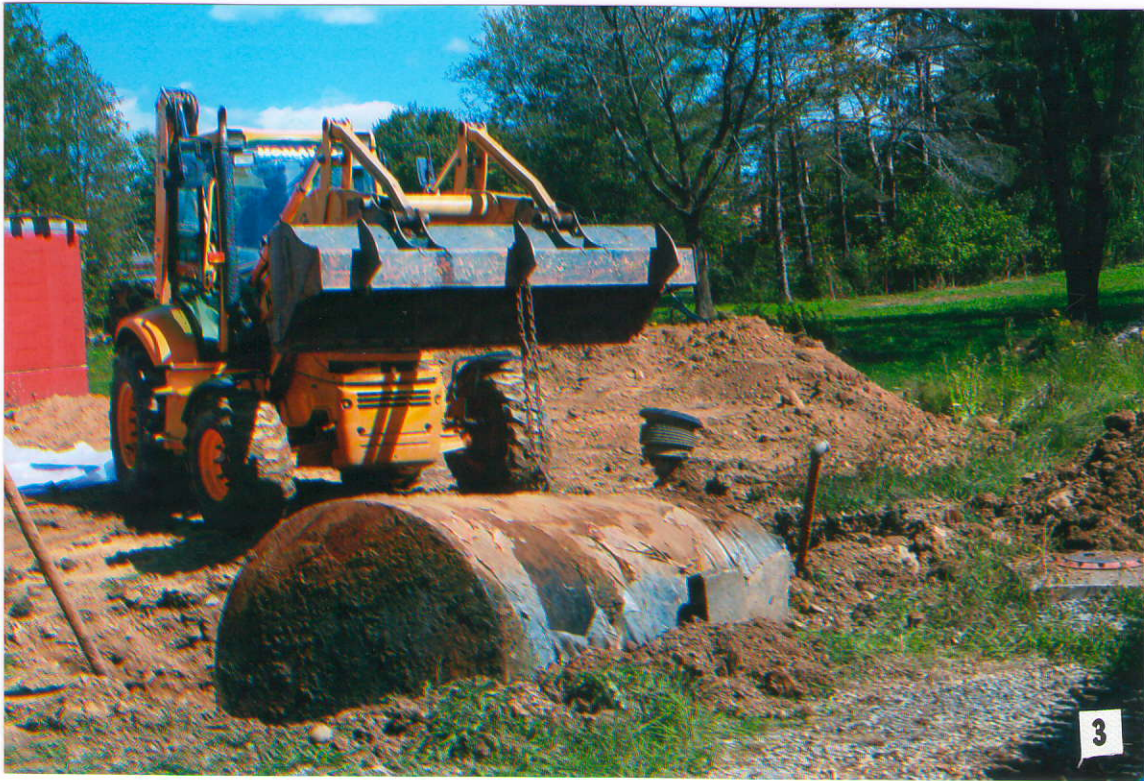
Photograph #3 – Removal of Tank #005 (1000 gallon kerosene)

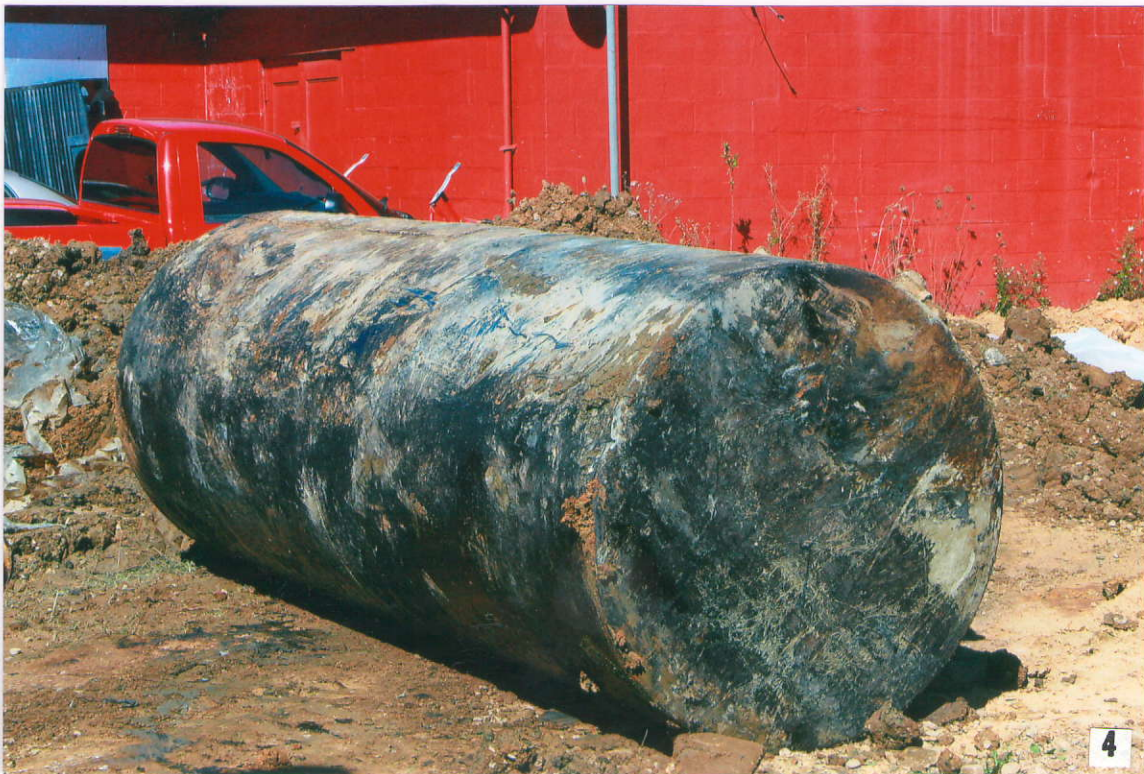
Photograph #4 – Removal of Tank #004 (2,000 gallon diesel)

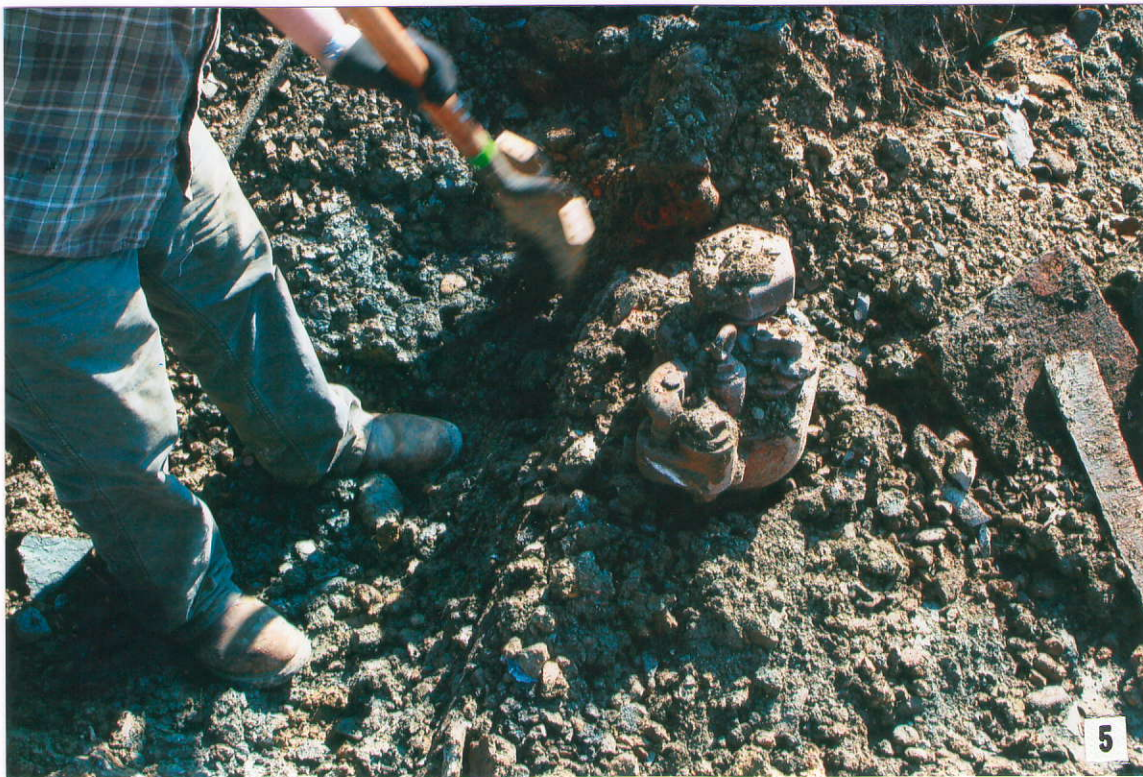
Photograph #5 – Impacted soil near pressure pump on Tank #001

It appears as if leakage from the dispensers and the product line fitting adjacent to the dispensers is the likely cause of the observed soil impacts. According to Koziara, a total of approximately 430 tons of soil was excavated from the vicinity of the dispenser islands and the four USTs during the removal activities. According to Koziara, approximately 350 tons came from the vicinity of the gasoline USTs, and gasoline associated dispenser islands and product lines had notable hydrocarbon odors. The gasoline impacted soil was stockpiled on the property encapsulated in 6 mil plastic pending disposal of the gasoline impacted soil stockpile.

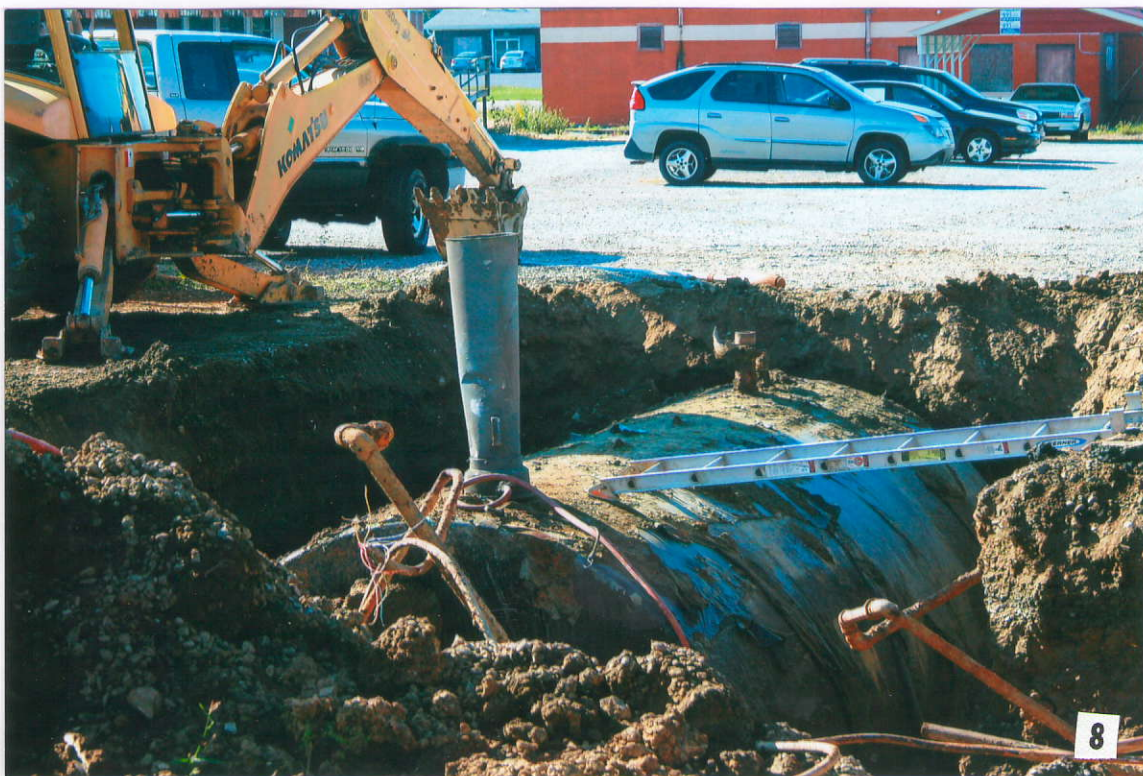
Photograph #6 – Vapor removal from tanks

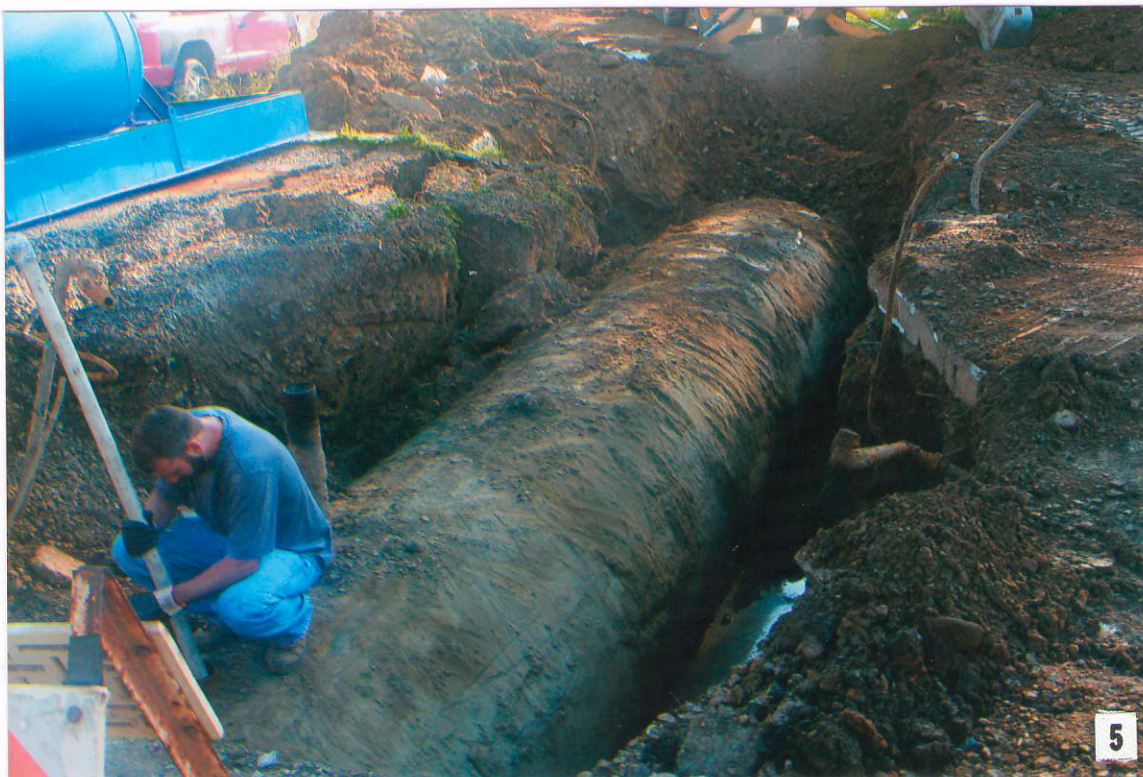
Photograph #7 – Removal of Tank #001 (6000 gallon gasoline)

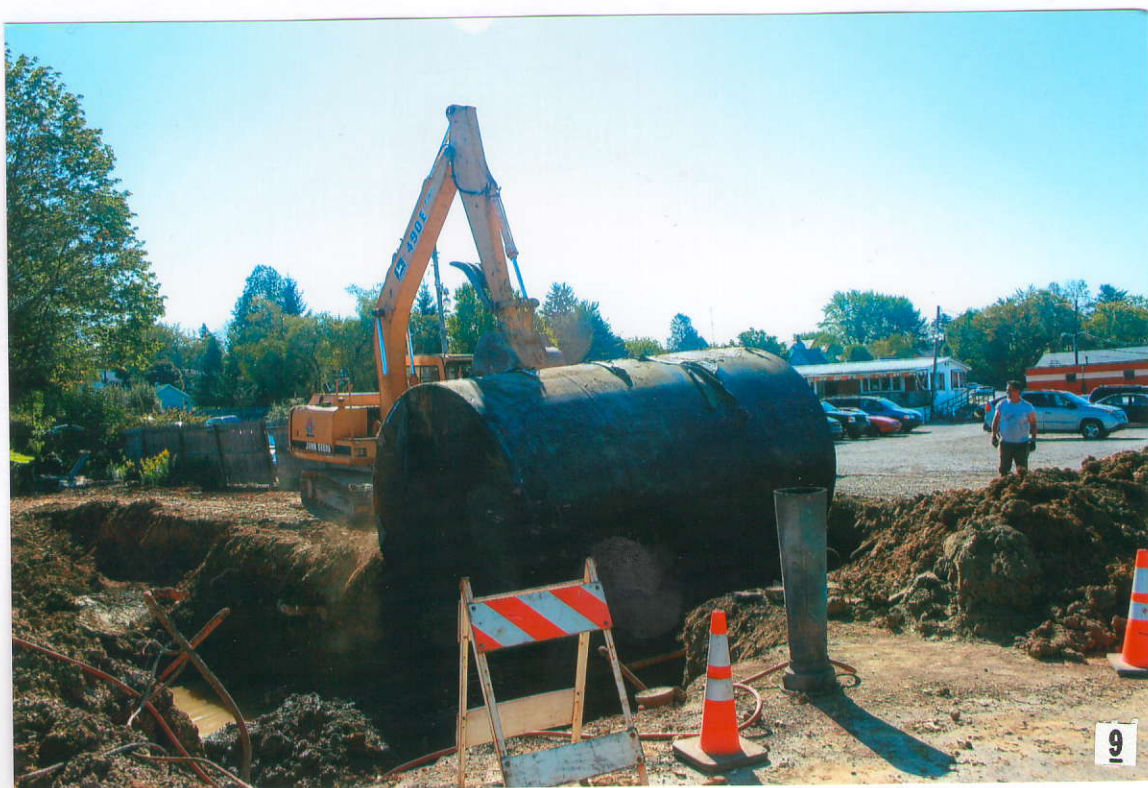
Photograph #8 – Removal of Tank #003 (10,000 gallon gasoline)

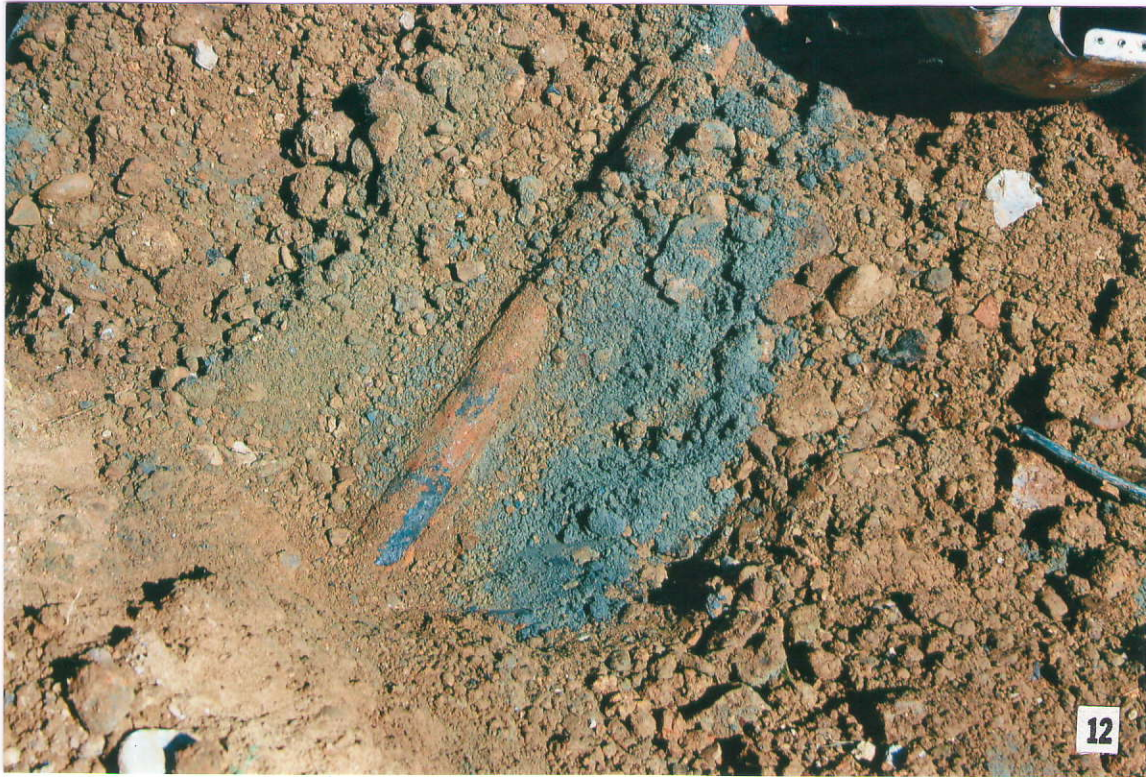
Photograph #9 – Contaminated soil around supply line from Tank #004

It appears that leakage from the dispensers and product lines adjacent to the dispensers is the likely cause of the observed soil impacts. This release was likely a chronic release in a product distribution line or at a dispenser that occurred over many years. This is also evident as the leak detection/tank gauging system never registered a significant release. The exact volume of the release is not known.

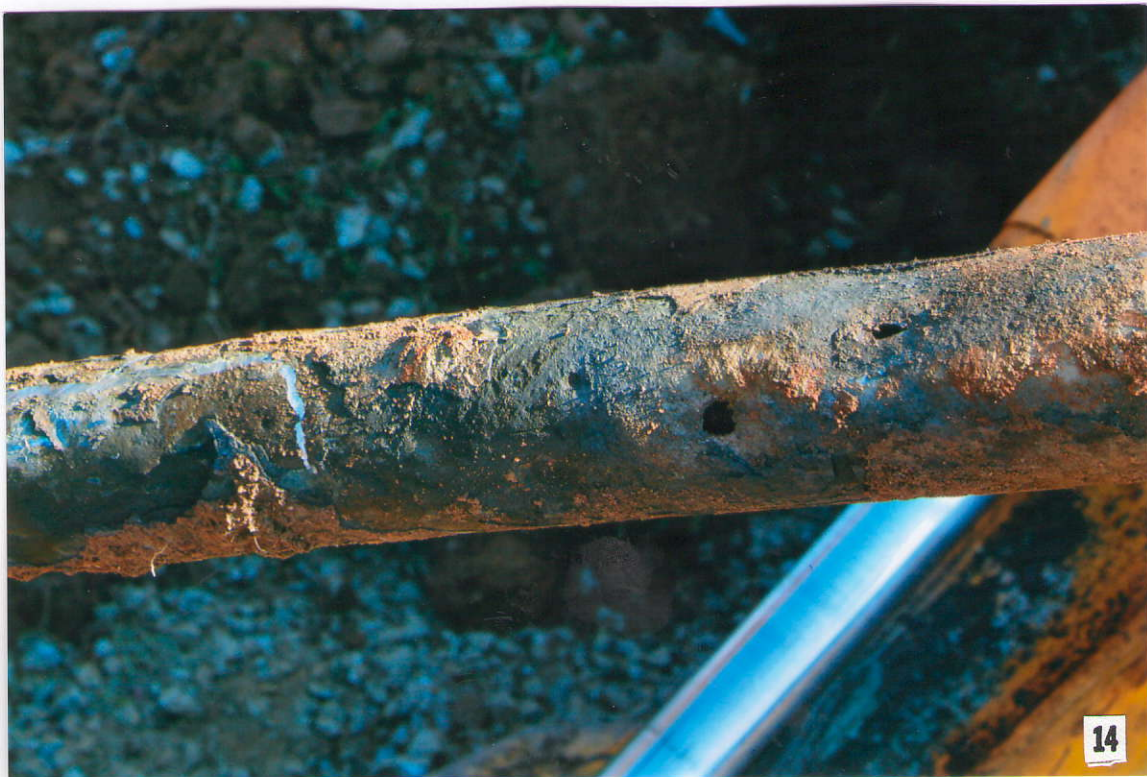
Photograph #10 – Holes in supply line from Tank #004

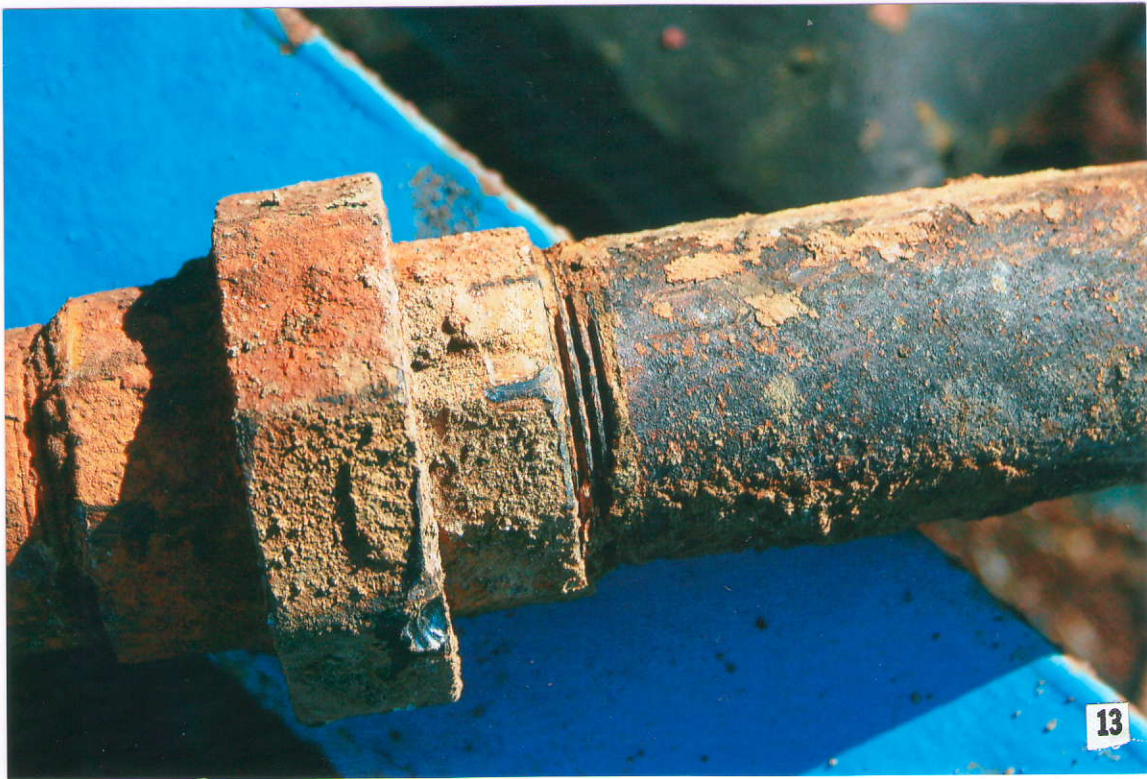
Photograph #11 – Leaking fitting on Tank #003

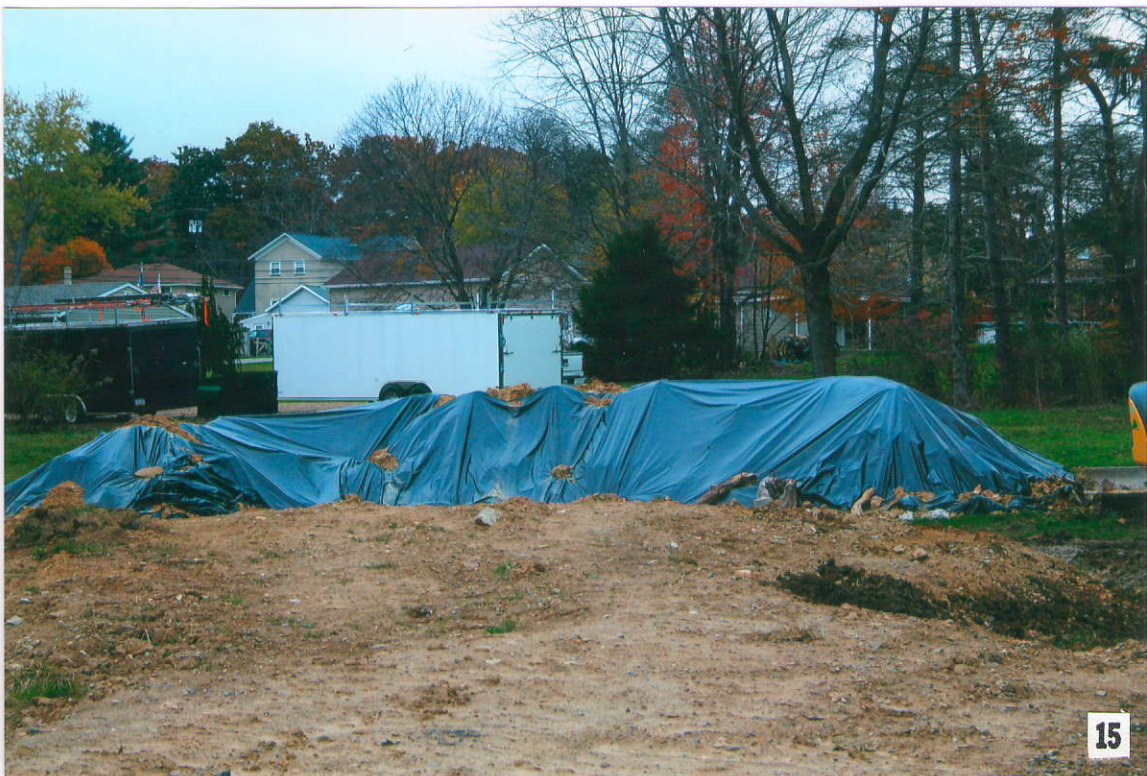
Photograph #12 – Contaminated soil pile

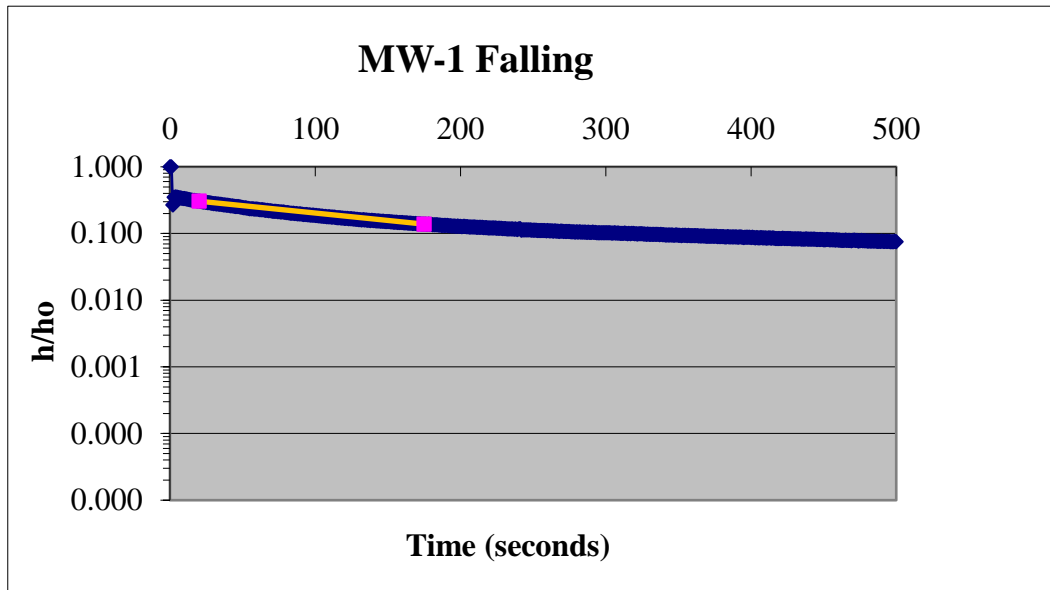
T	h/h_0
Initial	20	0.305
Final	175	0.138
Hvorslev Time	195.45	seconds

$r =$	0.083 feet	$r^2 * \ln$	0.0186003
$R =$	0.666 feet	$2LT$	2439.16558
$L =$	6.24 feet		
$T_0 =$	195.45 sec	$K =$	$\frac{r^2 * \ln(L/R)}{2LT_0}$
$r^2 =$	0.006889	K =	7.62568E-06 feet/sec
$L/R =$	9.369369369	K =	0.658858887 feet/day
$\ln(L/R) =$	2.7	K =	0.000232402 cm/sec

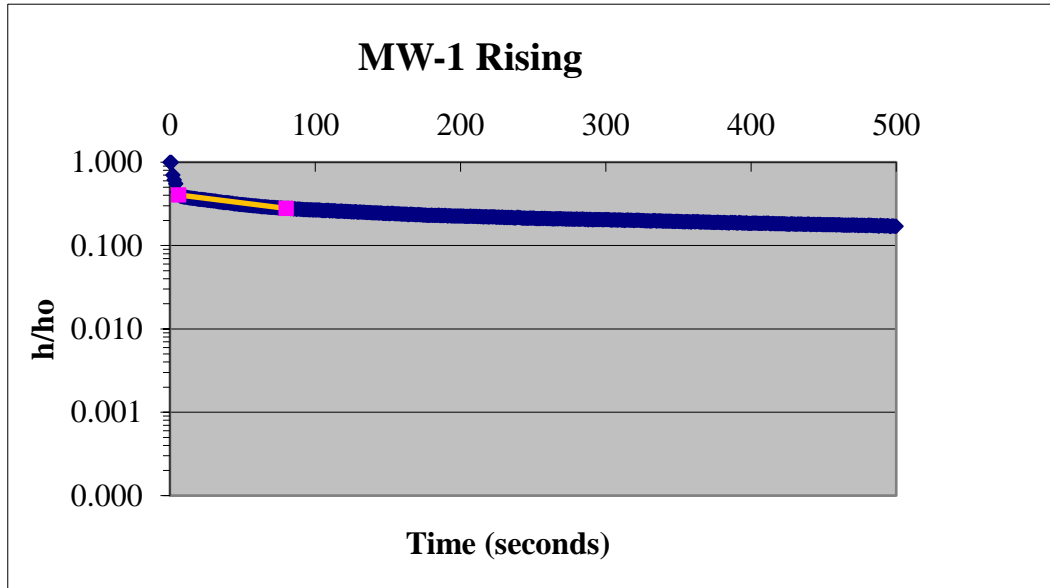
T	h/h_0
Initial	6	0.405
Final	80	0.279
Hvorslev Time	198.56	seconds

$r =$	0.083 feet	$r^2 * \ln$	0.0186003
$R =$	0.666 feet	$2LT$	889.567978
$L =$	2.24 feet		
$T_0 =$	198.56 sec	$K =$	$\frac{r^2 * \ln(L/R)}{2LT_0}$
$r^2 =$	0.006889	K =	2.09094E-05 feet/sec
$L/R =$	3.363363363	K =	1.806568986 feet/day
$\ln(L/R) =$	2.7	K =	0.000637238 cm/sec

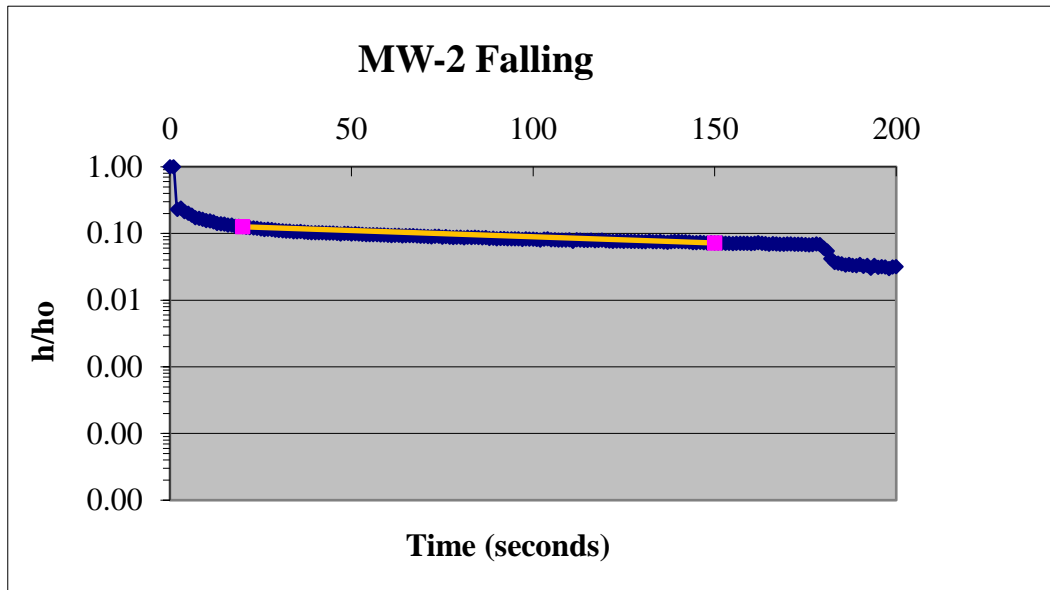
T	h/h_0
Initial	20	0.126
Final	150	0.072
Hvorslev Time	232.30	seconds

$r =$	0.083 feet	$r^2 * \ln$	0.0186003
$R =$	0.666 feet	$2LT$	2625.01529
$L =$	5.65 feet		
$T_0 =$	232.30 sec	$K =$	$\frac{r^2 * \ln(L/R)}{2LT_0}$
$r^2 =$	0.006889	K =	7.08579E-06 feet/sec
$L/R =$	8.483483483	K =	0.612212023 feet/day
$\ln(L/R) =$	2.7	K =	0.000215948 cm/sec

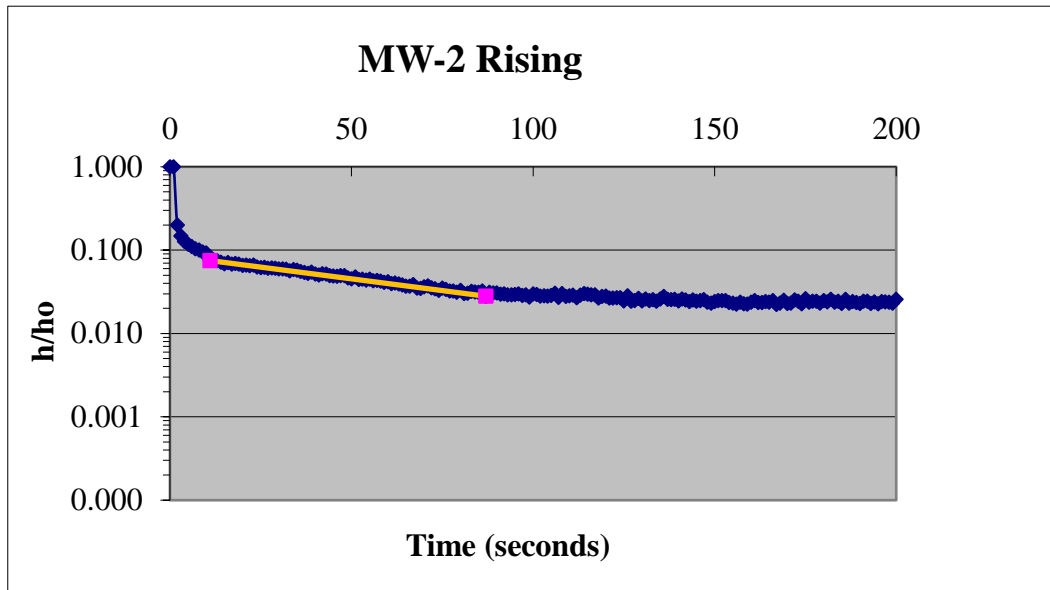
T	h/h_0
Initial	11	0.075
Final	87	0.028
Hvorslev Time	77.14	seconds

$r =$	0.083 feet	$r^2 * \ln$	0.0186003
$R =$	0.666 feet	$2LT$	871.6272118
$L =$	5.65 feet		
$T_0 =$	77.14 sec	$K =$	$\frac{r^2 * \ln(L/R)}{2LT_0}$
$r^2 =$	0.006889	K =	2.13397E-05 feet/sec
$L/R =$	8.483483483	K =	1.843753727 feet/day
$\ln(L/R) =$	2.7	K =	0.000650354 cm/sec

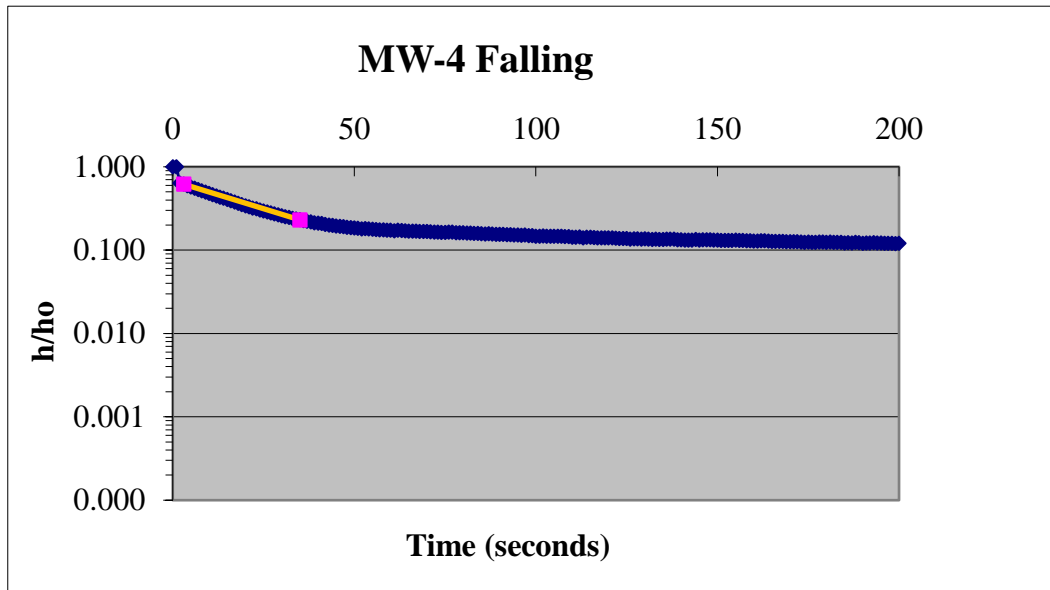
T	h/h_0
Initial	3	0.618
Final	35	0.231
Hvorslev Time	32.52	seconds

$r =$	0.083 feet	$r^2 * \ln$	0.0186003
$R =$	0.666 feet	$2LT$	438.3424681
$L =$	6.74 feet		
$T_0 =$	32.52 sec	$K =$	$\frac{r^2 * \ln (L/R)}{2LT_0}$
$r^2 =$	0.006889	$K =$	4.24333E-05 feet/sec
$L/R =$	10.12012012	$K =$	3.66623368 feet/day
$\ln (L/R) =$	2.7	$K =$	0.001293204 cm/sec

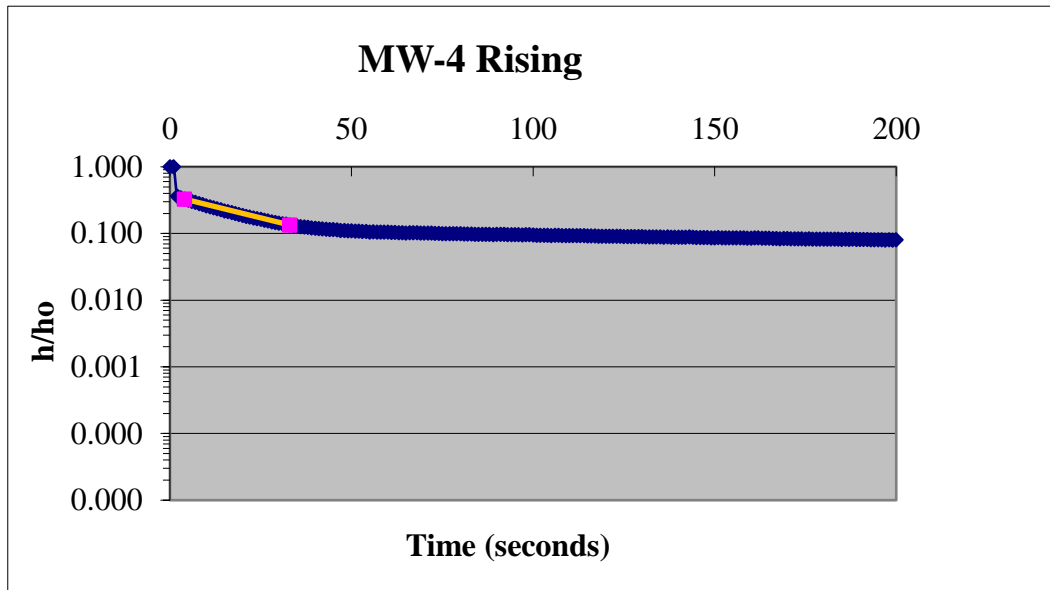
T	h/h_0
Initial	4	0.328
Final	33	0.134
Hvorslev Time	32.40	seconds

$r =$	0.083 feet	$r^2 * \ln$	0.0186003
$R =$	0.666 feet	$2LT$	436.6973166
$L =$	6.74 feet	$K =$	$\frac{r^2 * \ln(L/R)}{2LT_0}$
$T_0 =$	32.40 sec	$K =$	4.25931E-05 feet/sec
$r^2 =$	0.006889	$K =$	3.680045329 feet/day
$L/R =$	10.12012012	$K =$	0.001298076 cm/sec
$\ln(L/R) =$	2.7

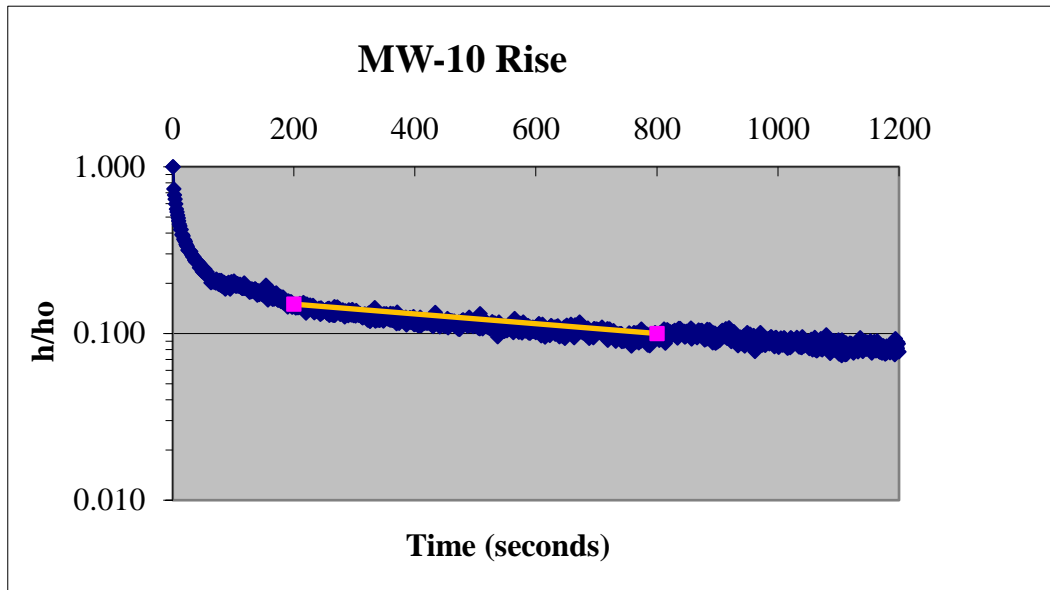
T	h/h_0
Initial	200	0.15
Final	800	0.1
Hvorslev Time	1479.78	seconds

$r =$	0.083 feet	$r^2 * \ln$	0.0186003
$R =$	0.666 feet	$2LT$	9677.774786
$L =$	3.27 feet		
$T_0 =$	1479.78 sec	$K =$	$\frac{r^2 * \ln (L/R)}{2LT_0}$
$r^2 =$	0.006889	K =	1.92196E-06 feet/sec
$L/R =$	4.90990991	K =	0.166057379 feet/day
$\ln (L/R) =$	2.7	K =	5.8574E-05 cm/sec

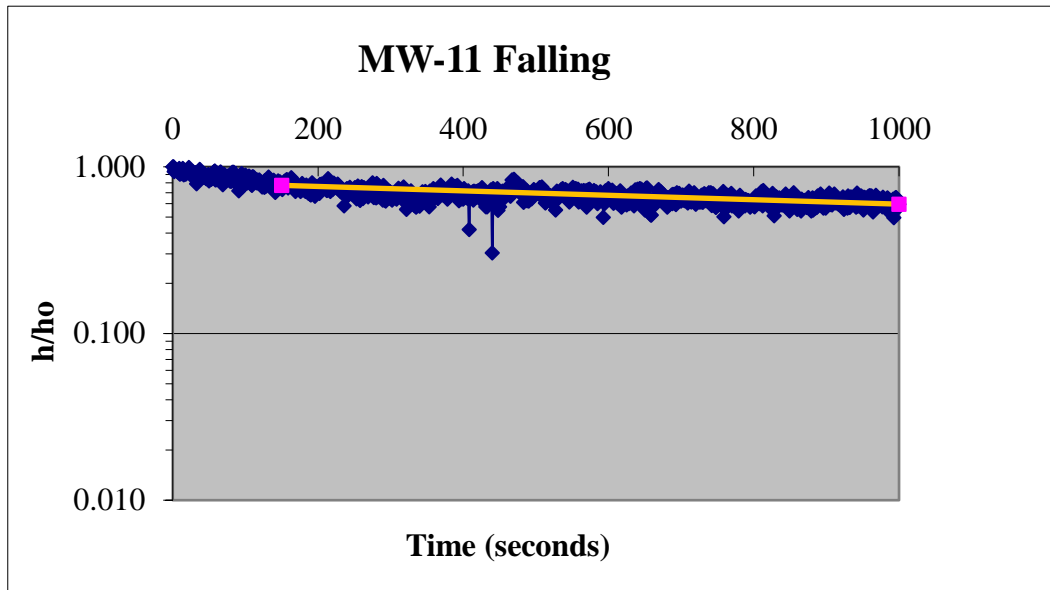
T	h/h_0
Initial	150	0.774
Final	1000	0.597
Hvorslev Time	3273.58	seconds

$r =$	0.083 feet	$r^2 * \ln$	0.0186003
$R =$	0.666 feet	$2LT$	34438.03608
$L =$	5.26 feet		
$T_0 =$	3273.58 sec	$K =$	$\frac{r^2 * \ln (L/R)}{2LT_0}$
$r^2 =$	0.006889	$K =$	5.40109E-07 feet/sec
$L/R =$	7.897897898	$K =$	0.046665435 feet/day
$\ln (L/R) =$	2.7	$K =$	1.64605E-05 cm/sec

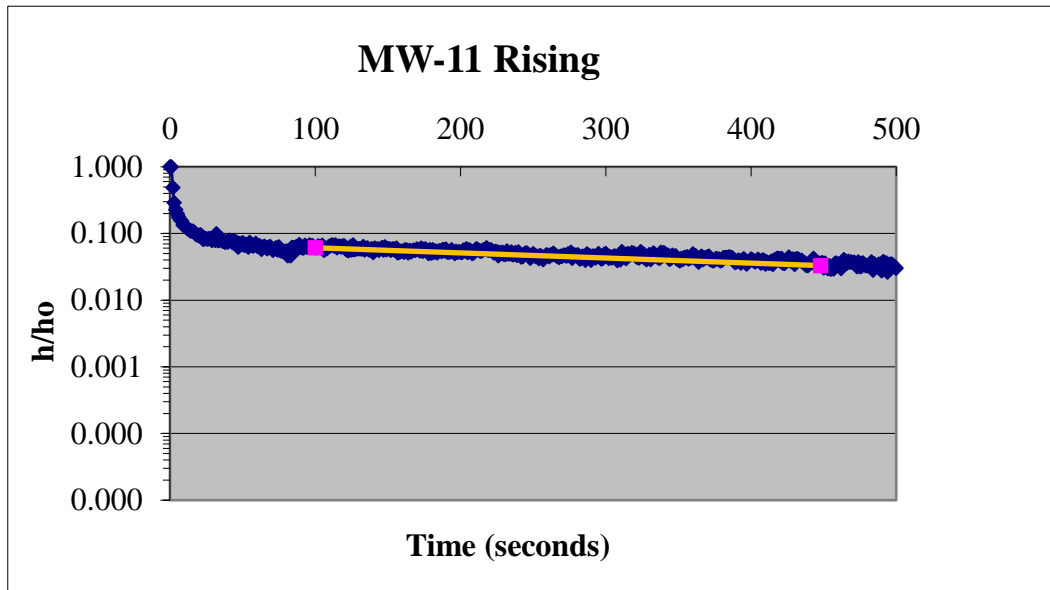
T	h/h_0
Initial	100	0.061
Final	448	0.033
Hvorslev Time	566.44	seconds

$r =$	0.083 feet	$r^2 * \ln$	0.0186003
$R =$	0.666 feet	$2LT$	5958.920572
$L =$	5.26 feet		
$T_0 =$	566.44 sec	$K =$	$\frac{r^2 * \ln(L/R)}{2LT_0}$
$r^2 =$	0.006889	K =	3.12142E-06 feet/sec
$L/R =$	7.897897898	K =	0.269690777 feet/day
$\ln(L/R) =$	2.7	K =	9.5129E-05 cm/sec

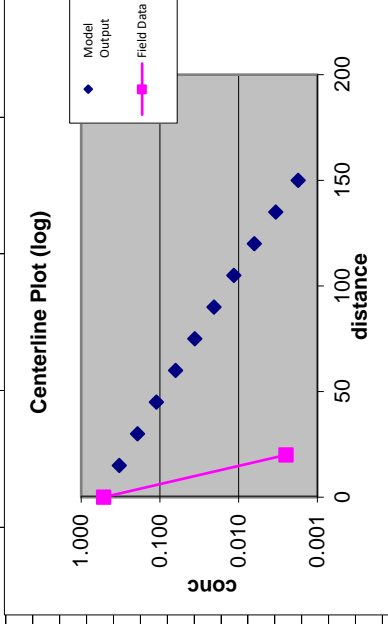
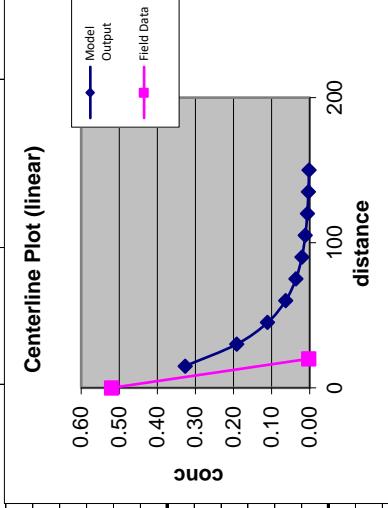
ADVECTIVE TRANSPORT WITH THREE DIMENSIONAL DISPERSION,1ST ORDER DECAY and RETARDATION - WITH CALIBRATION TOOL																
Project: Seneca Mini Mart		Prepared by: RRB														
Date: 7/26/2017		Contaminant: MTBE, MW-8
