REVISED FEASIBLE REMEDIAL ALTERNATIVES ANALYSIS REPORT

PUMP-N-PANTRY #001 PROPERTY

99 GROW AVENUE

BRIDGEWATER TOWNSHIP, SUSQUEHANNA COUNTY, PENNSYLVANIA

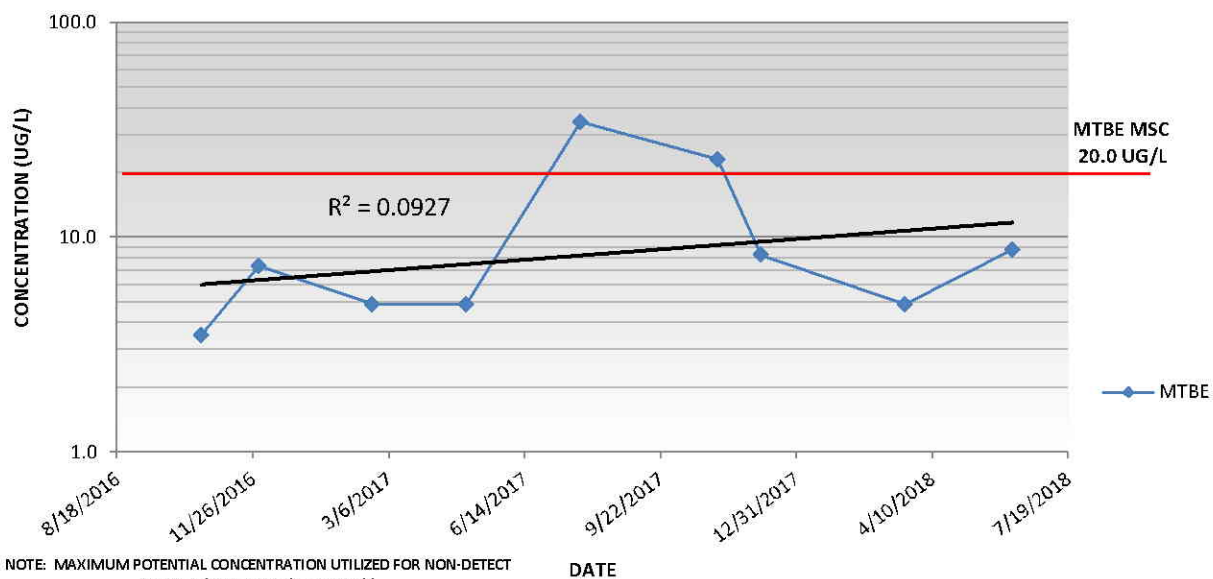
**MW-2  
MTBE VS TIME**

NOTE: MAXIMUM POTENTIAL CONCENTRATION UTILIZED FOR NON-DETECT RESULTS (I.E. <5.0 UG/L = 4.9 UG/L)

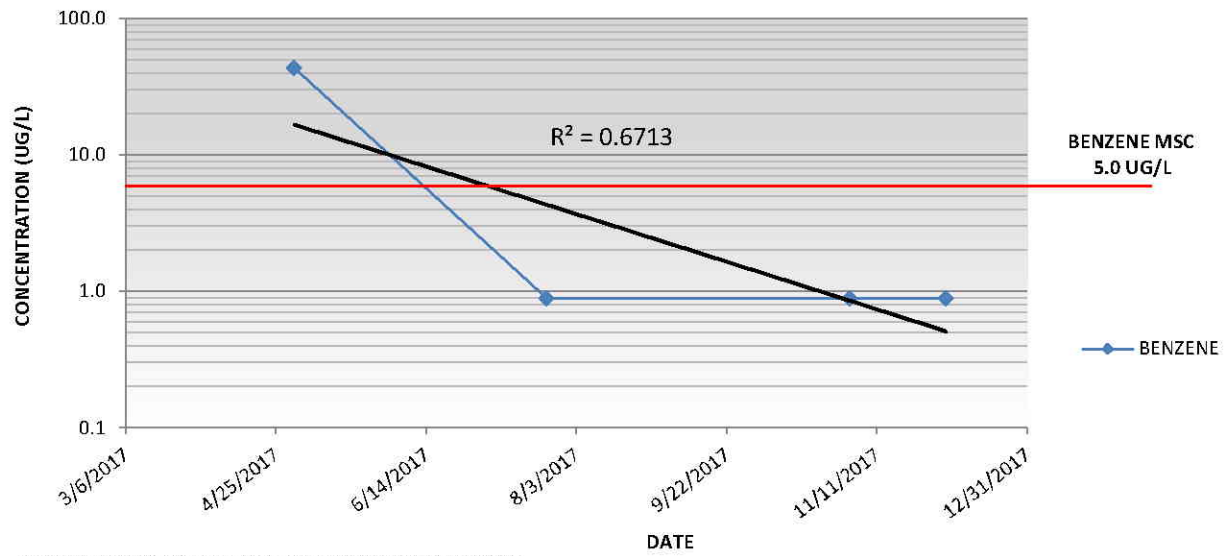
RW-1  
BENZENE VS TIME

NOTE: MAXIMUM POTENTIAL CONCENTRATION UTILIZED FOR NON-DETECT  
RESULTS (I.E. <1.0 UG/L = 0.9 UG/L)
