SITE CHARACTERIZATION REPORT AND REMEDIAL ACTION PLAN

Shenango Township Municipal Building
3439 Hubbard-West Middlesex Road
West Middlesex, PA 16159
Shenango Township, Mercer County
PADEP Facility ID No. 43-04177
PAUSTIF Claim No. 2016-008

March 15, 2017

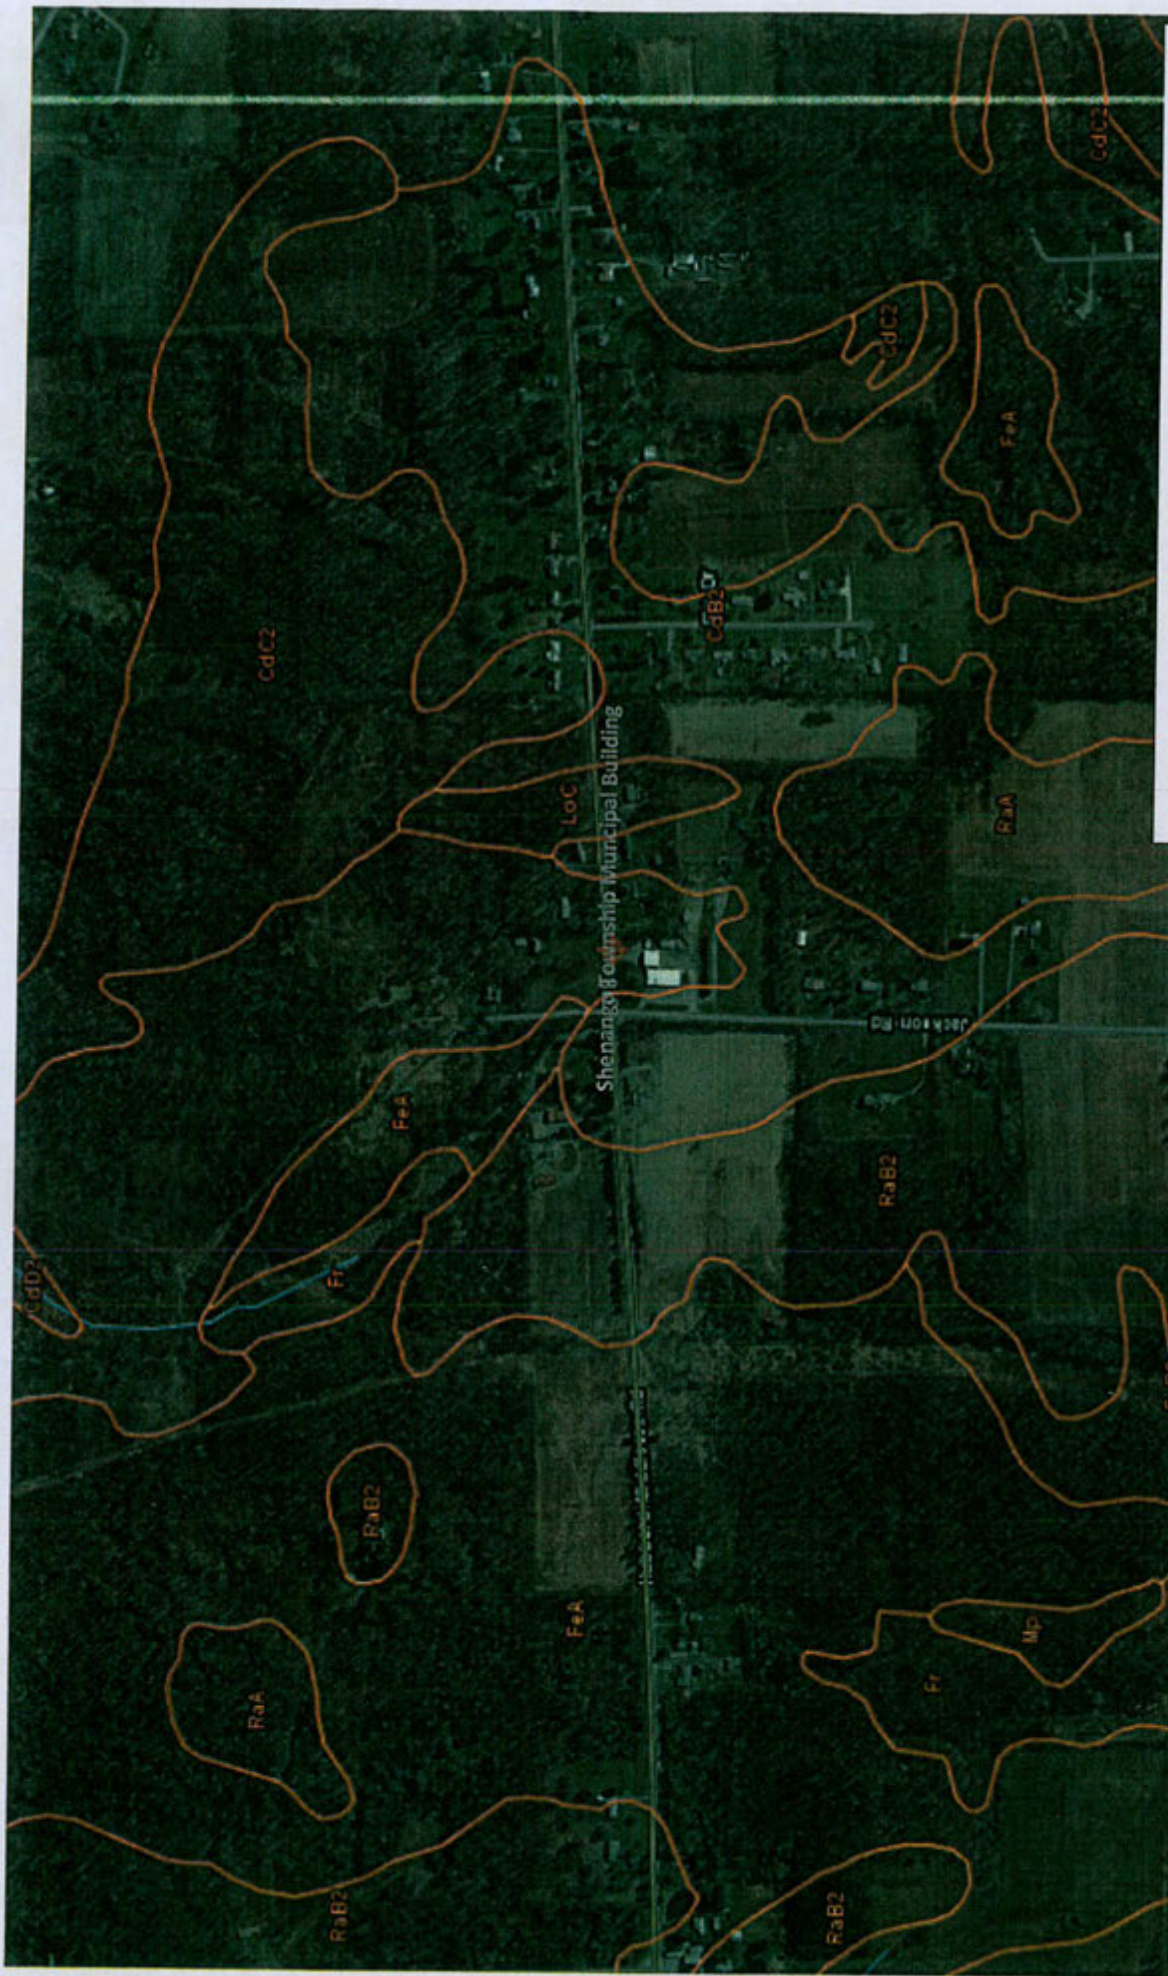
Figure 9- Soils Map

Soil Survey of Mercer County, USDA

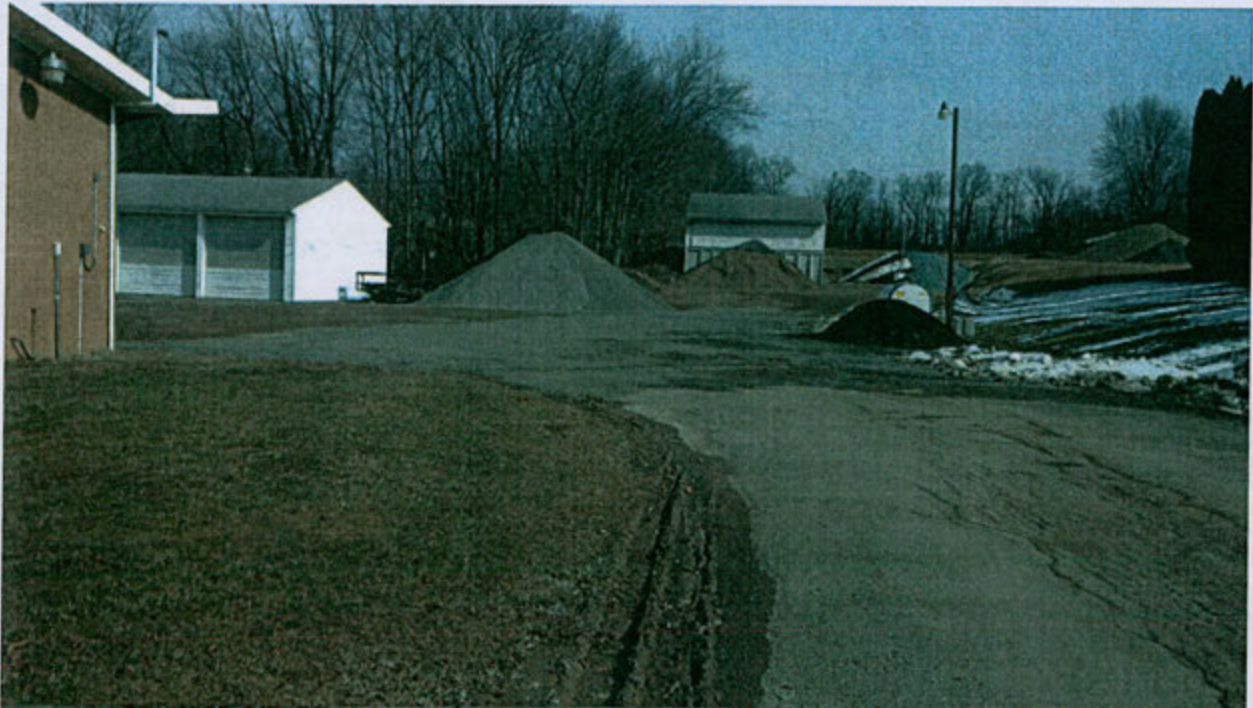
1) Looking East Toward Former UST Area.

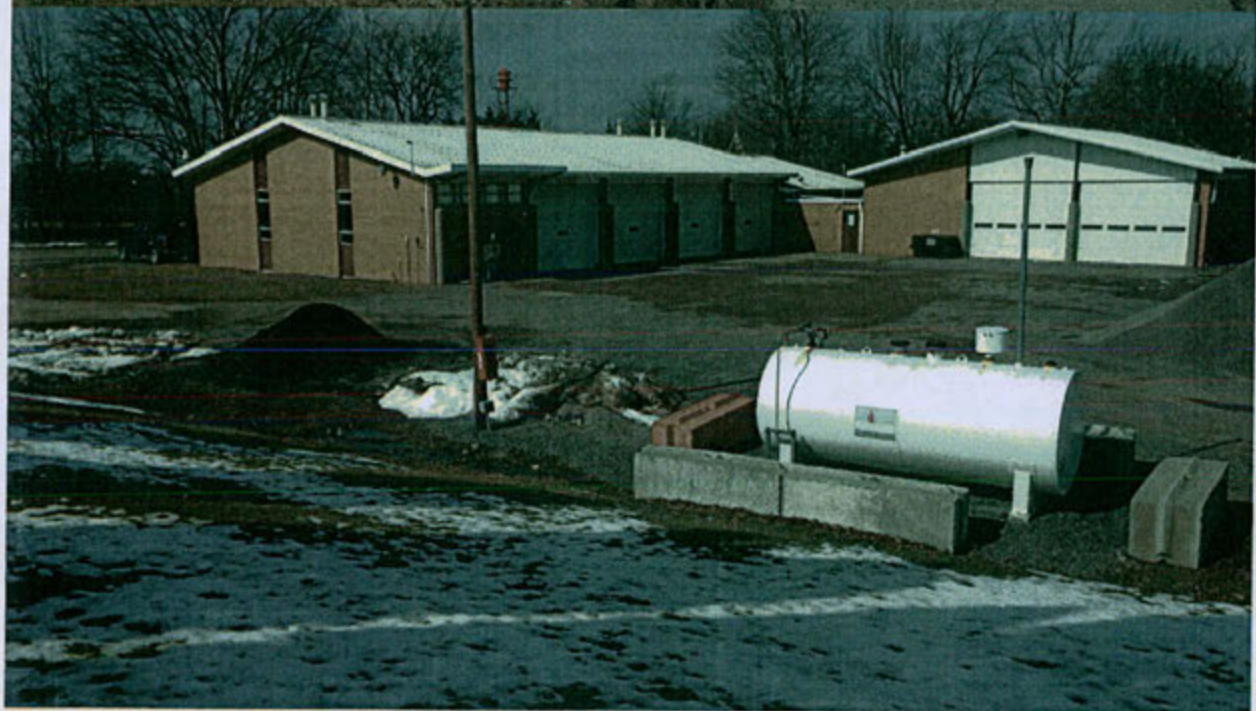
2) Looking N-NW Toward Former UST Area.

(AST) is currently located along the gravel driveway area southeast of the UST (Photographs #2 and 3). This AST is brand new and unused, having never contained any petroleum product or hazardous substance. No other fueling systems are known to exist within at least 1,000 feet of the Shenango Township UST systems. No other site investigations for a fuel release are known to exist or have existed within the area of concern for SC.

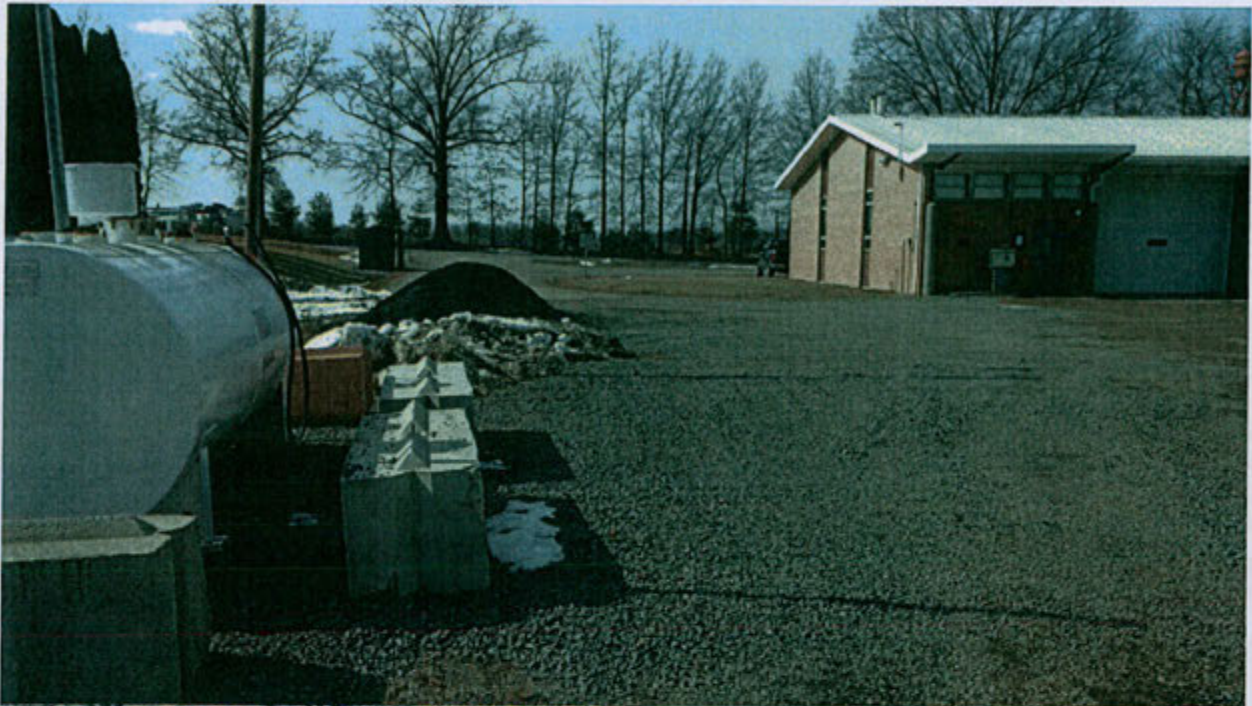
3) Looking West Toward Former UST Area.

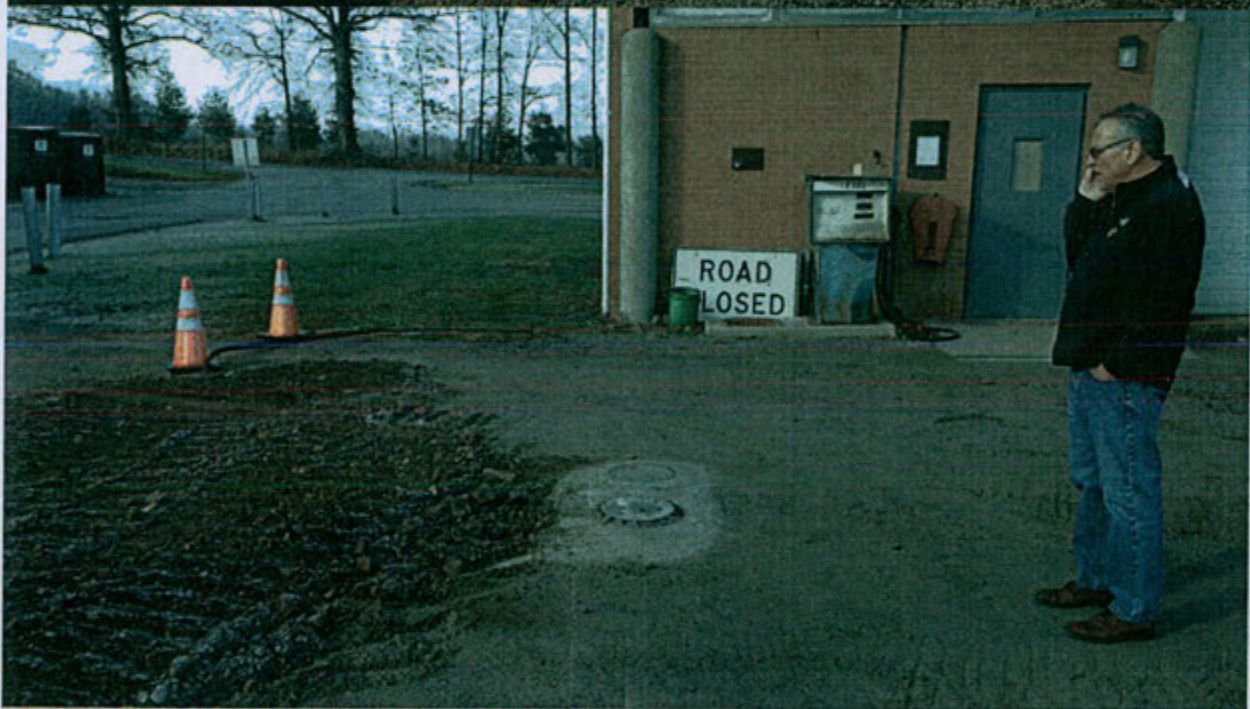
4) Looking West, N Edge of UST Excavation and Dispenser(s).

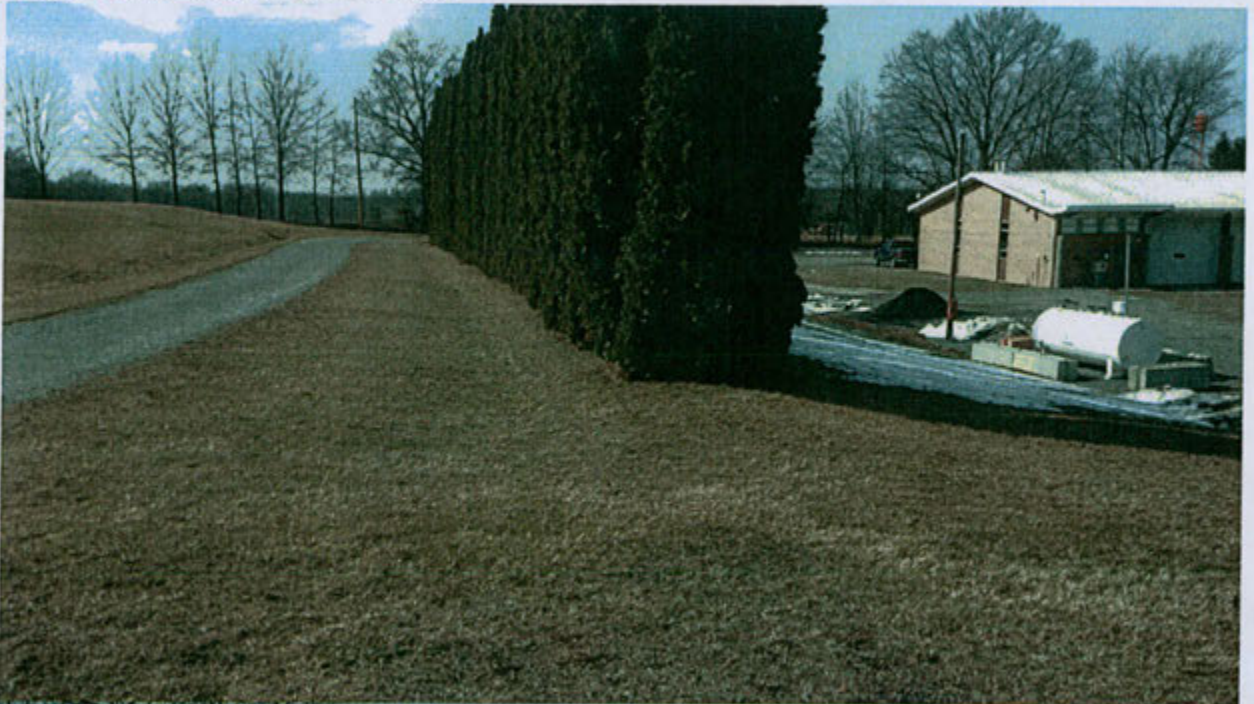
5) Looking West, South Side of Former UST Area.

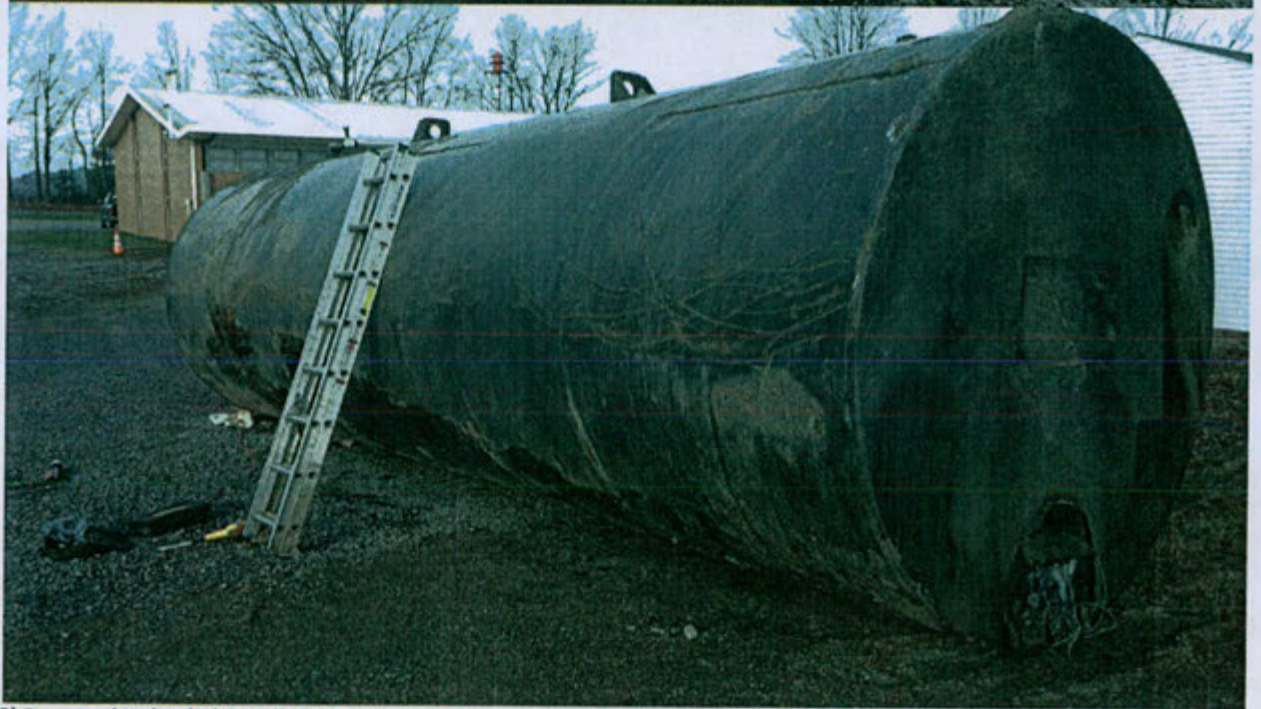
8) Removed Unleaded Gasoline UST.

Since being installed in 1979, Township personnel indicated that only routine maintenance has occurred to the tank systems. The UST systems were/are equipped with spill and overfill protection and a “Veeder-Root” leak detection system. The Veeder Root system automatically prints out leak detection reports that are retained by Township personnel. No leaks have been identified by the Veeder-Root system to date. According to Township personnel, the removed UST “looked perfect” when removed from the ground, as supported by Photograph #8 located in Appendix J.

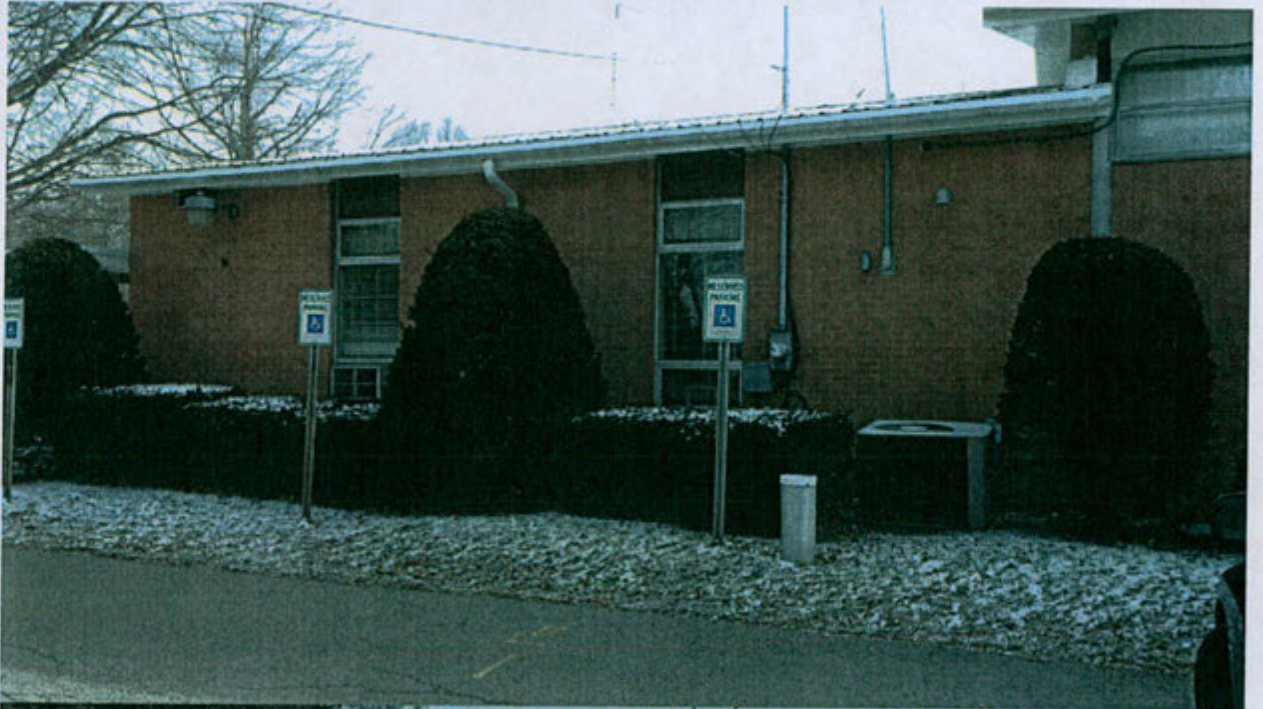
9) Shenango Twp Municipal Bldg Water Well (W Side).

One water supply well is present on the Shenango Township Municipal Building complex property. This well is located west of the office section of the main building, down-gradient from the UST cavity (Figure 4B and Photograph #9). This well has a reported total depth of 125 feet with surface casing extending to 27 feet. This Township water supply well was sampled on July 26, 2016, and on February 24, 2017; no detectable COC concentrations were found (Table 4). The Township water supply well is not used for consumption purposes and signs have been posted at sinks advising not to drink the water. A water cooler is provided for drinking water. The Township water well will be sampled monthly beginning in February 2017.

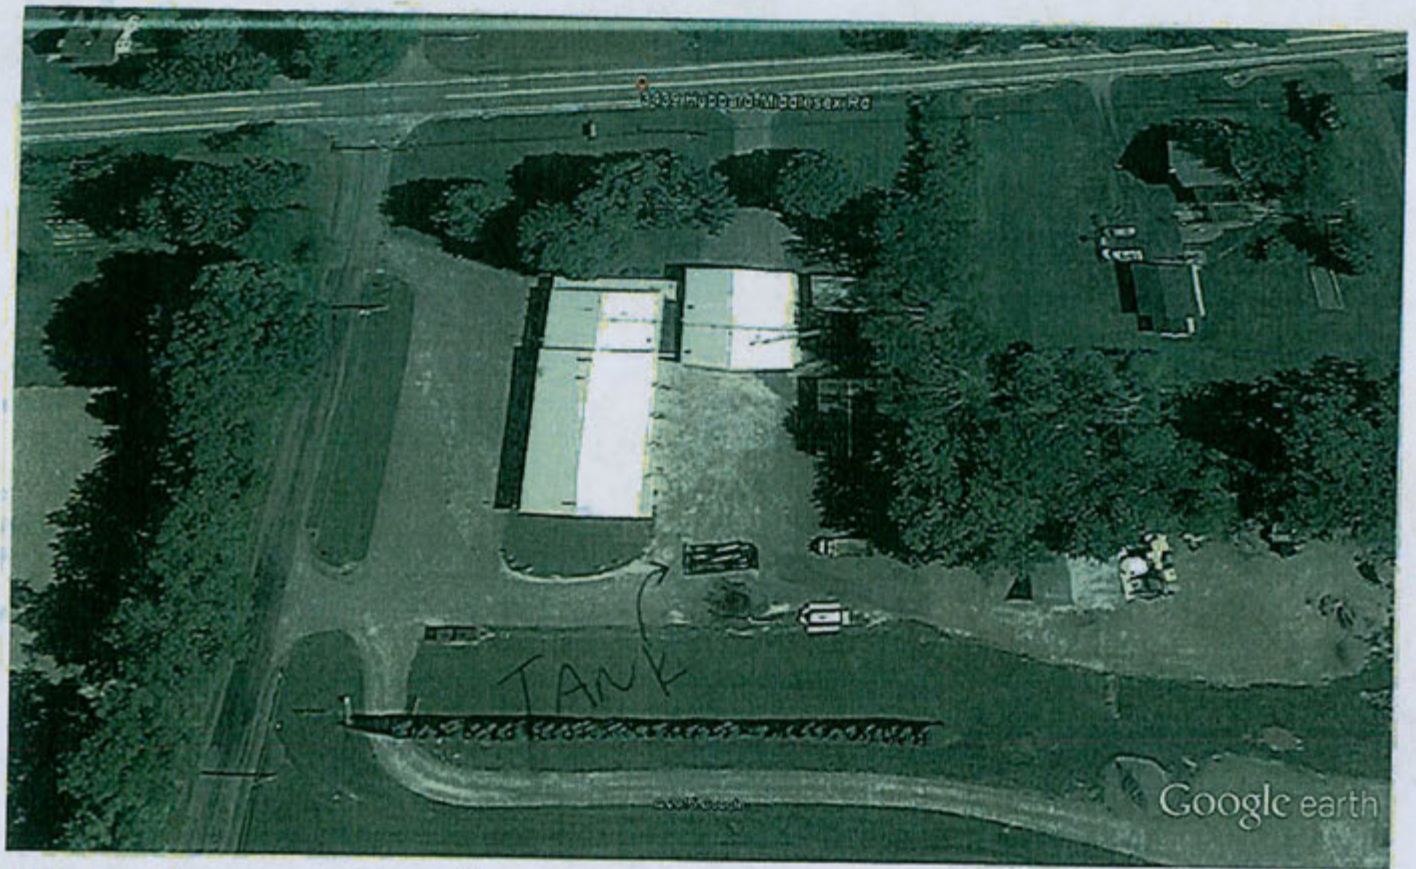
RED INDICATES WHERE SOIL & WATER SAMPLES WERE TAKEN
WATER @ 8' DEEP

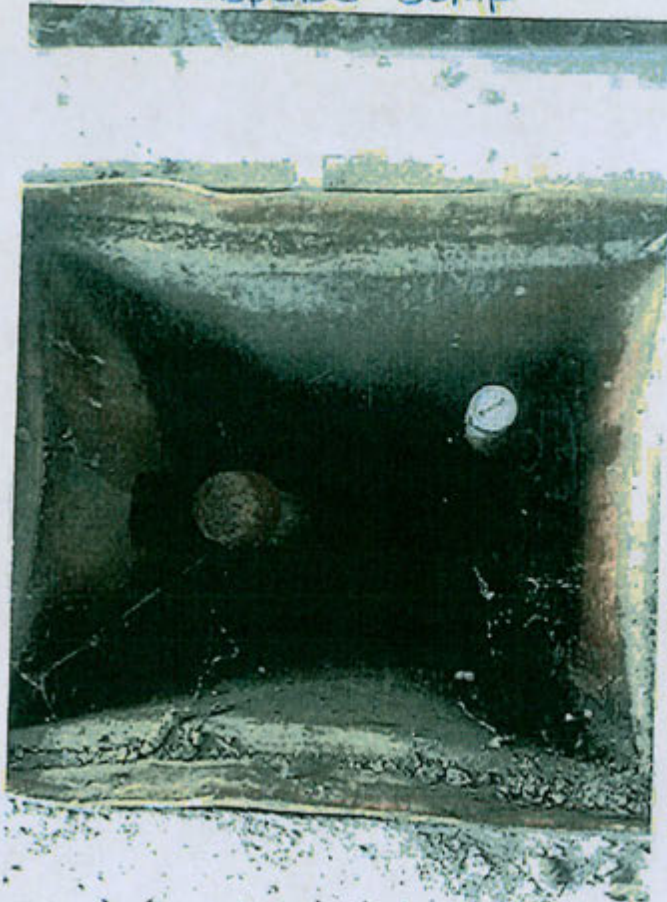
Dispenser Sump
