UNDERGROUND STORAGE TANK FACILITY INTERIM SITE CHARACTERIZATION REPORT

Leo's 3 Car Wash
PADEP Facility I.D. #25-90615
2938 West 26th Street
Erie, Pennsylvania 16506

February 13, 2003

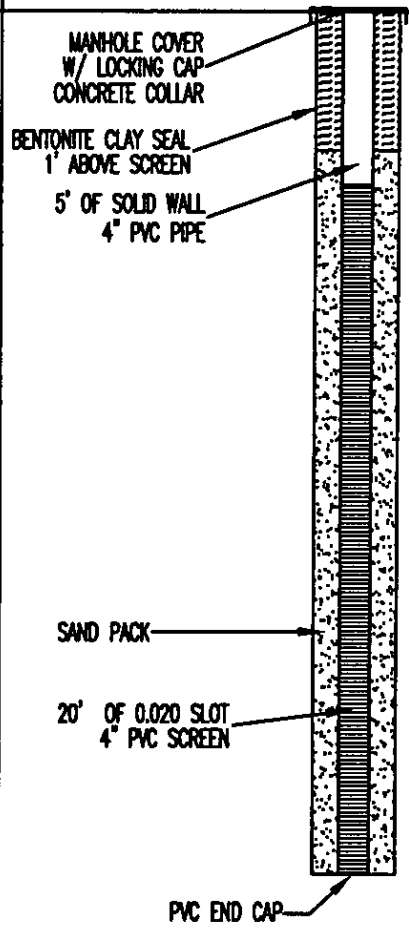
MW#8

<p>MANHOLE COVER W/ LOCKING CAP CONCRETE COLLAR</p> <p>BENTONITE CLAY SEAL 1' ABOVE SCREEN</p> <p>5' OF SOLID WALL 4" PVC PIPE</p> <p>SAND PACK</p> <p>20' OF 0.020 SLOT 4" PVC SCREEN</p> <p>PVC END CAP</p>	0
5	BROWN GRAY SANDY SILTY CLAY

4"	15		5
	BROWN GRAY SANDY SILTY CLAY

-	-		10
10	BROWN SILTY SAND & GRAVEL

16"	20		15
	BROWN SILTY SAND & GRAVEL

-	-		20
15	GRAY SILT & SHALE CHIPS

-	-		25
20	GRAY SILT & SHALE CHIPS

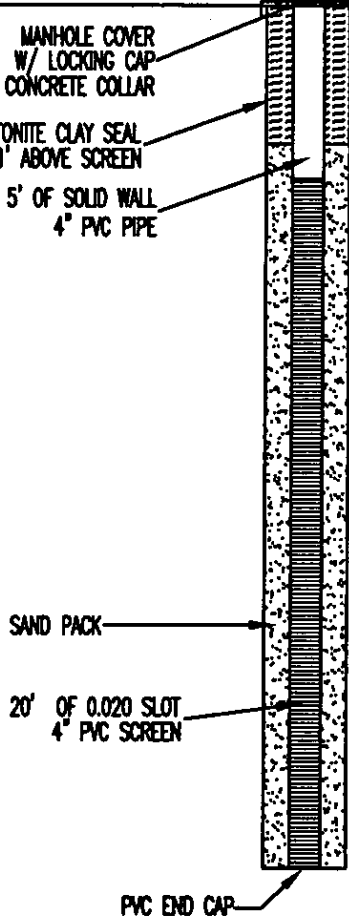
MW#9

<p>MANHOLE COVER W/ LOCKING CAP CONCRETE COLLAR</p> <p>BENTONITE CLAY SEAL 1' ABOVE SCREEN</p> <p>5' OF SOLID WALL 4" PVC PIPE</p> <p>SAND PACK</p> <p>20' OF 0.020 SLOT 4" PVC SCREEN</p> <p>PVC END CAP</p>	0
5	BROWN SANDY SILTY CLAY & GRAVEL

14"	3		5
	BROWN SANDY SILTY CLAY & GRAVEL

-	-		
10	BROWN SANDY SILTY CLAY & GRAVEL

12"	3		10
	BROWN SANDY SILTY CLAY & GRAVEL

-	-		
15	GRAY SILT & SHALE

-	-		15
20	GRAY SILT & SHALE
