### UNDERGROUND STORAGE TANK FACILITY SITE CHARACTERIZATION / REVISED REMEDIAL ACTION PLAN

LEO'S 3 CAR WASH  
2938 WEST 26TH STREET  
ERIE, PENNSYLVANIA 16506

FACILITY ID# 25-90615

PREPARED: May 2014

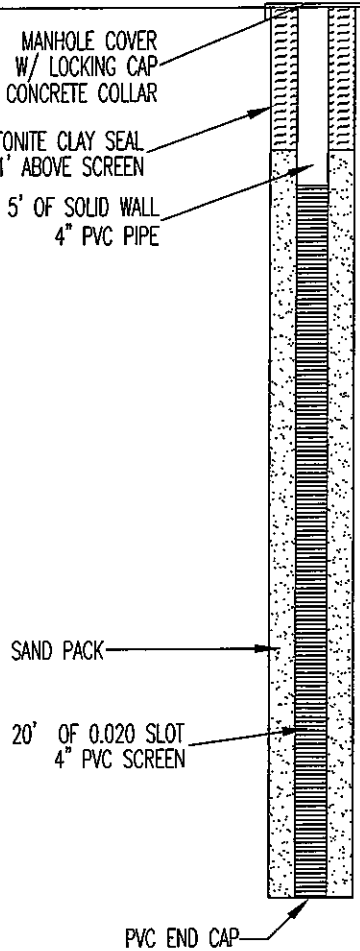
<p>MANHOLE COVER W/ LOCKING CAP CONCRETE COLLAR</p> <p>BENTONITE CLAY SEAL 1' ABOVE SCREEN</p> <p>5' OF SOLID WALL 4" PVC PIPE</p> <p>SAND PACK</p> <p>20' OF 0.020 SLOT 4" PVC SCREEN</p> <p>PVC END CAP</p>	0
5	BROWN SANDY SILTY CLAY & GRAVEL

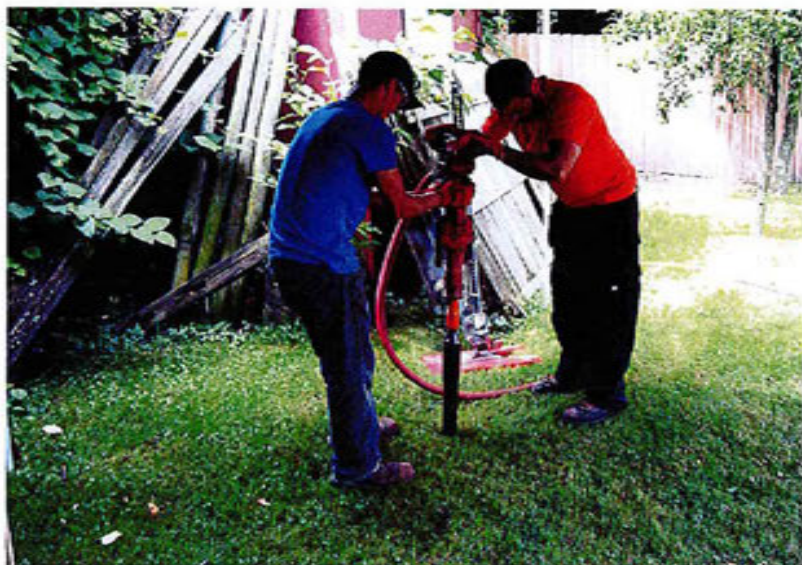
Advancing Off-Site Monitoring Well #18 on Dzikowski

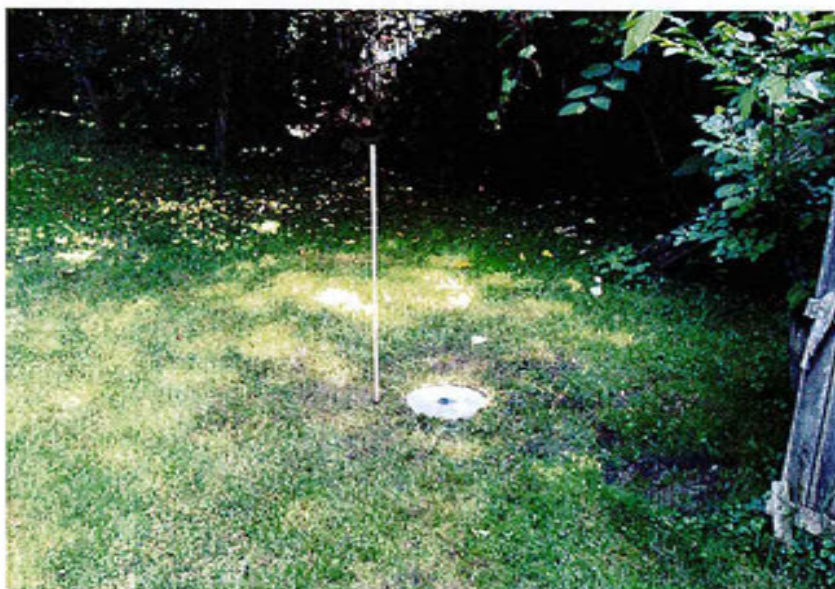
Completed Monitoring Well #18 on Dzikowski

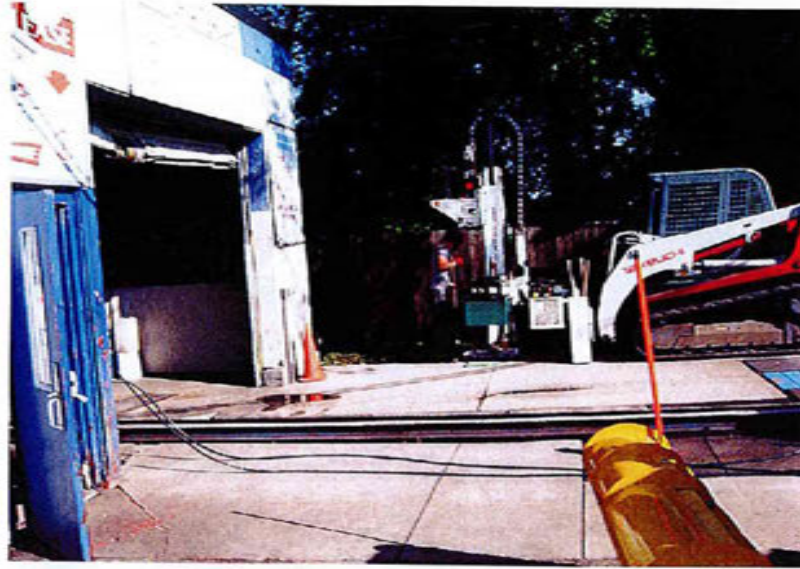
Location of Monitoring Well #19 on Leo's Site

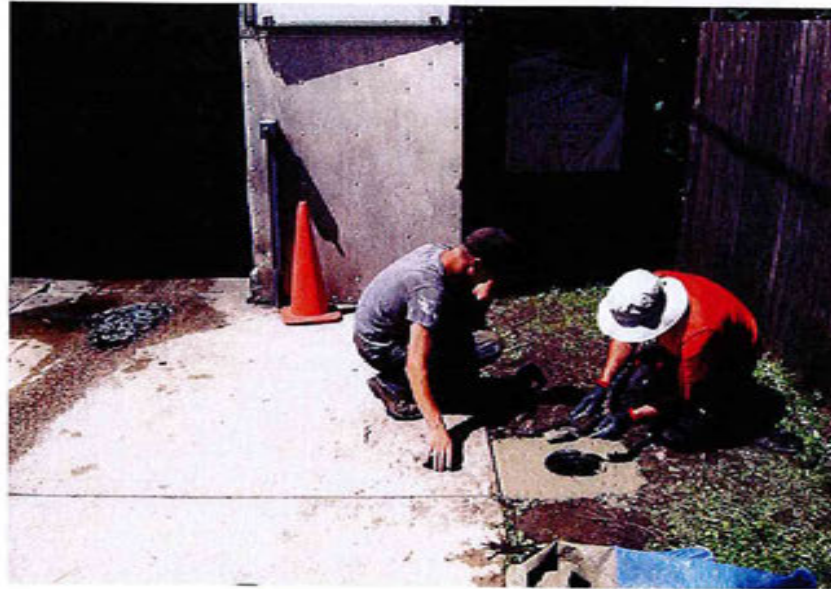
Finishing Cement Around MW #19 on Leo's Site

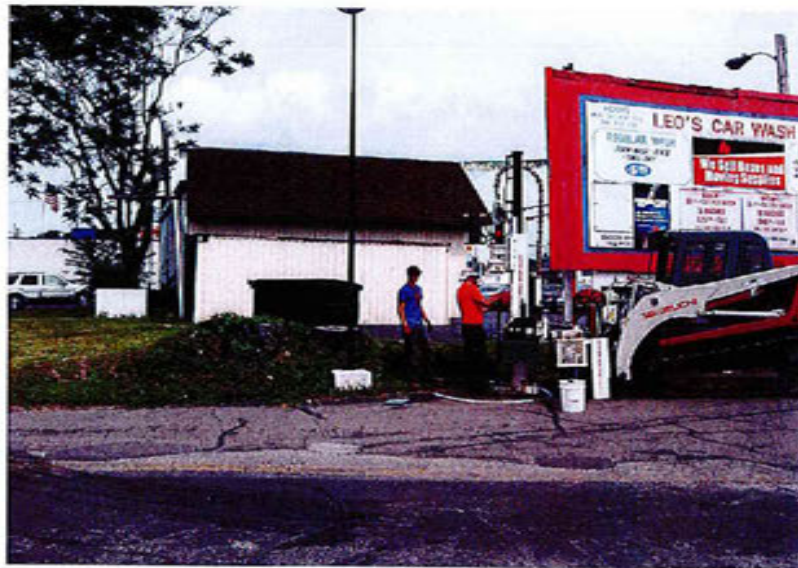
Location of Monitoring Well #20

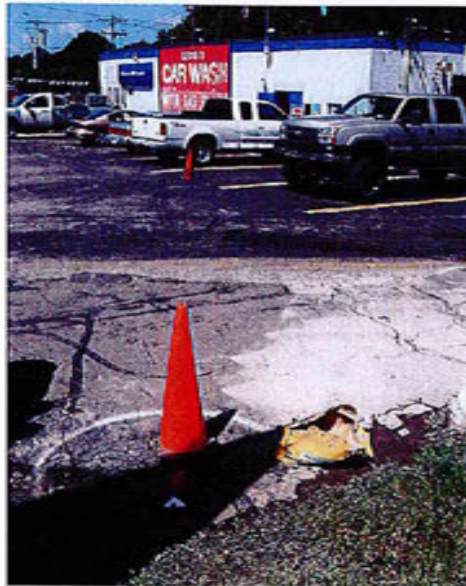
Completed Monitoring Well #20 on Leo's Site

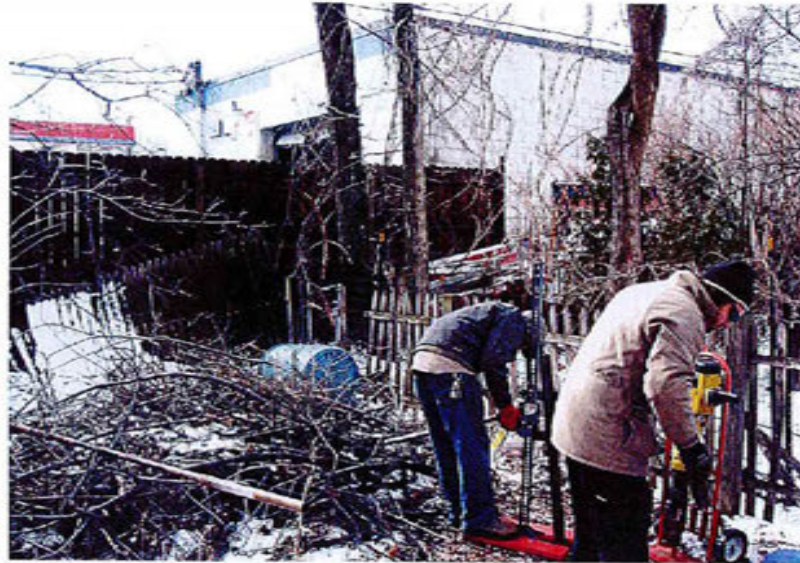
Setting-Up to Advance Off-Site MW #21 on Parker Property

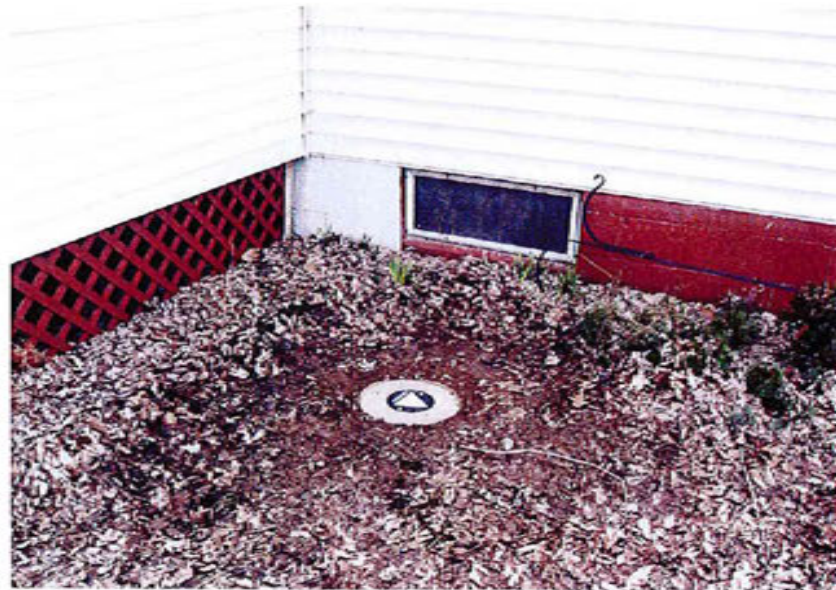
Vapor Point on Parker Property

It was noted in the disapproval letter that vapor intrusion has not been addressed at the site. AEA proposes to install two (2) vapor points at the locations illustrated on the attached field investigation map. The vapor points will be constructed using a manufactured vapor point consisting of a 1" PVC pipe that has a 1 foot sand packed screen interval and risers that are sealed with bentonite to the surface. Samples will be collected using SUMMA canisters in accordance with standard operating procedures described in PADEP's guidance and sent to Lancaster Laboratories, in Lancaster, PA for analysis.

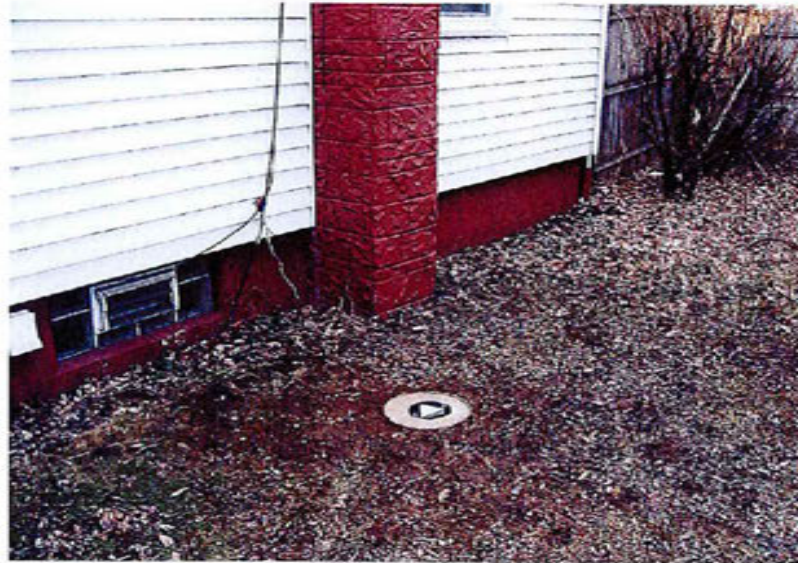
Vapor Point on Dzikowski Property

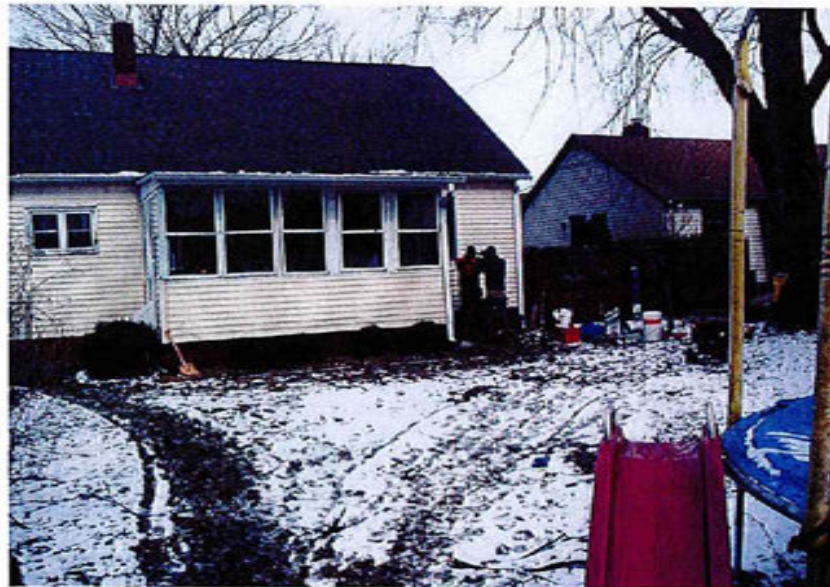
Photo Depicting Off-Site Properties Down-Gradient of Leo's Car Wash

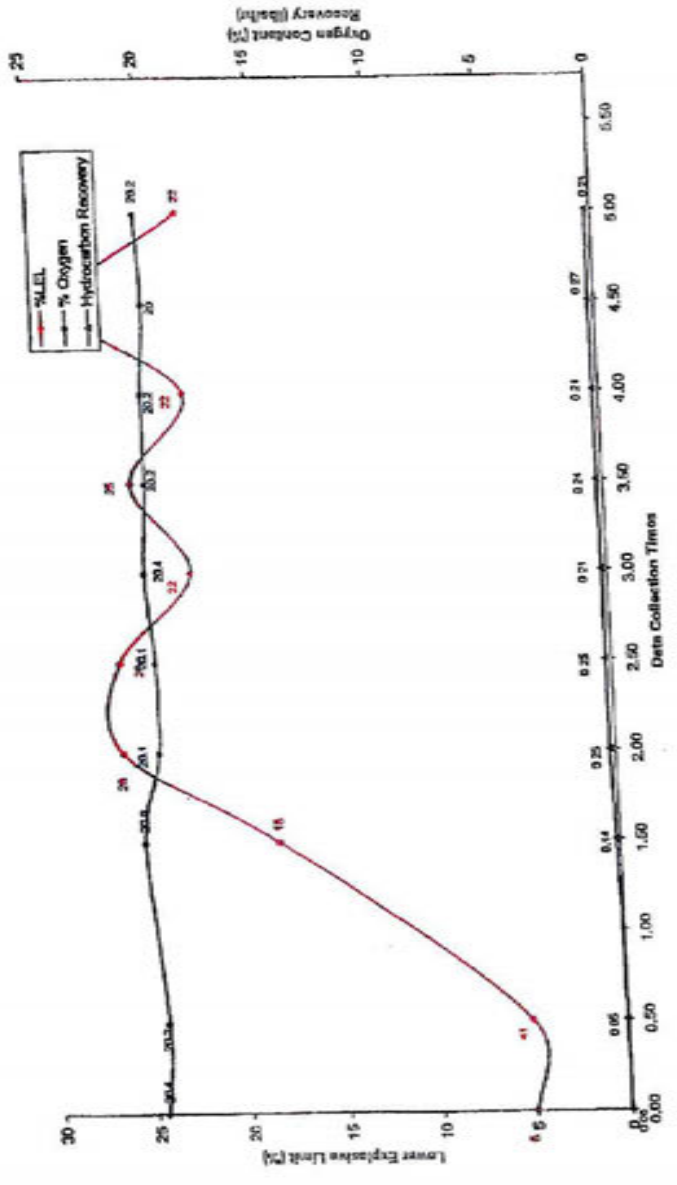
CHART 1: RECOVERY DATA (MW#2)

CHART 1  
 RECOVERY DATA  
 Lower Explosive Limit, Hydrocarbon Recovery and Oxygen  
 Led's #3 Gas Wash  
 Erie, Pennsylvania

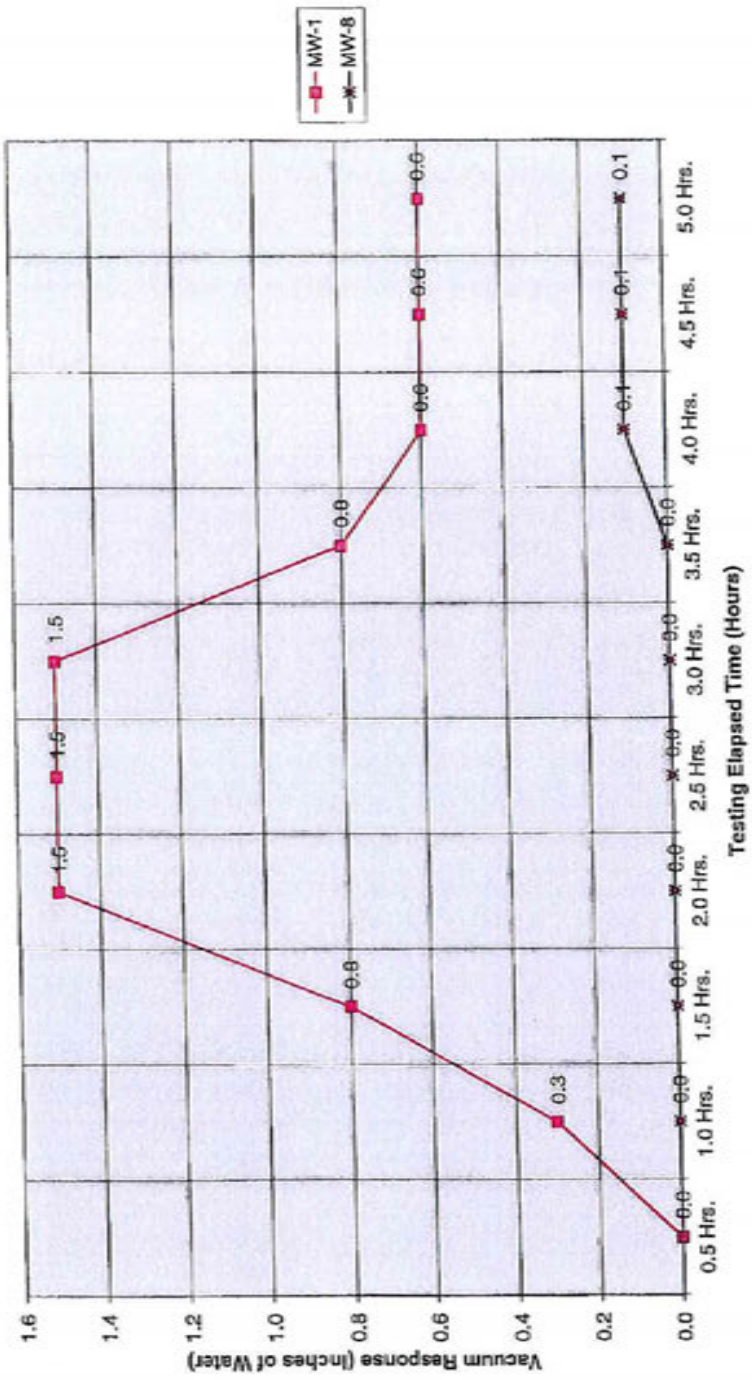
CHART 2: VACUUM RESPONSE DATA (MW#2)

Chart 2  
 Vacuum Response Data  
 LEO'S #3 CAR WASH ERIE, PA

Magnahelic gauges were mounted on adjacent monitoring wells (MW#1, MW#3, MW#4, MW#6, MW#7 and MW#8) to measure resultant formation vacuums. A maximum vacuum response of 1.5 inches of water was obtained in MW#1. An induced vacuum of 0.1 inches of water was observed in monitoring well MW#8. Vacuum response data is summarized on Table 3. Vacuum response data from select wells is graphed on Chart 2.

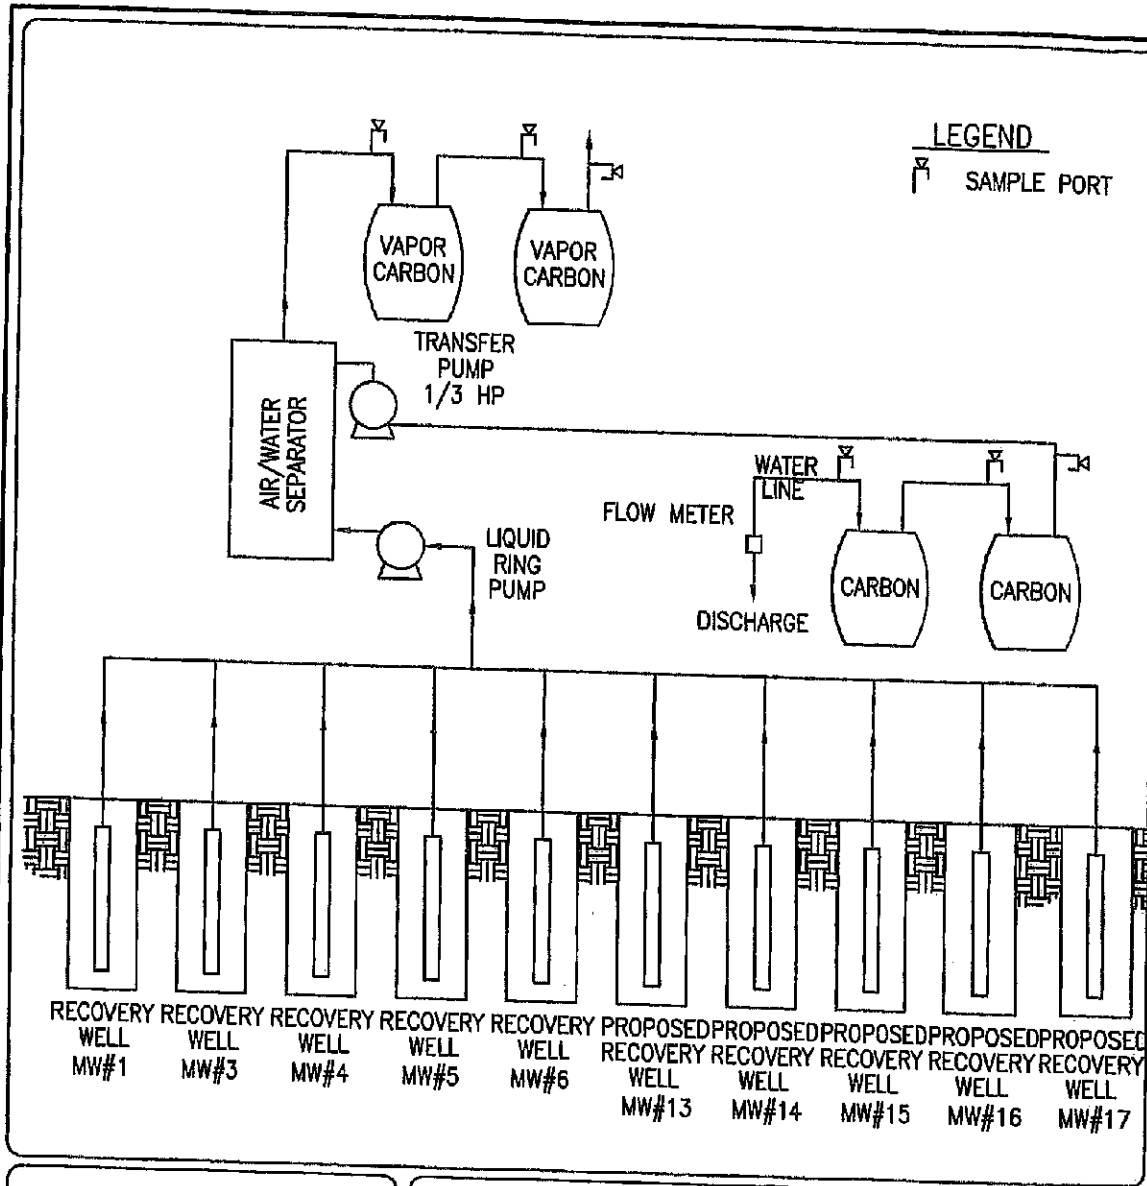
APPENDIX C: DESIGN & CONSTRUCTION DETAIL

**LEO'S #3 CAR WASH**  
**2938 WEST 26TH STREET**

The current remediation system consists of a 7.5 Hp oil sealed liquid ring pump (LRP) to recover liquid and vapor phase fluids. The pump consists of a shrouded rotor which rotates freely within an eccentric casing. There is no metal to metal contact between the rotor and casing. Centrifugal force acting on liquids within the pump causes the liquids to form a ring inside the casing. A fixed port cylinder, concentric with the rotor, directs the gas into the suction ports. Gas is trapped between the blades by the liquid pistons formed by centrifugal force as the liquid recedes from the port cylinder. It is trapped at the point of maximum eccentricity and is then compressed by the liquid ring as it is forced radially inward toward the central port cylinder. After each revolution, the compressed gas and accompanying liquid are discharged. During the pumping cycle, the gas is in intimate contact with the sealing liquid and compression is nearly isothermal. When handling saturated vapor-gas mixtures, the liquid ring acts as a condenser, greatly

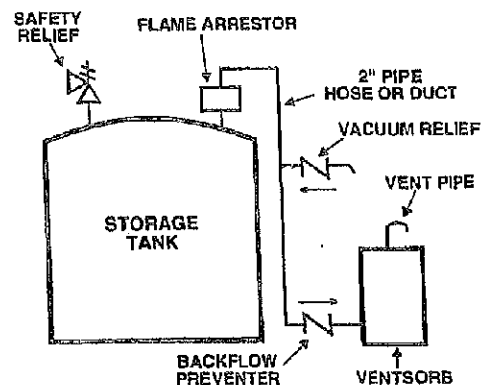
Typical VentSorb Installation at Storage Tank

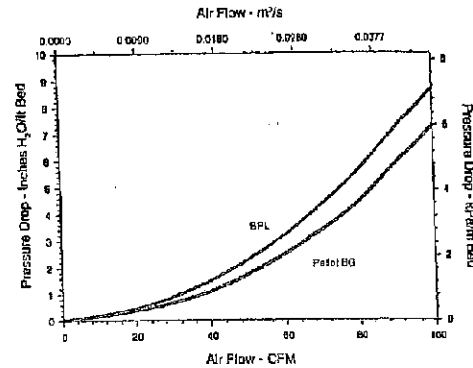
## VENTSORB PRESSURE DROP

Pressure drop through a VentSorb unit is a function of the process air flow as shown in the graph. A VentSorb canister can handle up to 100 cfm at a pressure drop of less than 15 inches water column. If higher flows or lower pressure drop is needed, multiple canisters may be installed in parallel operation. The maximum canister pressure should not exceed 4 psig.
