FINAL SITE CHARACTERIZATION REPORT  
STATEWIDE HEALTH STANDARD  
QUINN'S CAFÉ STOP PROPERTY  
PADEP FACILITY ID #35-20617  
USTIF CLAIM #2016-0136  
224 MAIN STREET  
BOROUGH OF ARCHBALD, LACKAWANNA COUNTY, PENNSYLVANIA

PREPARED BY  
LABELLA ASSOCIATES, P.C.  
1000 DUNHAM DRIVE  
SUITE B  
DUNMORE, PENNSYLVANIA 18512  
LABELLA ASSOCIATES PROJECT NUMBER: 2171853

OCTOBER 5, 2018

FINAL SITE CHARACTERIZATION REPORT  
QUINN'S CAFÉ STOP PROPERTY  
BOROUGH OF ARCHBALD, LACKAWANNA COUNTY, PENNSYLVANIA

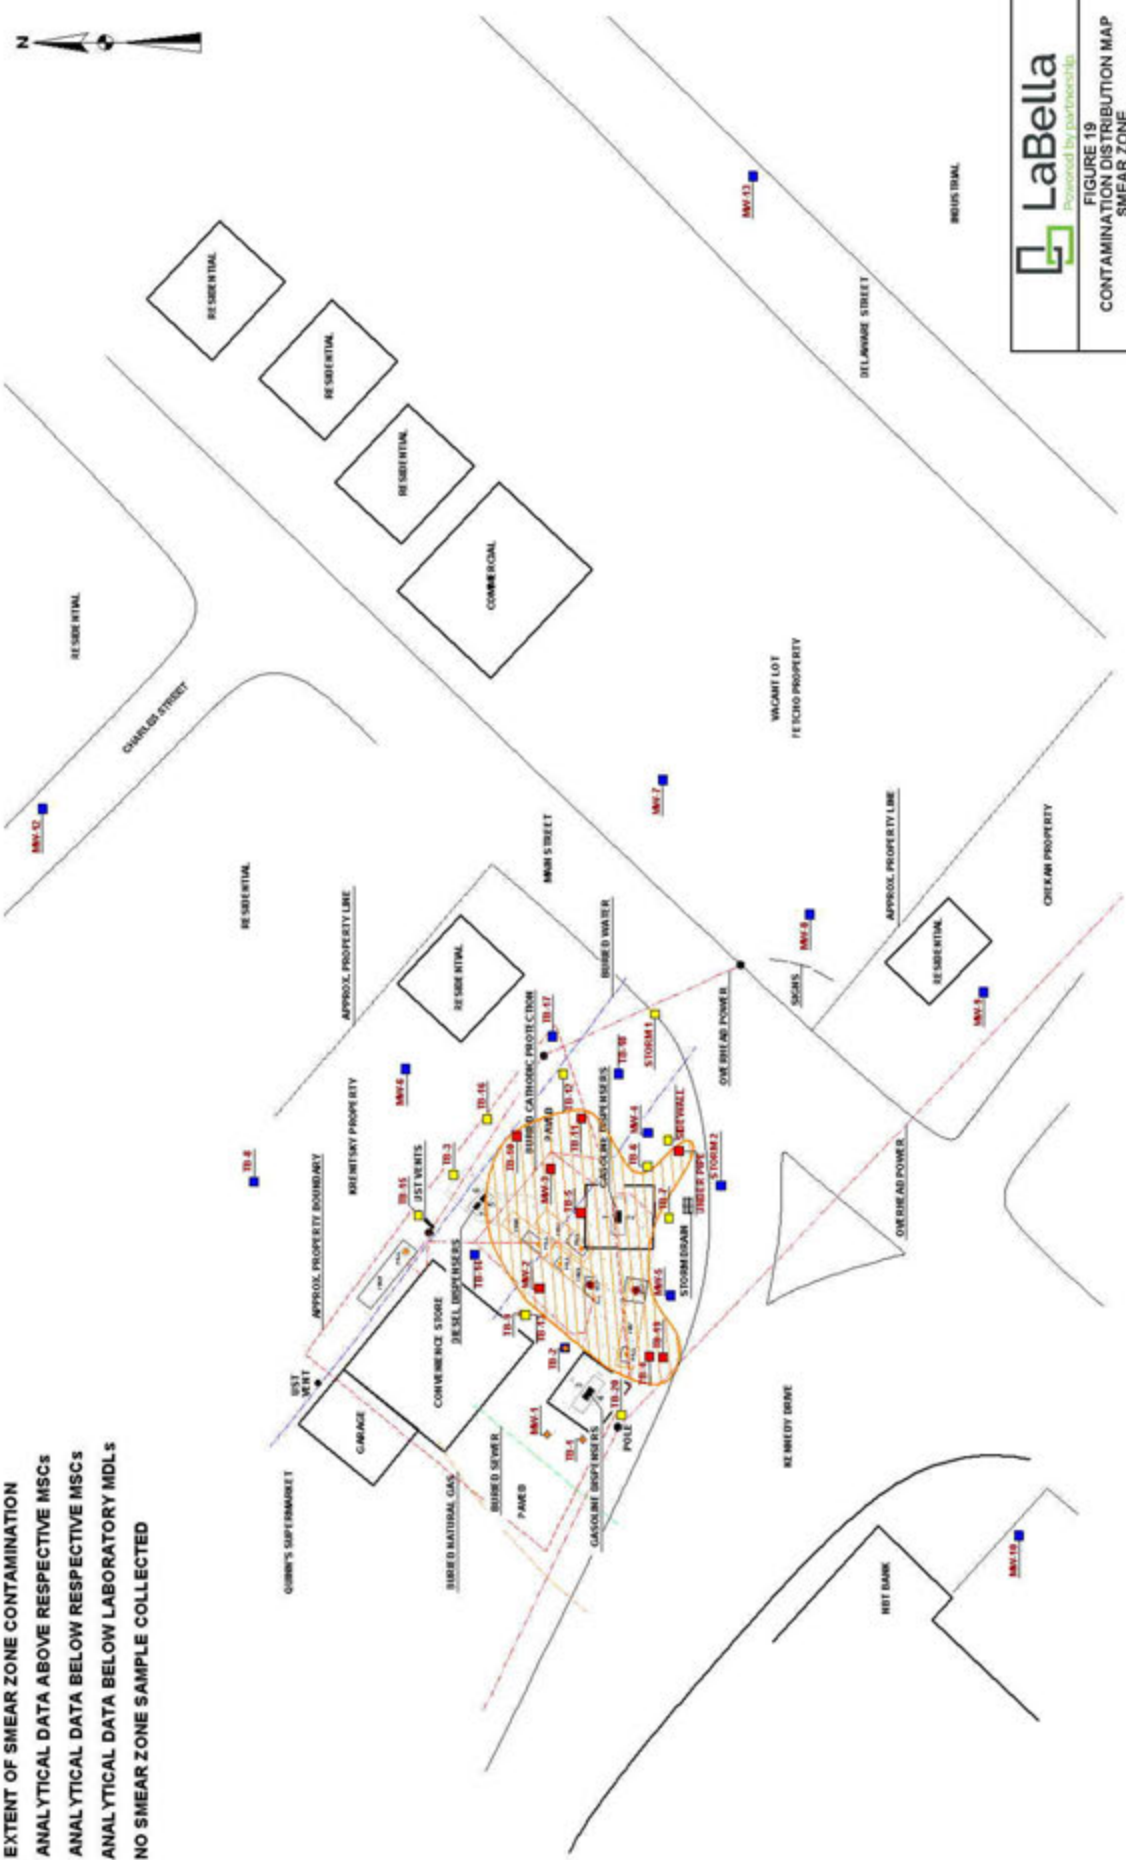
FIGURE 19  
CONTAMINATION DISTRIBUTION MAP  
SMEAR ZONE  
QUINN'S CAFE STOP PROPERTY  
224 MAIN STREET  
BOROUGH OF ARCHBALD,  
LACKAWANNA COUNTY, PENNSYLVANIA  
DRAWN BY: KC DATE: 09/06/2018  
SCALE: 1"=40'

- EXTENT OF SMEAR ZONE CONTAMINATION
- ANALYTICAL DATA ABOVE RESPECTIVE MSCs
- ANALYTICAL DATA BELOW RESPECTIVE MSCs
- ANALYTICAL DATA BELOW LABORATORY MDLs
- NO SMEAR ZONE SAMPLE COLLECTED

- The subject property is underlain by brown sands and silts with abundant sandstone pebbles, cobbles and boulders typical of an alluvial deposit. A shallow groundwater aquifer has been identified in the unconsolidated geologic unit. This aquifer is located at an approximate depth of 5.0 feet below grade. This depth varies in response to the infiltration of precipitation. A relatively thin Smear Zone of 1.0' to 2.0' has been documented onsite.

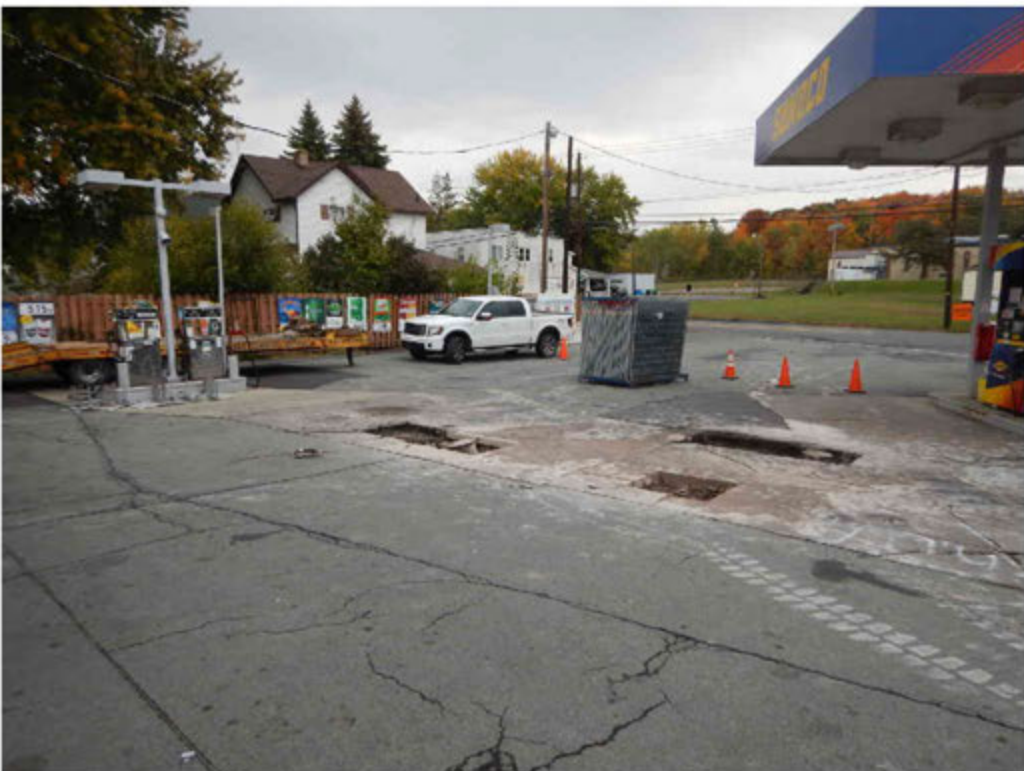
Photo #5

View of conditions during the spill bucket and tank top upgrades in October 2016.

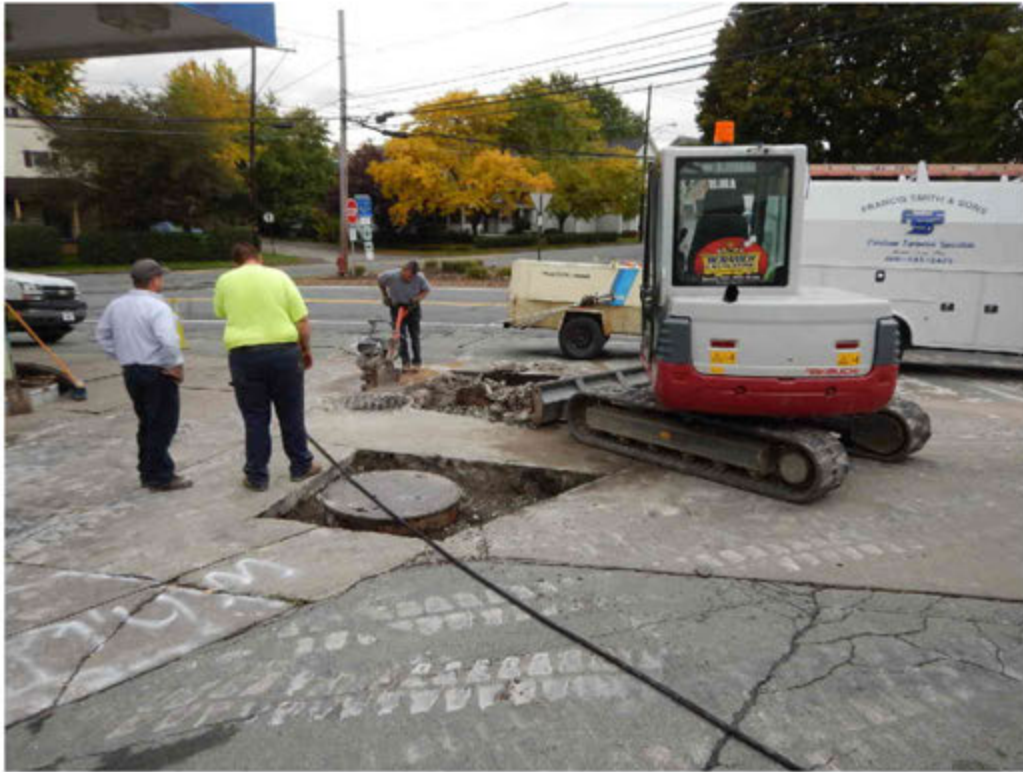
Photo #6

View of conditions during the spill bucket and tank top upgrades in October 2016.

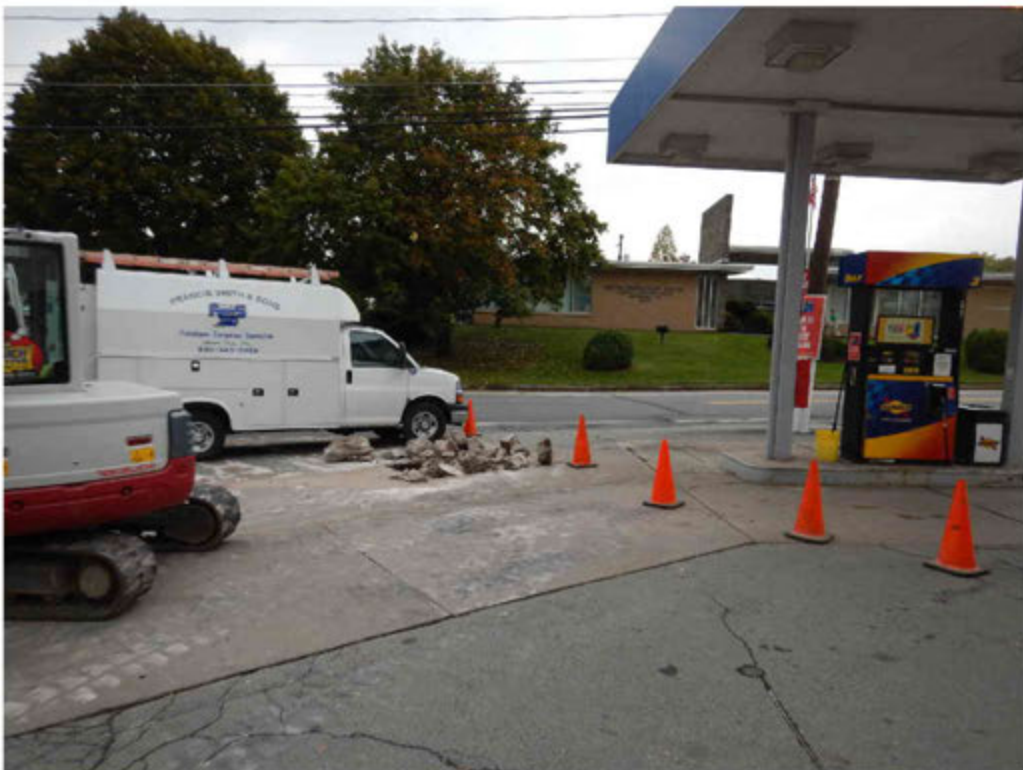
Photo #7

View of conditions during the spill bucket and tank top upgrades in October 2016.

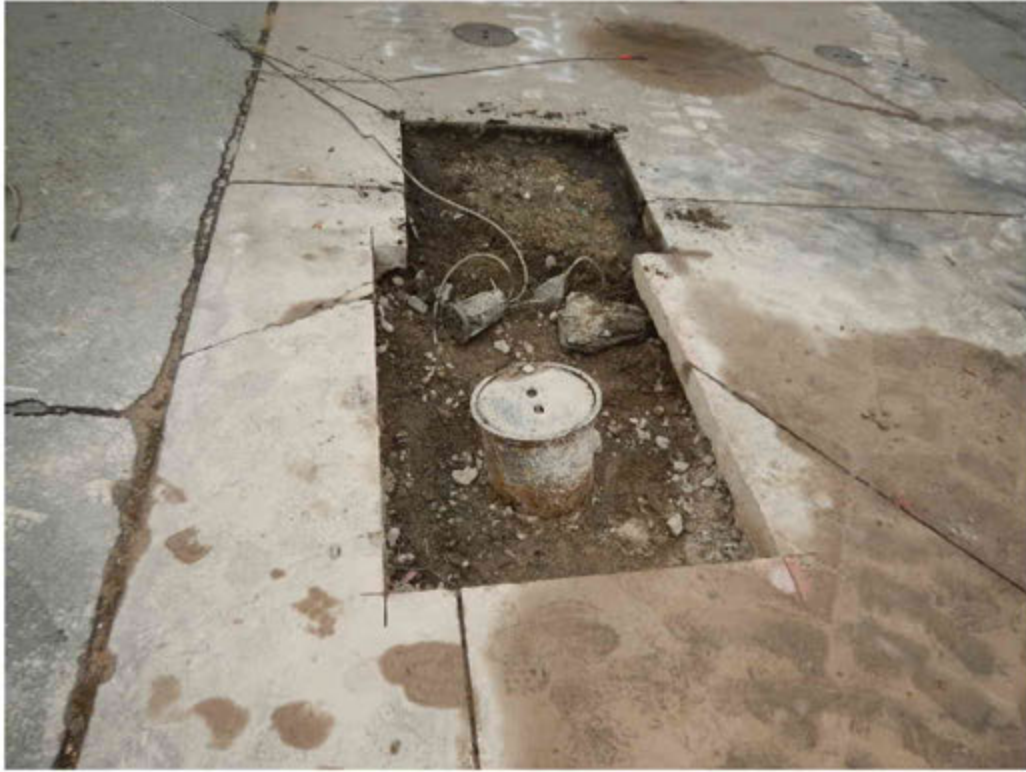
Photo #8

View of conditions during the spill bucket and tank top upgrades in October 2016.

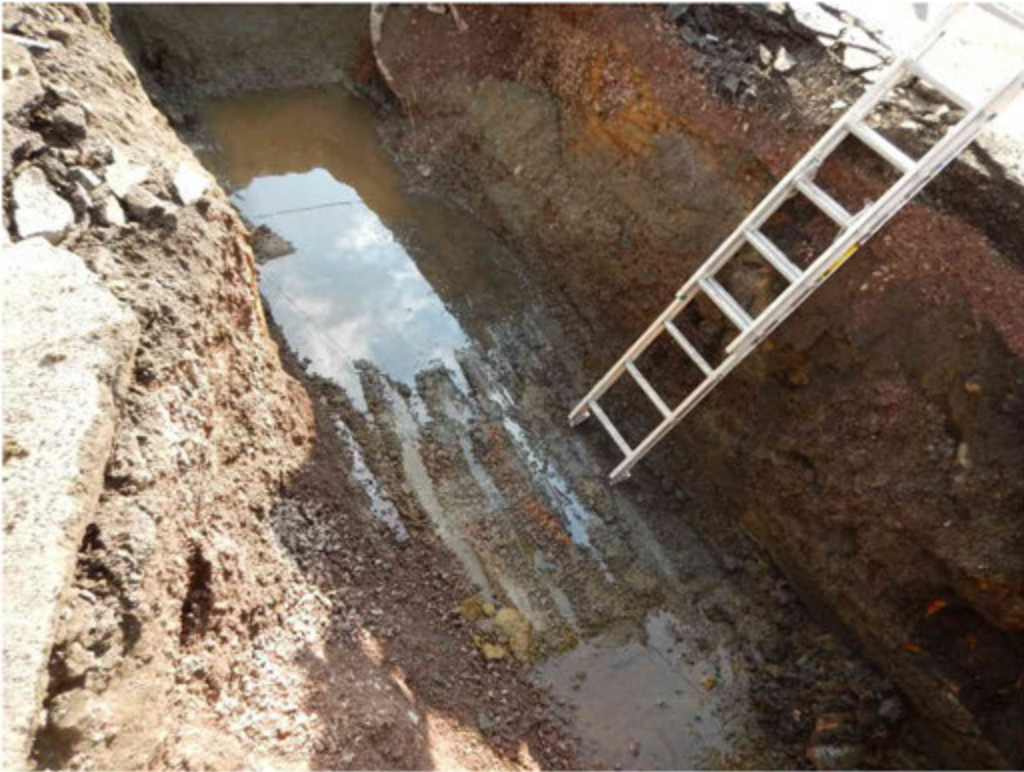
Photo #14

View of conditions within the excavation installed during the storm sewer investigation.

- Potential contamination was observed beneath the storm sewer pipe within the gravel bedding. Soil and groundwater appeared to be impacted. Charles Corby & Sons Excavating (Corby), the general contractor for the PennDOT road expansion project, completed the removal of the pipe and impacted gravel pipe bedding to the top of bedrock. Groundwater was encountered between 5.5 feet below grade and 6.5 feet below grade. Bedrock was encountered between 5.5 feet and 7.0 feet below grade.

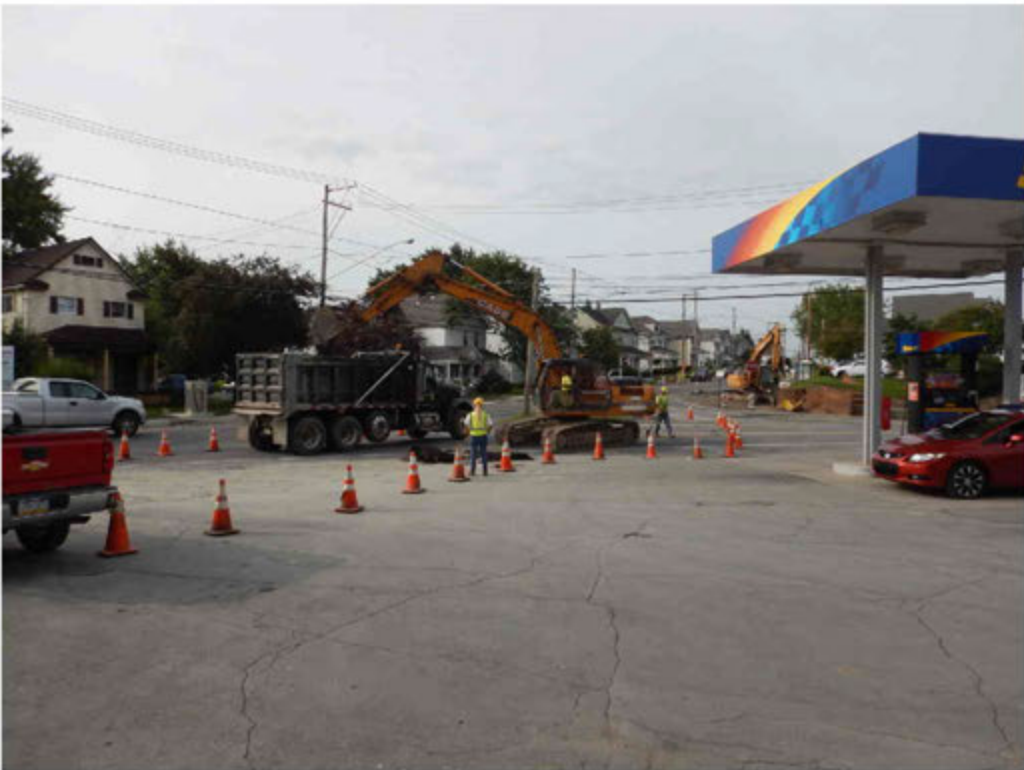
Photo #15

View of conditions during the storm sewer investigation.

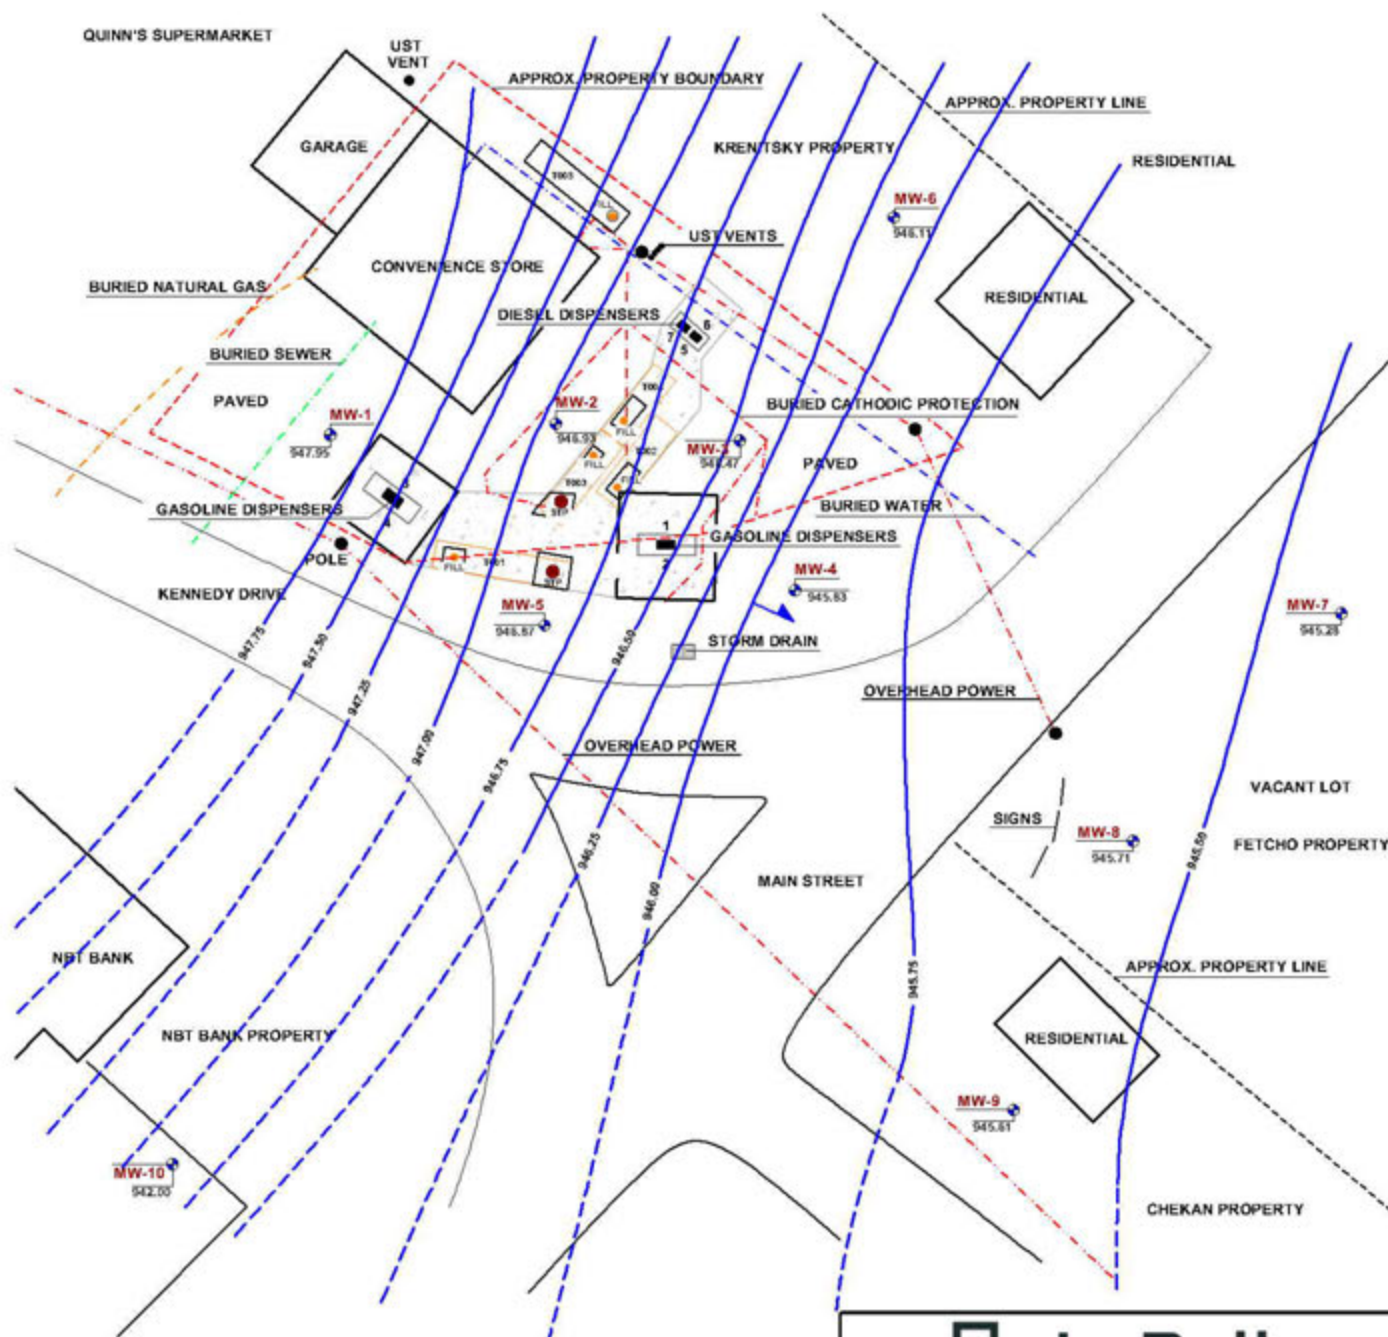
GROUNDWATER ELEVATIONS IN FEET. CONTOUR INTERVAL = 0.25'.

MW-10 WAS OMITTED DURING THE PREPARATION OF THIS GROUNDWATER CONTOUR MAP DUE TO AN ANOMALOUSLY LOW GROUNDWATER ELEVATION

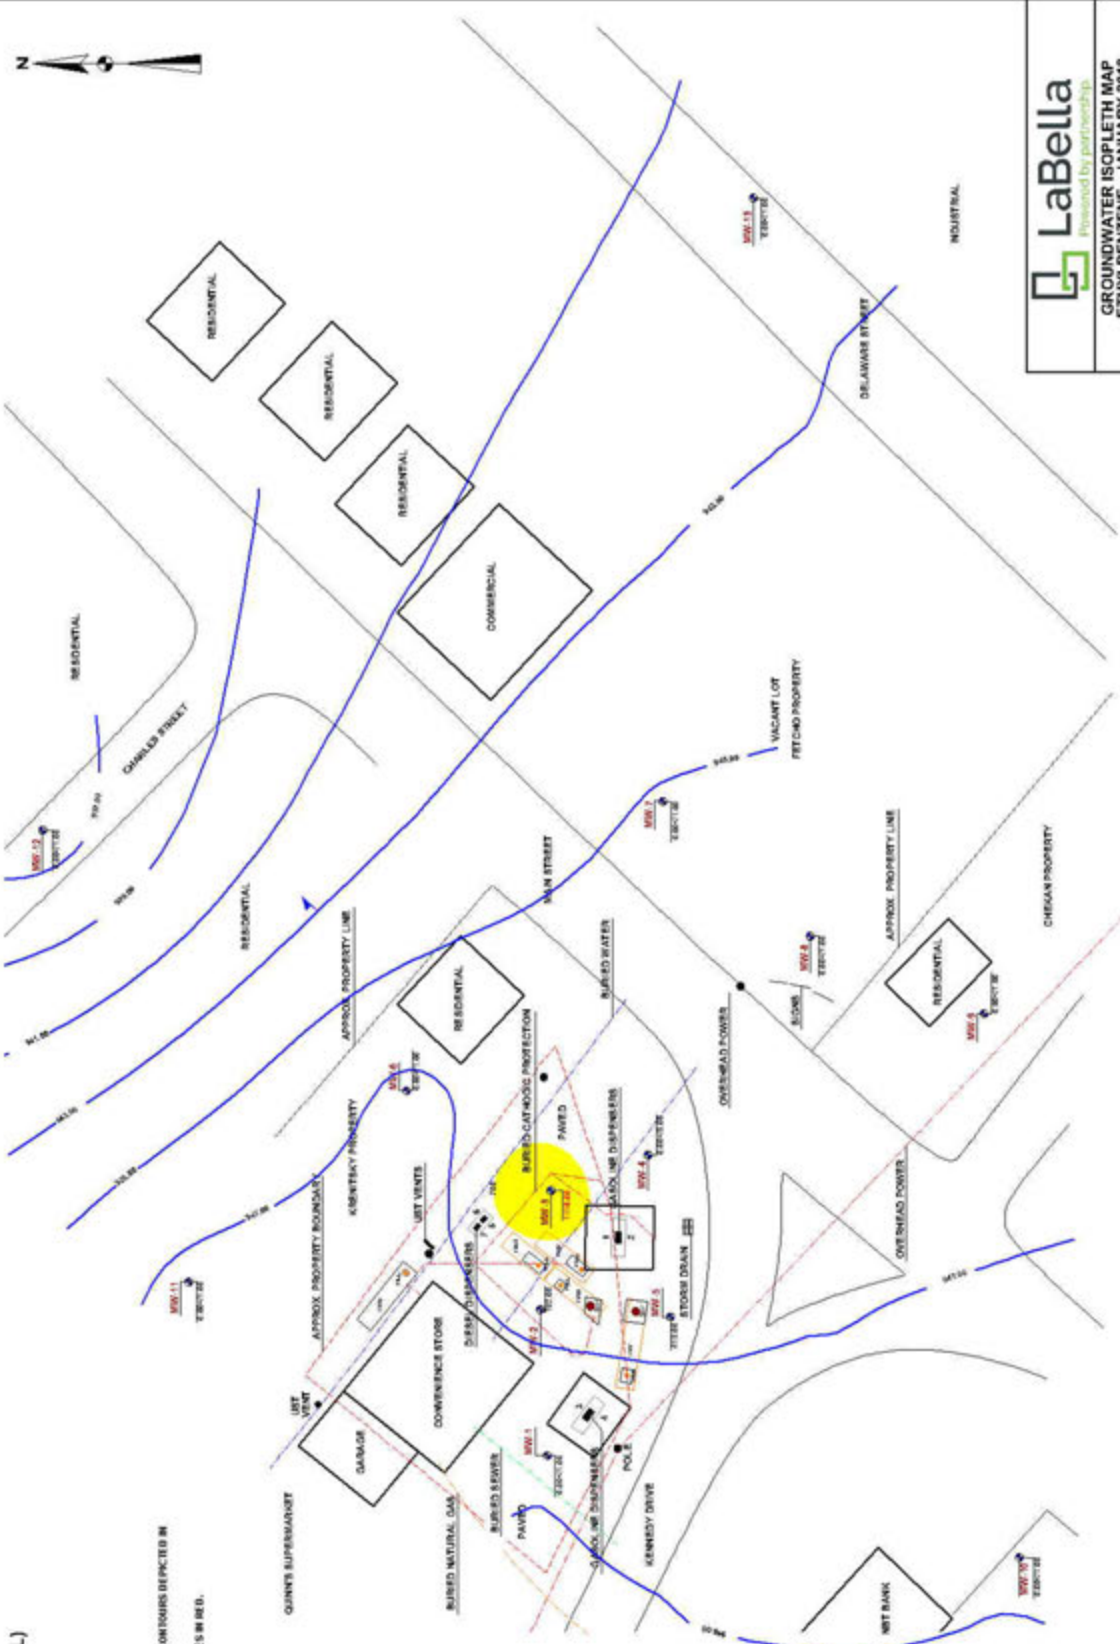
- 1.) JANUARY 22, 2018 GROUNDWATER ELEVATION CONTOURS DEPICTED IN BLUE. CONTOUR INTERVAL = 2.0'.
- 2.) ETHYLBENZENE ME: MGC = 198.8 UG/L. EXCEEDANCES IN RED.

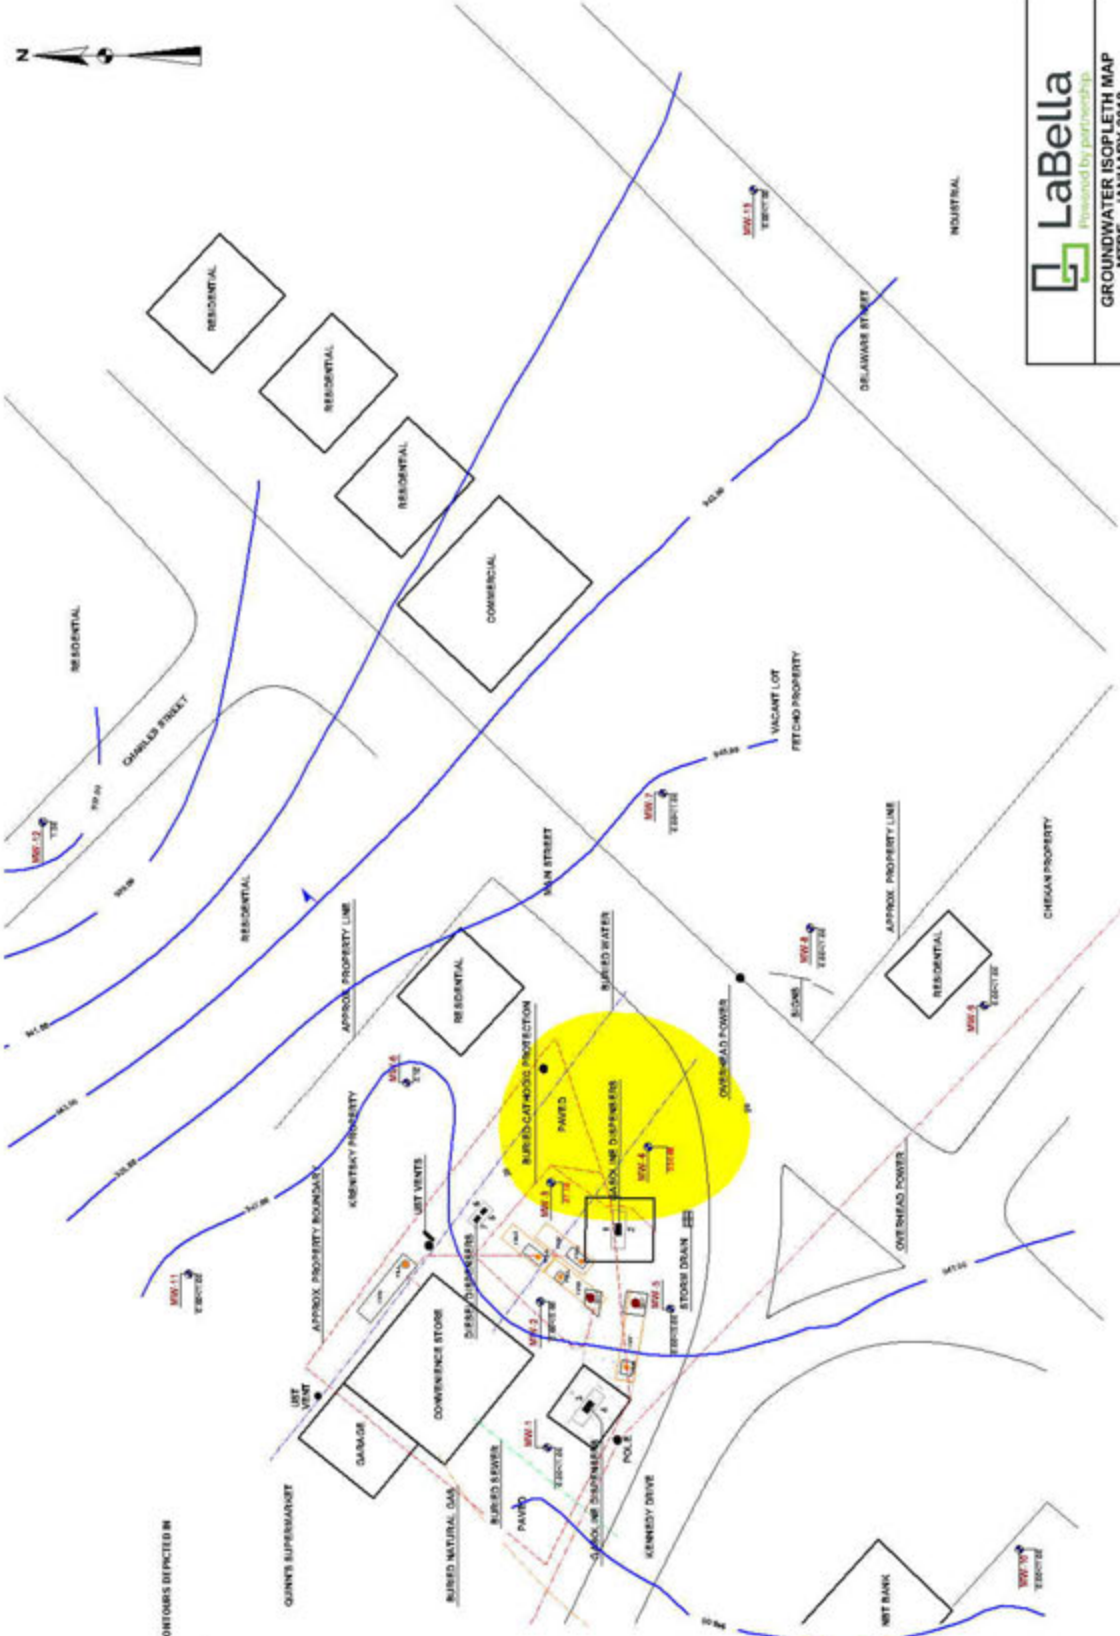
GROUNDWATER ISOPLETH MAP  
MTBE - JANUARY 2016  
QUINN'S CAFE STOP PROPERTY  
224 MAIN STREET  
BOROUGH OF ARCHBOLD,  
LACKAWANNA COUNTY, PENNSYLVANIA  
DRAWN BY: KC DATE: 01/25/2016  
SCALE: 1" = 40'

2.1 MTBE MSC - 26.8 UG/L. EXCEEDANCES IN RED.
