ENVIRONMENTAL CHARACTERIZATION
PROGRESS REPORT

**United Tire Service
(East Penn Tire and Battery)
4094 Chestnut Street
Emmaus, Pennsylvania 18049
Facility ID# 39-27735
USTIF # 20180151**

Project No. WACHTER-002

July 15, 2019

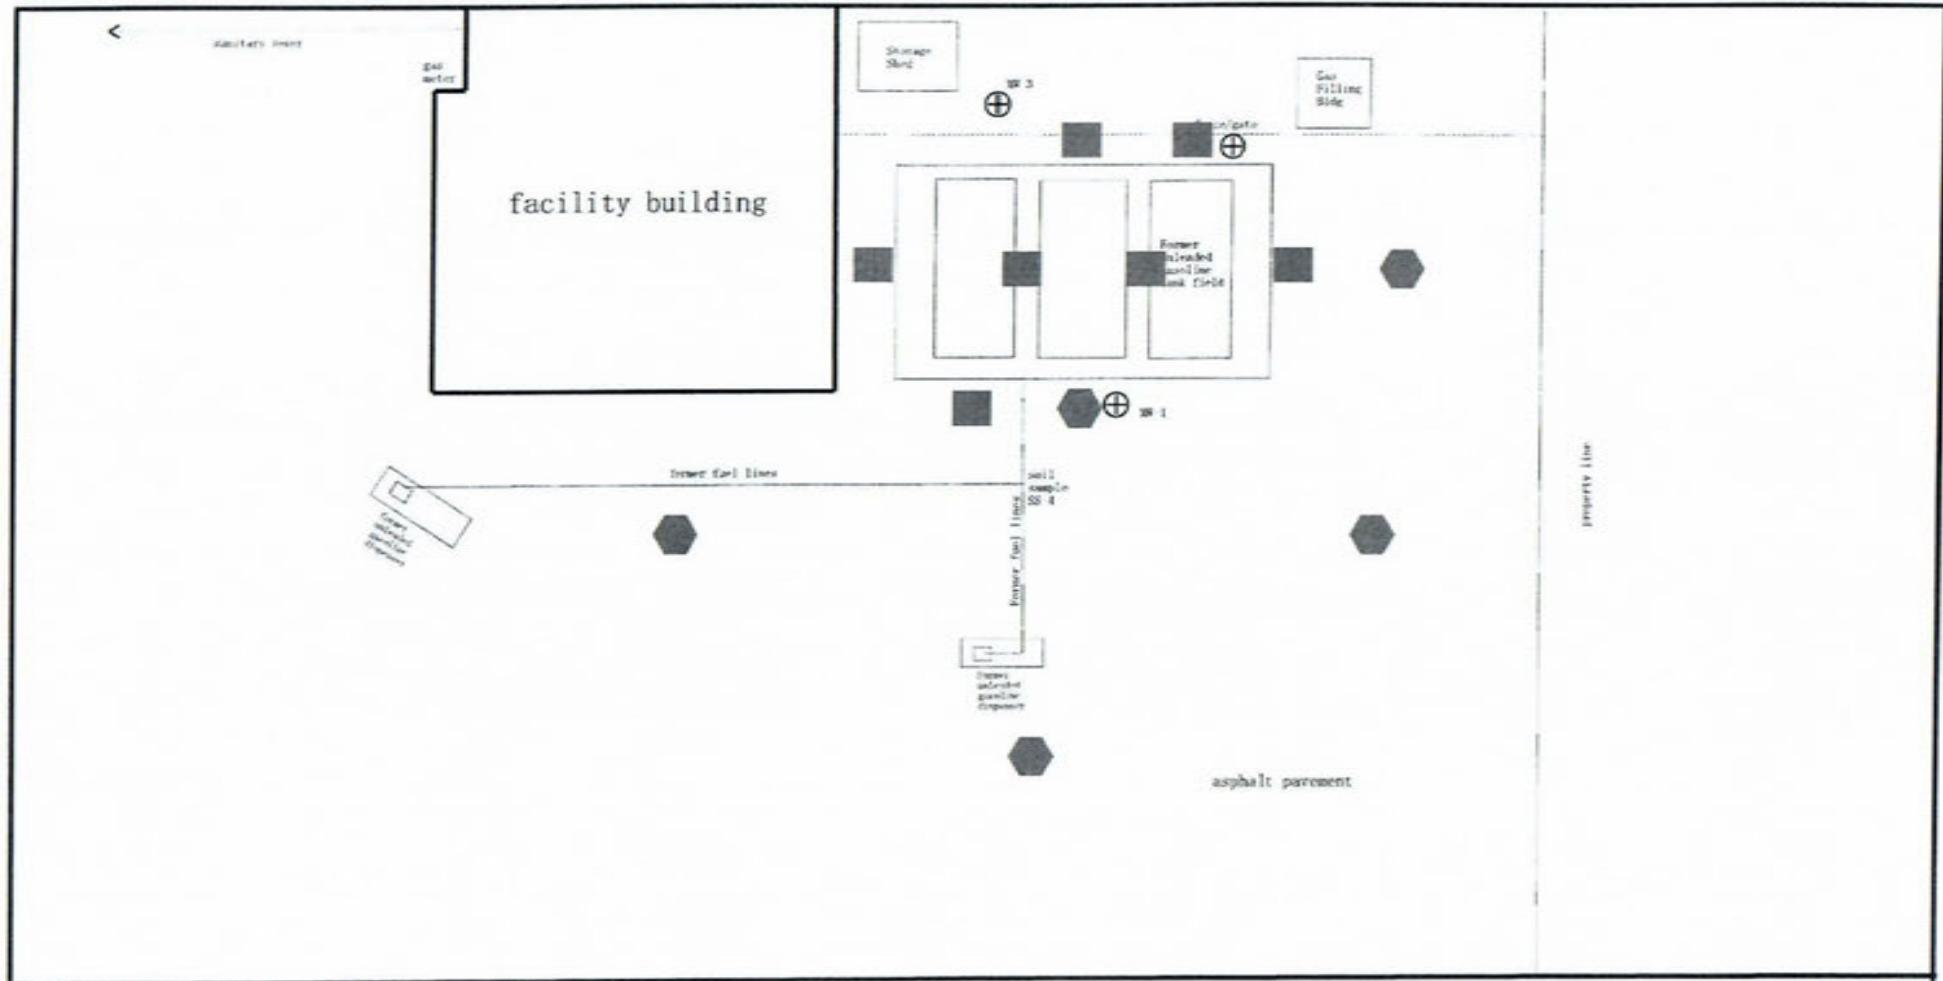
COVENTRY ENVIRONMENTAL ASSOCIATES, INC. PO Box 224 St. Peters, Pennsylvania	Job no. WACHTER-001	scale: 1" = 20' (approx)	drawing no. 2.0
East Penn Tire and Battery 4094 Chestnut Street Emmaus, Pennsylvania (facility ID 39-27735)		TITLE: Site Plan

The subject property is the United Tire Service (UTS) facility located at 4094 Chestnut Street, Emmaus, Pennsylvania (Facility ID# 39-27735), Upper Milford Township, Lehigh County, Pennsylvania (Figures 1 and 2). The subject facility is currently comprised of approximately one acre of land with two buildings, a storage shed and a small building for LP gas, which are utilized as a tire and automotive repair facility and tire storage building. There is one steel aboveground storage tank (300 to 500 gallons) utilized for storage of waste oil located at the rear of the main facility building.

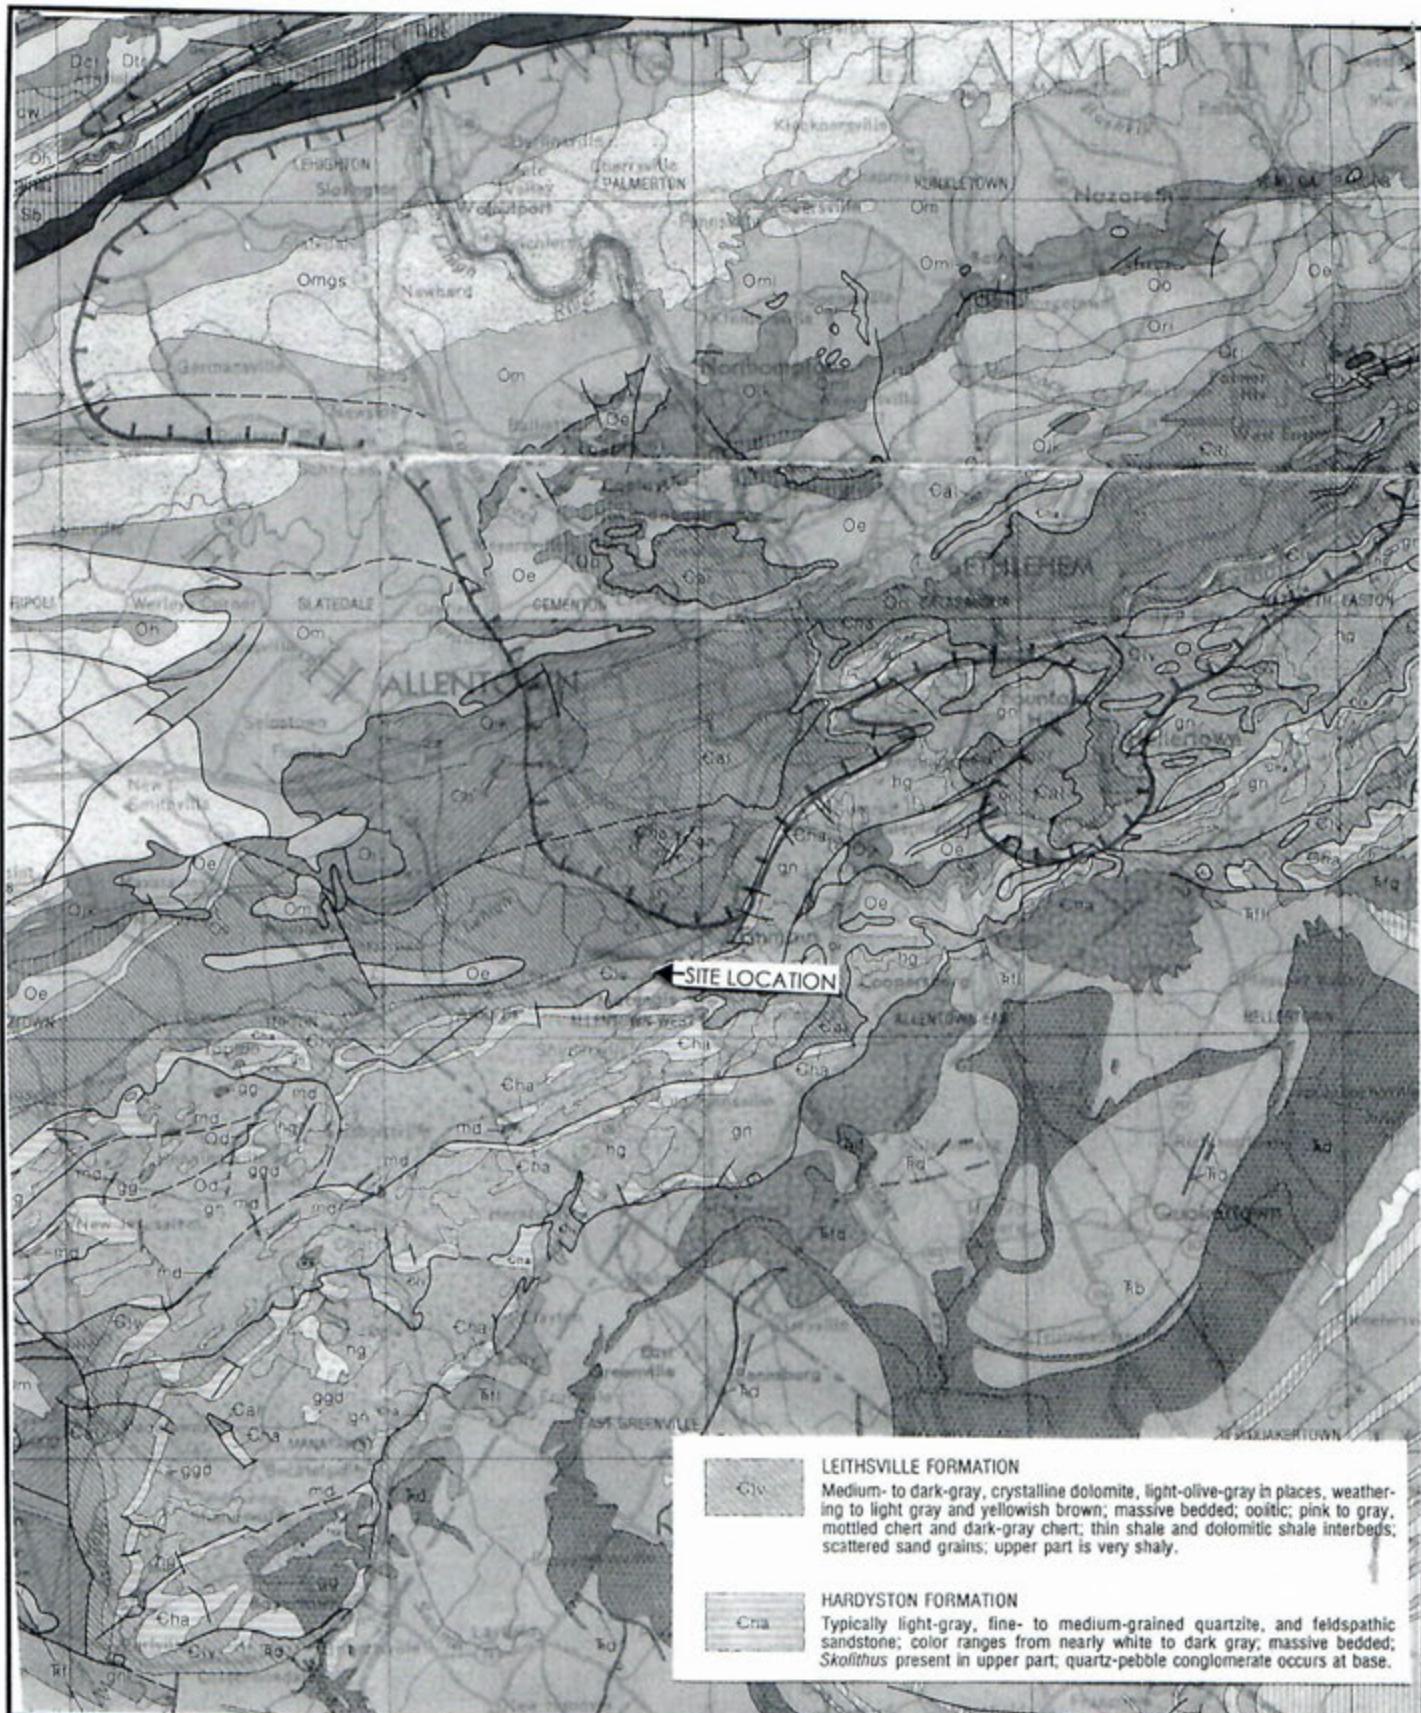
COVENTRY ENVIRONMENTAL ASSOCIATES, INC. PO Box 224 St. Peters, PENNSYLVANIA 19470	Job no. WACHTER--001	drawn by: jvw	scale: 1" = 4 miles (approx)	drawing no. <u>3.0</u>
	date: 3/1/19	checked by:	TITLE:	
United Tire Service 4094 Chestnut Street Emmaus, Pennsylvania		Site Geology Map		north

Based on published literature (Geologic Map of Pennsylvania, PA Topographic and Geologic Survey, 1980) and borehole logging during monitoring well installation, the bedrock at the site is comprised of gray dolomite with shale interbeds of the Cambrian, Leithsville Formation (Figure 3). Competent bedrock, was not encountered during monitoring well installation to a depth of approximately 50 feet bgs. It should be noted that a residential housing development with associated excavation is located on a topographic high approximately 400 feet east of the site. Bedrock excavated at this location is comprised of quartzite of the Hardyston Formation. Due to the lack of nearby bedrock exposure and absence of mapped structural data, the bedrock structural conditions in the site vicinity are not well known. Competent bedrock was not encountered during borehole installation to a depth of approximately 50 feet bgs. Materials overlying the competent bedrock have been completely weathered to a tan silt and clay.

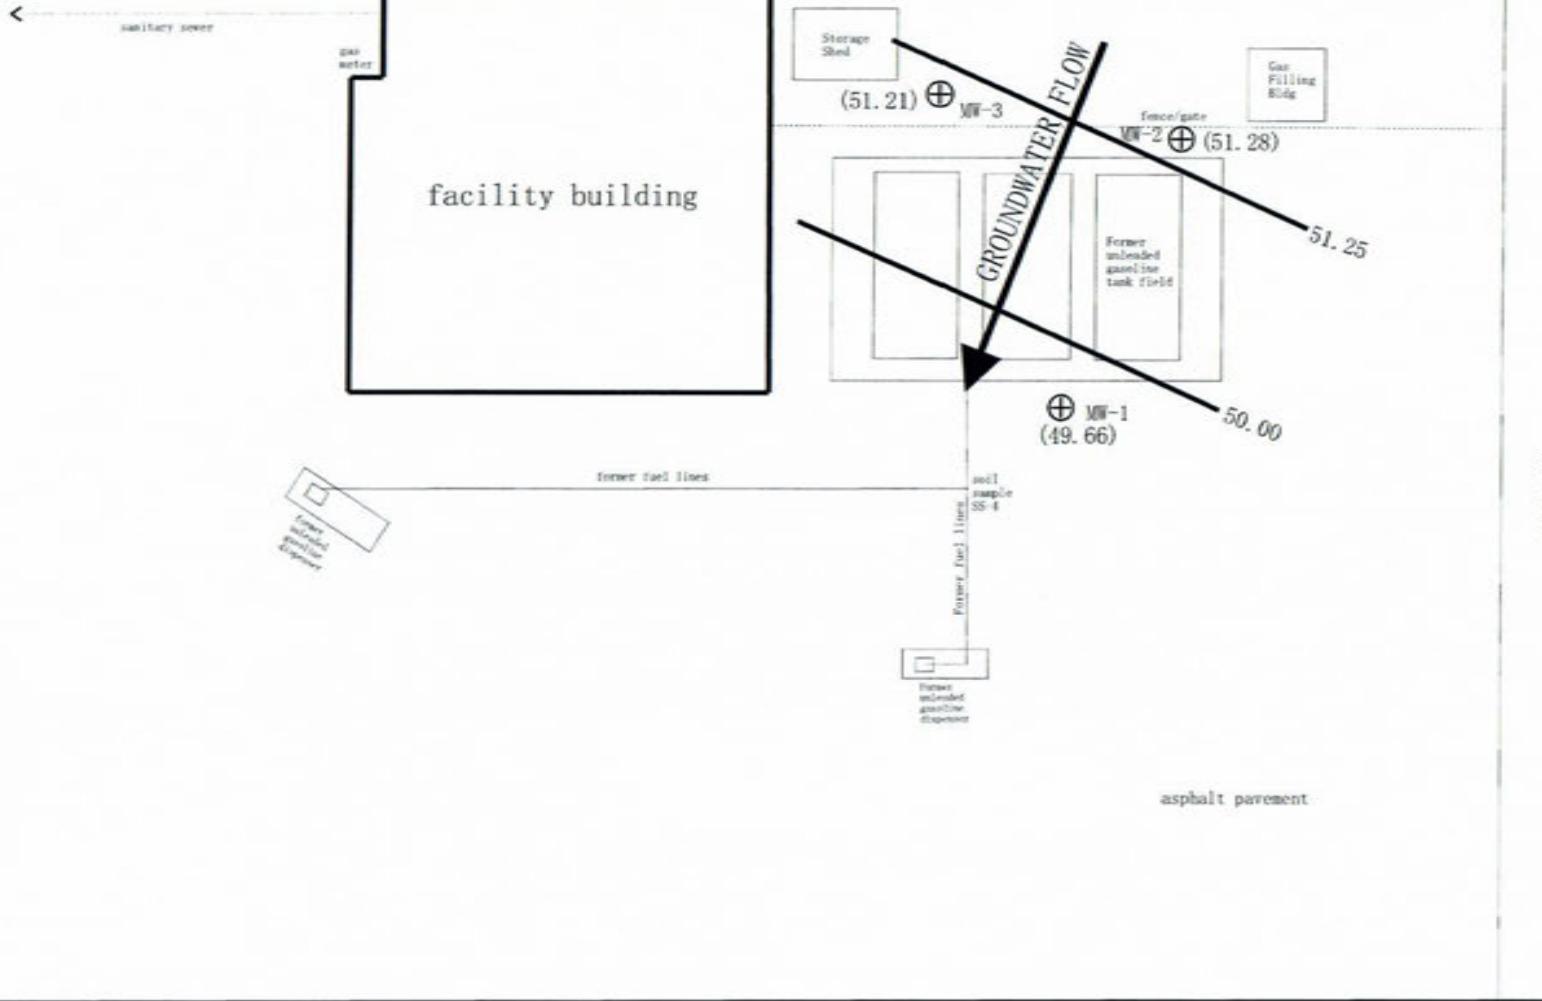
Groundwater Flow Direction
(May 9, 2019)

The above data was utilized to calculate water table elevations in each well and thereby determine the direction of groundwater flow across the site. The direction of the groundwater flow based on the water level data is shown on Figures 4.0 and 5.0. Determination of the groundwater flow direction at the site based on the available data indicates that the general component of flow is to the southeast. It should be noted that this direction is not coincident with topography and the area surface drainage system. In addition, it should be noted that the water detected in the tank excavation was a perch condition and it appears likely that the nearby stream is a losing stream. It should be emphasized that additional groundwater data is required to confirm the flow direction at the project site. Furthermore, while a professional survey of the wells has not been completed to date (in process), given the significantly lower depth to the water table measured in MW-1, determination of flow direction is not likely to change.

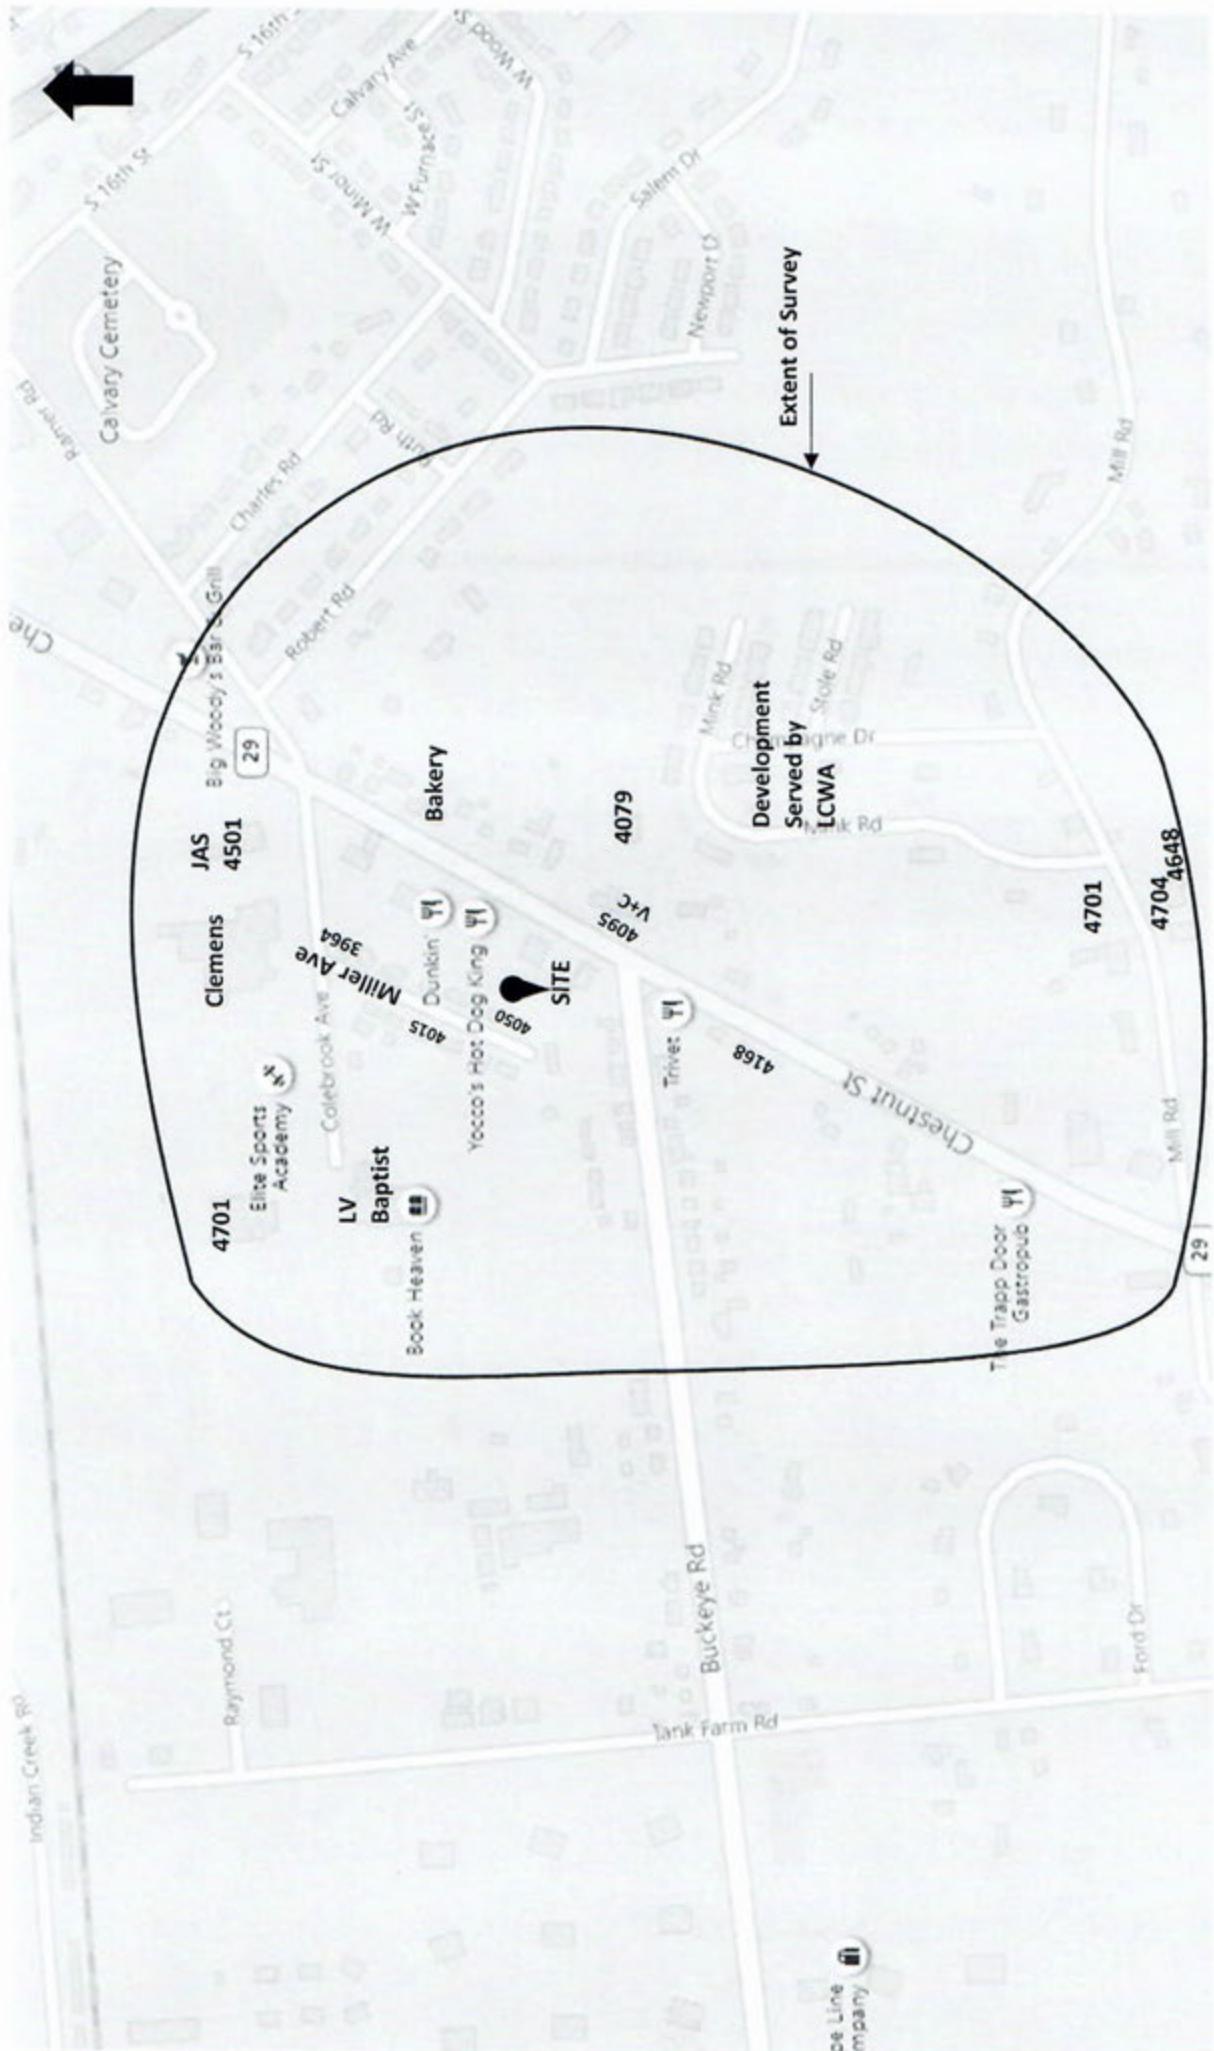
COVENTRY ENVIRONMENTAL ASSOCIATES, INC. PO Box 224 St. Peters, Pennsylvania	Job no. WACHTER-002	Scale: 1"=600ft (approx.)	Drawing no. 6.0
United Tire Service 4094 Chestnut Street Emmaus, Pennsylvania (facility ID 39-27735)		TITLE: Area of Private Well Survey

- Big Woodys (ID 12), 0.246 miles NE direction (3941 Chestnut St.).
- It should be noted that Buckeye pipeline is located at a distance of 0.517 Miles, west direction (non-community system) and has reported non-compliance with numerous volatile organic compounds.

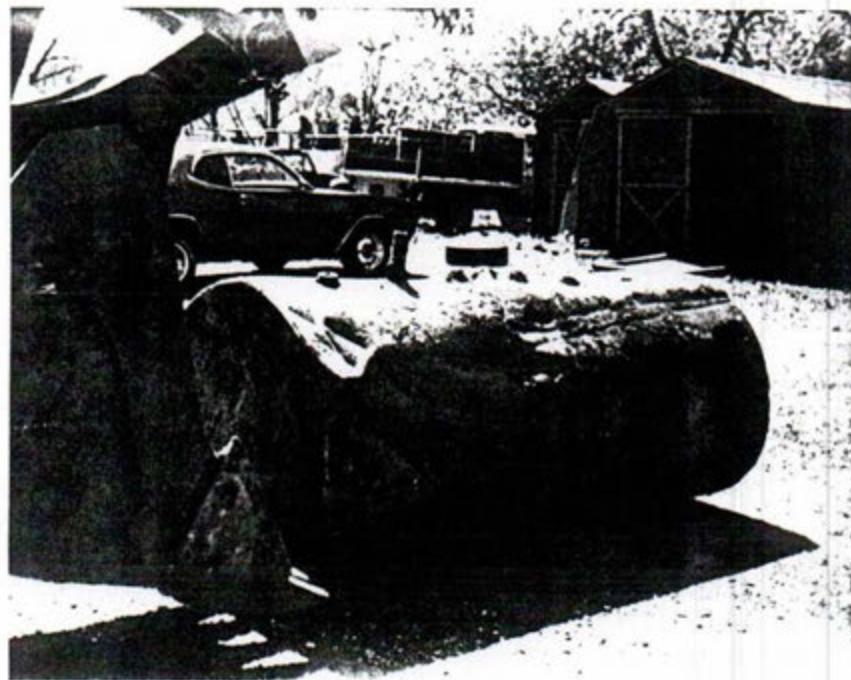
Above: Tank area before excavation

Below: 1,000 tank after removal

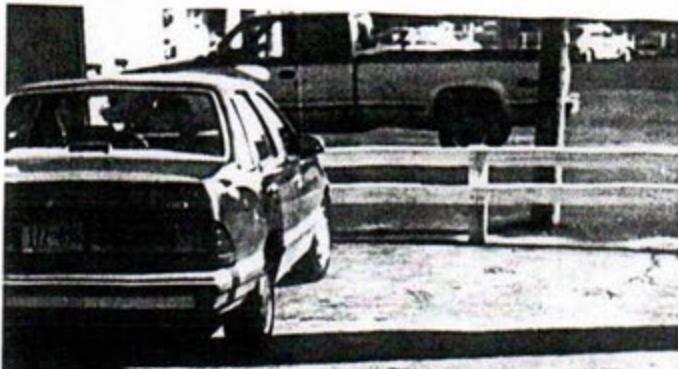
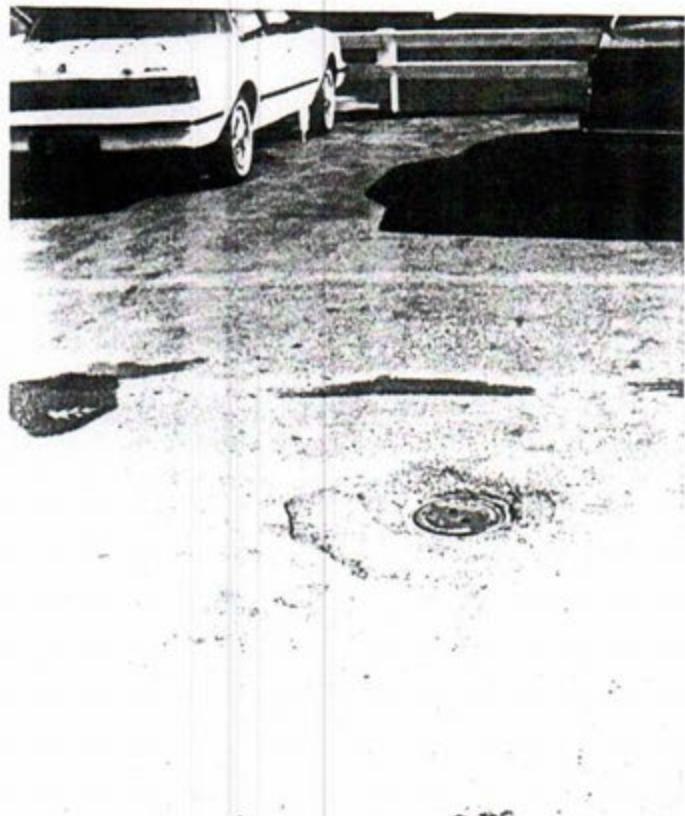
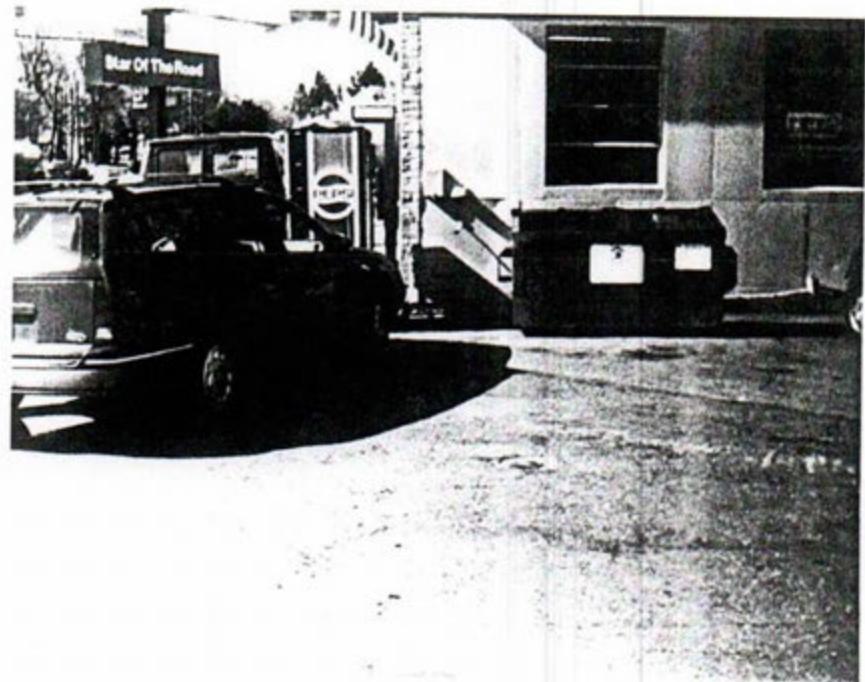
Above: 6,000 tank area before excavation

Right: 4,000 tank area before excavation

Below: 10,000 tank area before excavation

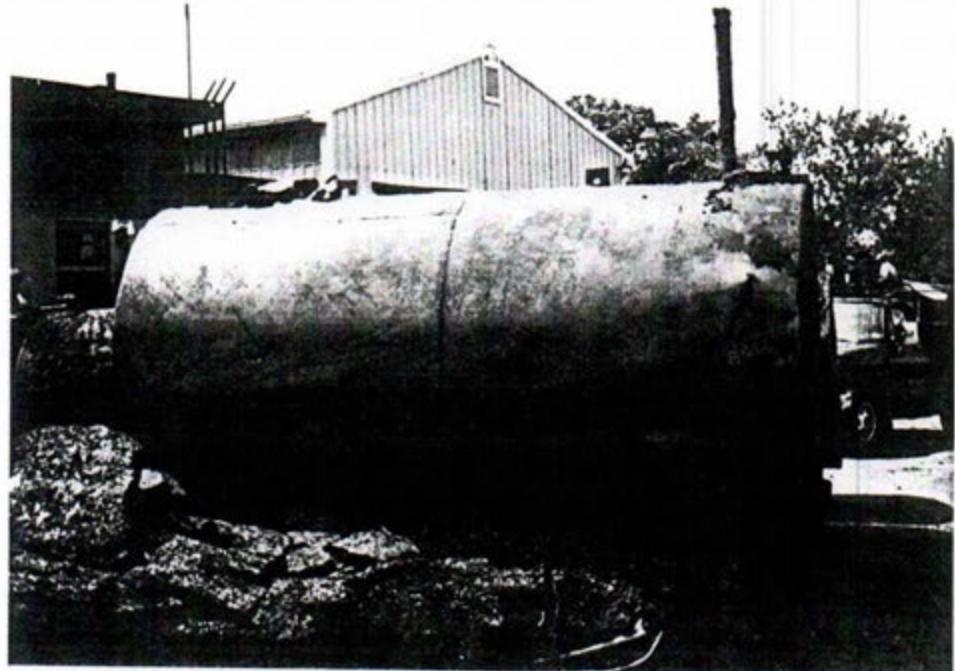
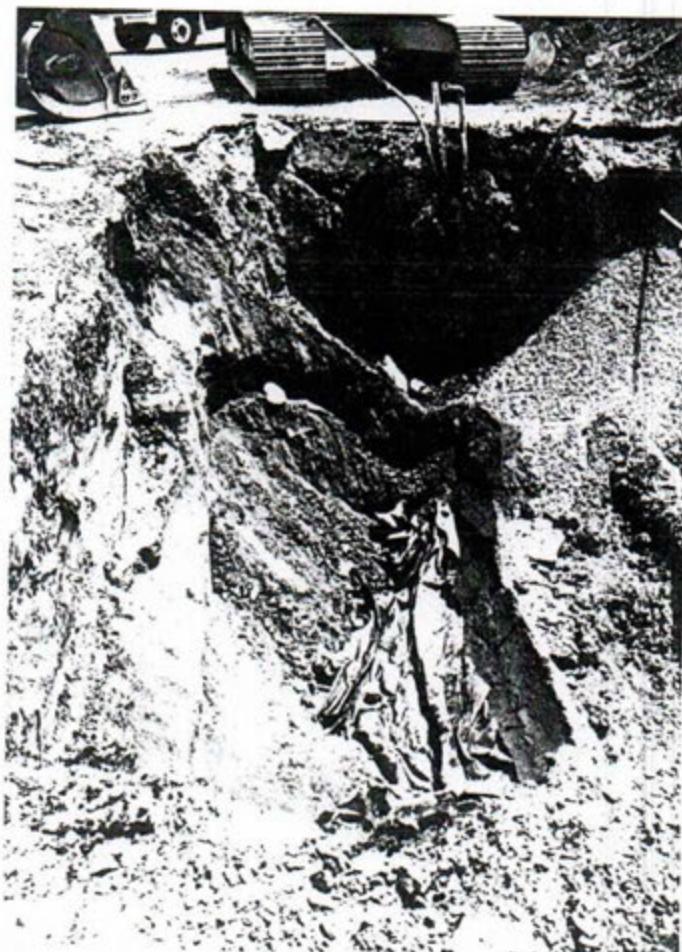
Above: 6,000 tank after removal

Below: Excavation after 6,000
tank removed

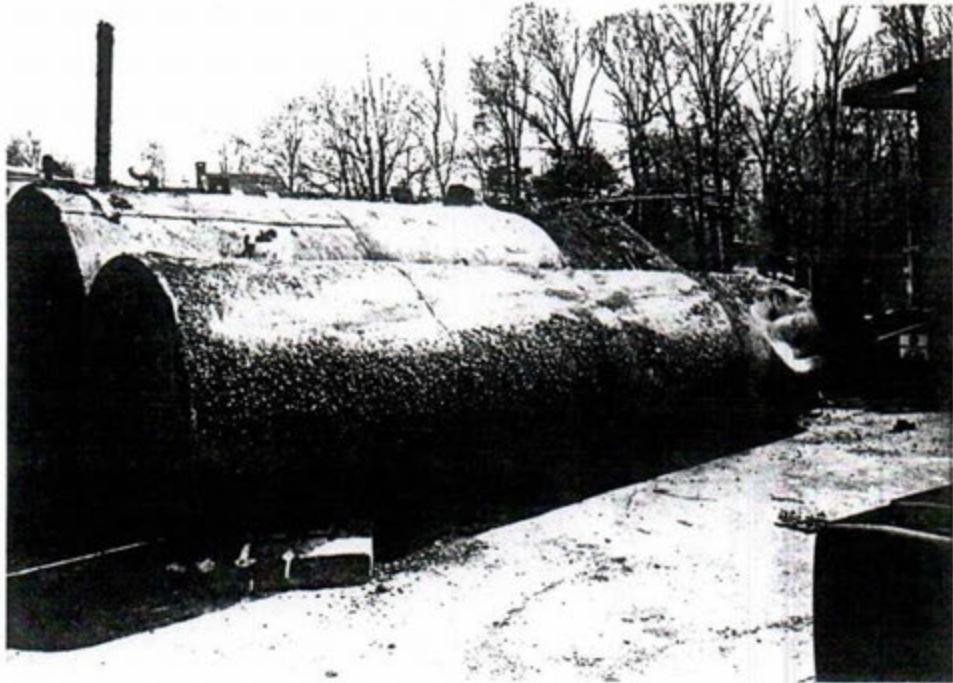
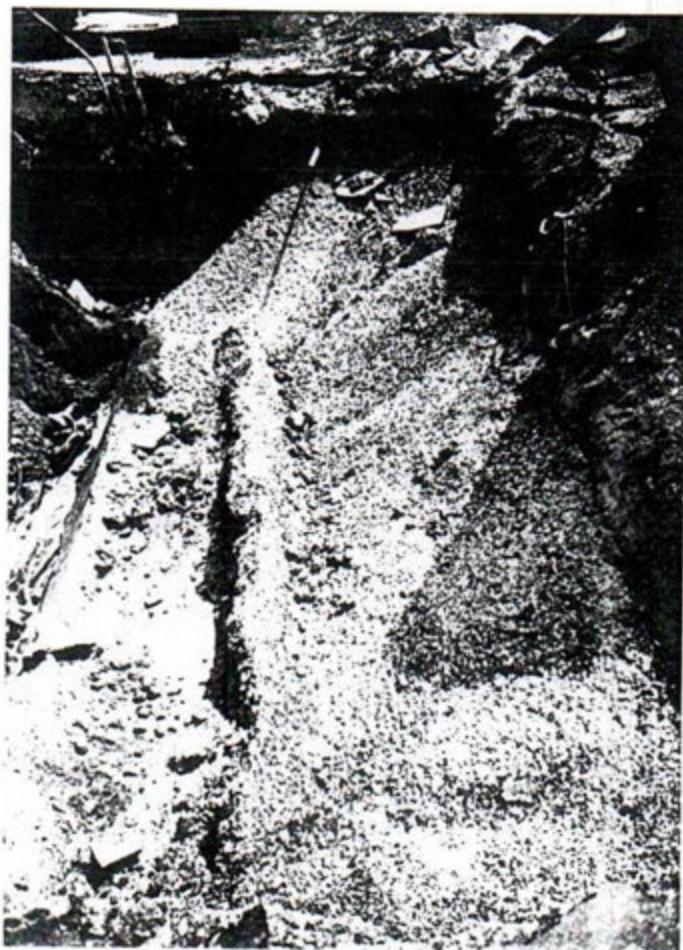
Above: 4,000 tank after removal

Below: Excavation after 4,000 tank removed

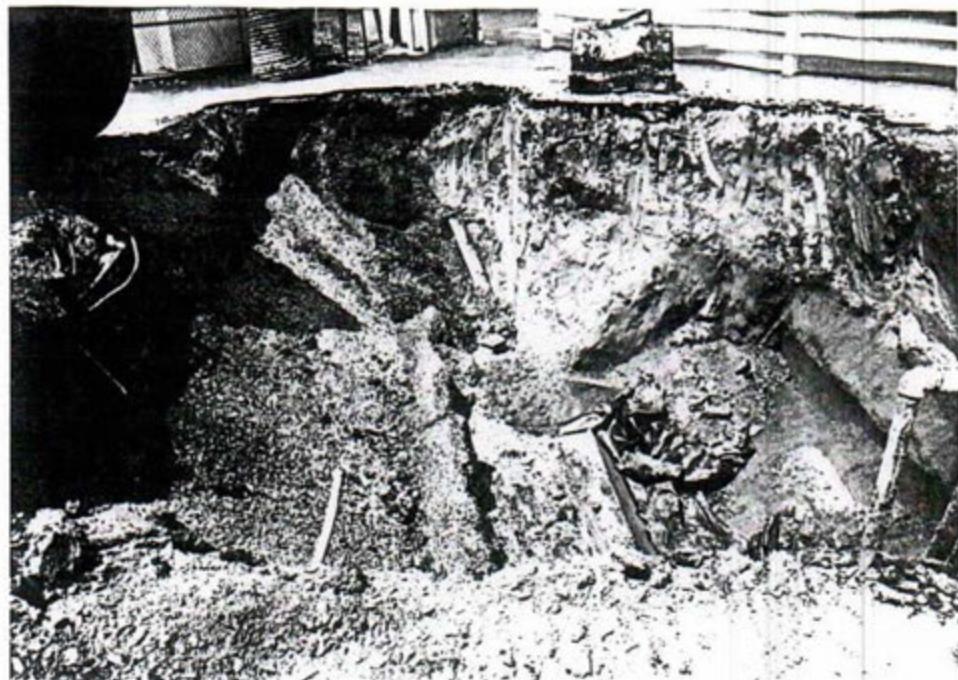
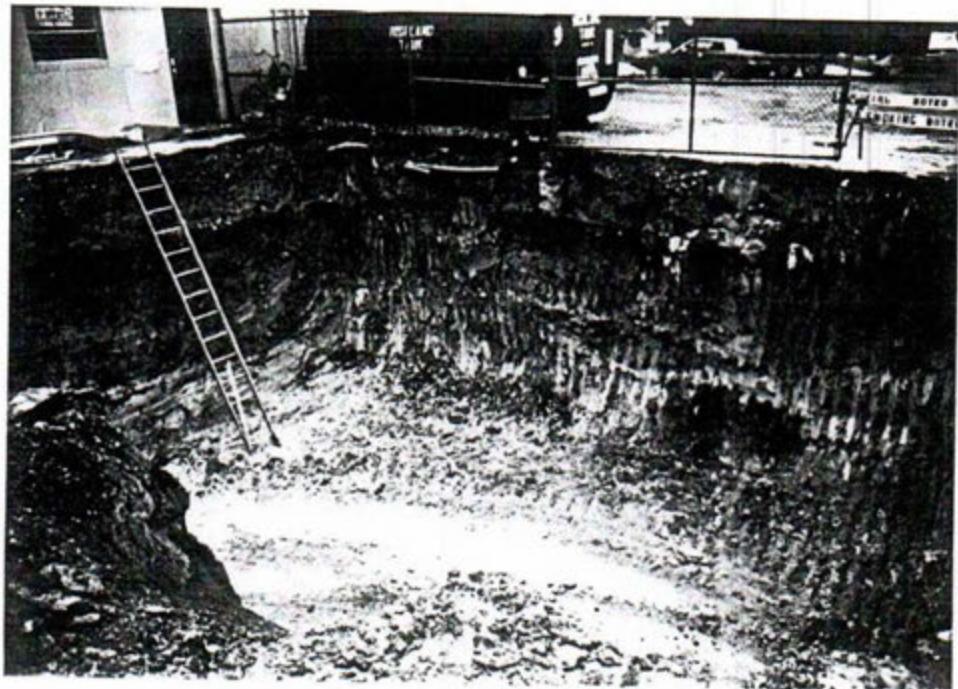
Above: Excavation after 4,000 & 6,000 tanks removed

Below: Excavation after remediation and prepared for new tank installation

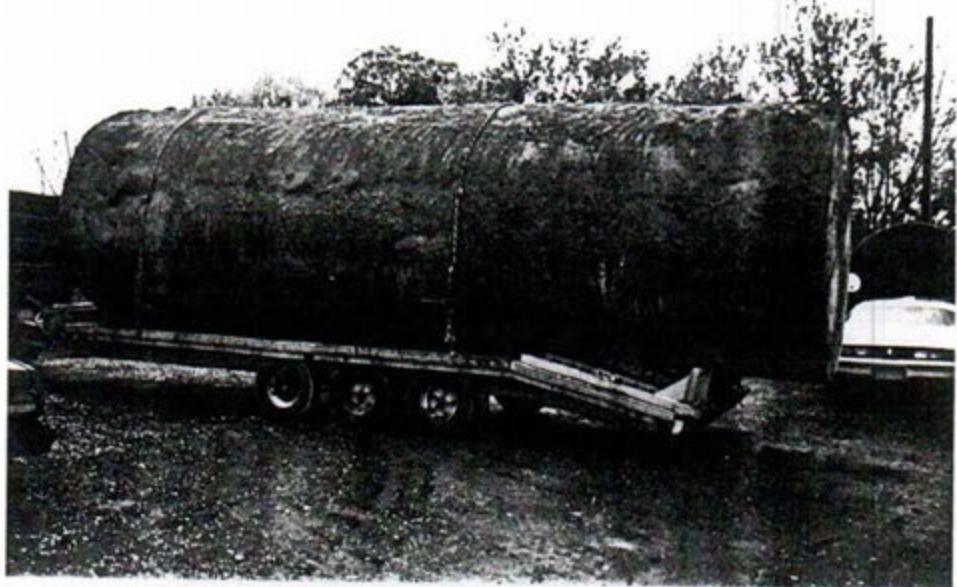
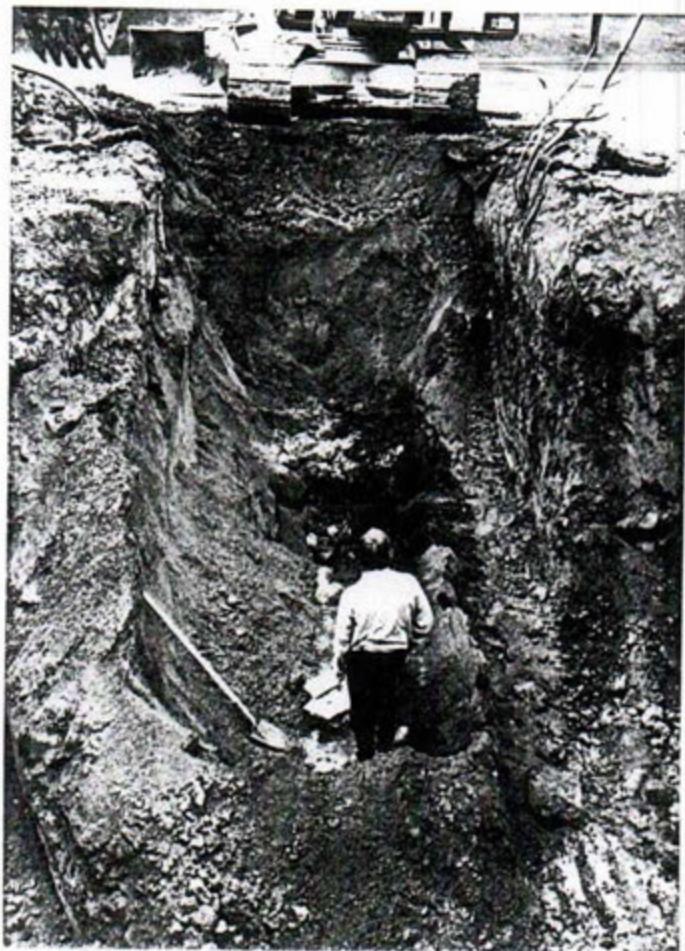
Above: 10,000 tank after removal

Below: Excavation after 10,000 tank removed
