Environmental Remediation & Recovery, Inc.

RE: Russell City Store
1536 State Route 66
DeYoung, Pennsylvania 16728
PADEP Facility ID # 24-30431
USTIF Claim #2014170
ER&R Project # 2014.74

**UNDERGROUND STORAGE TANK SYSTEM
CLOSURE REPORT FORM**

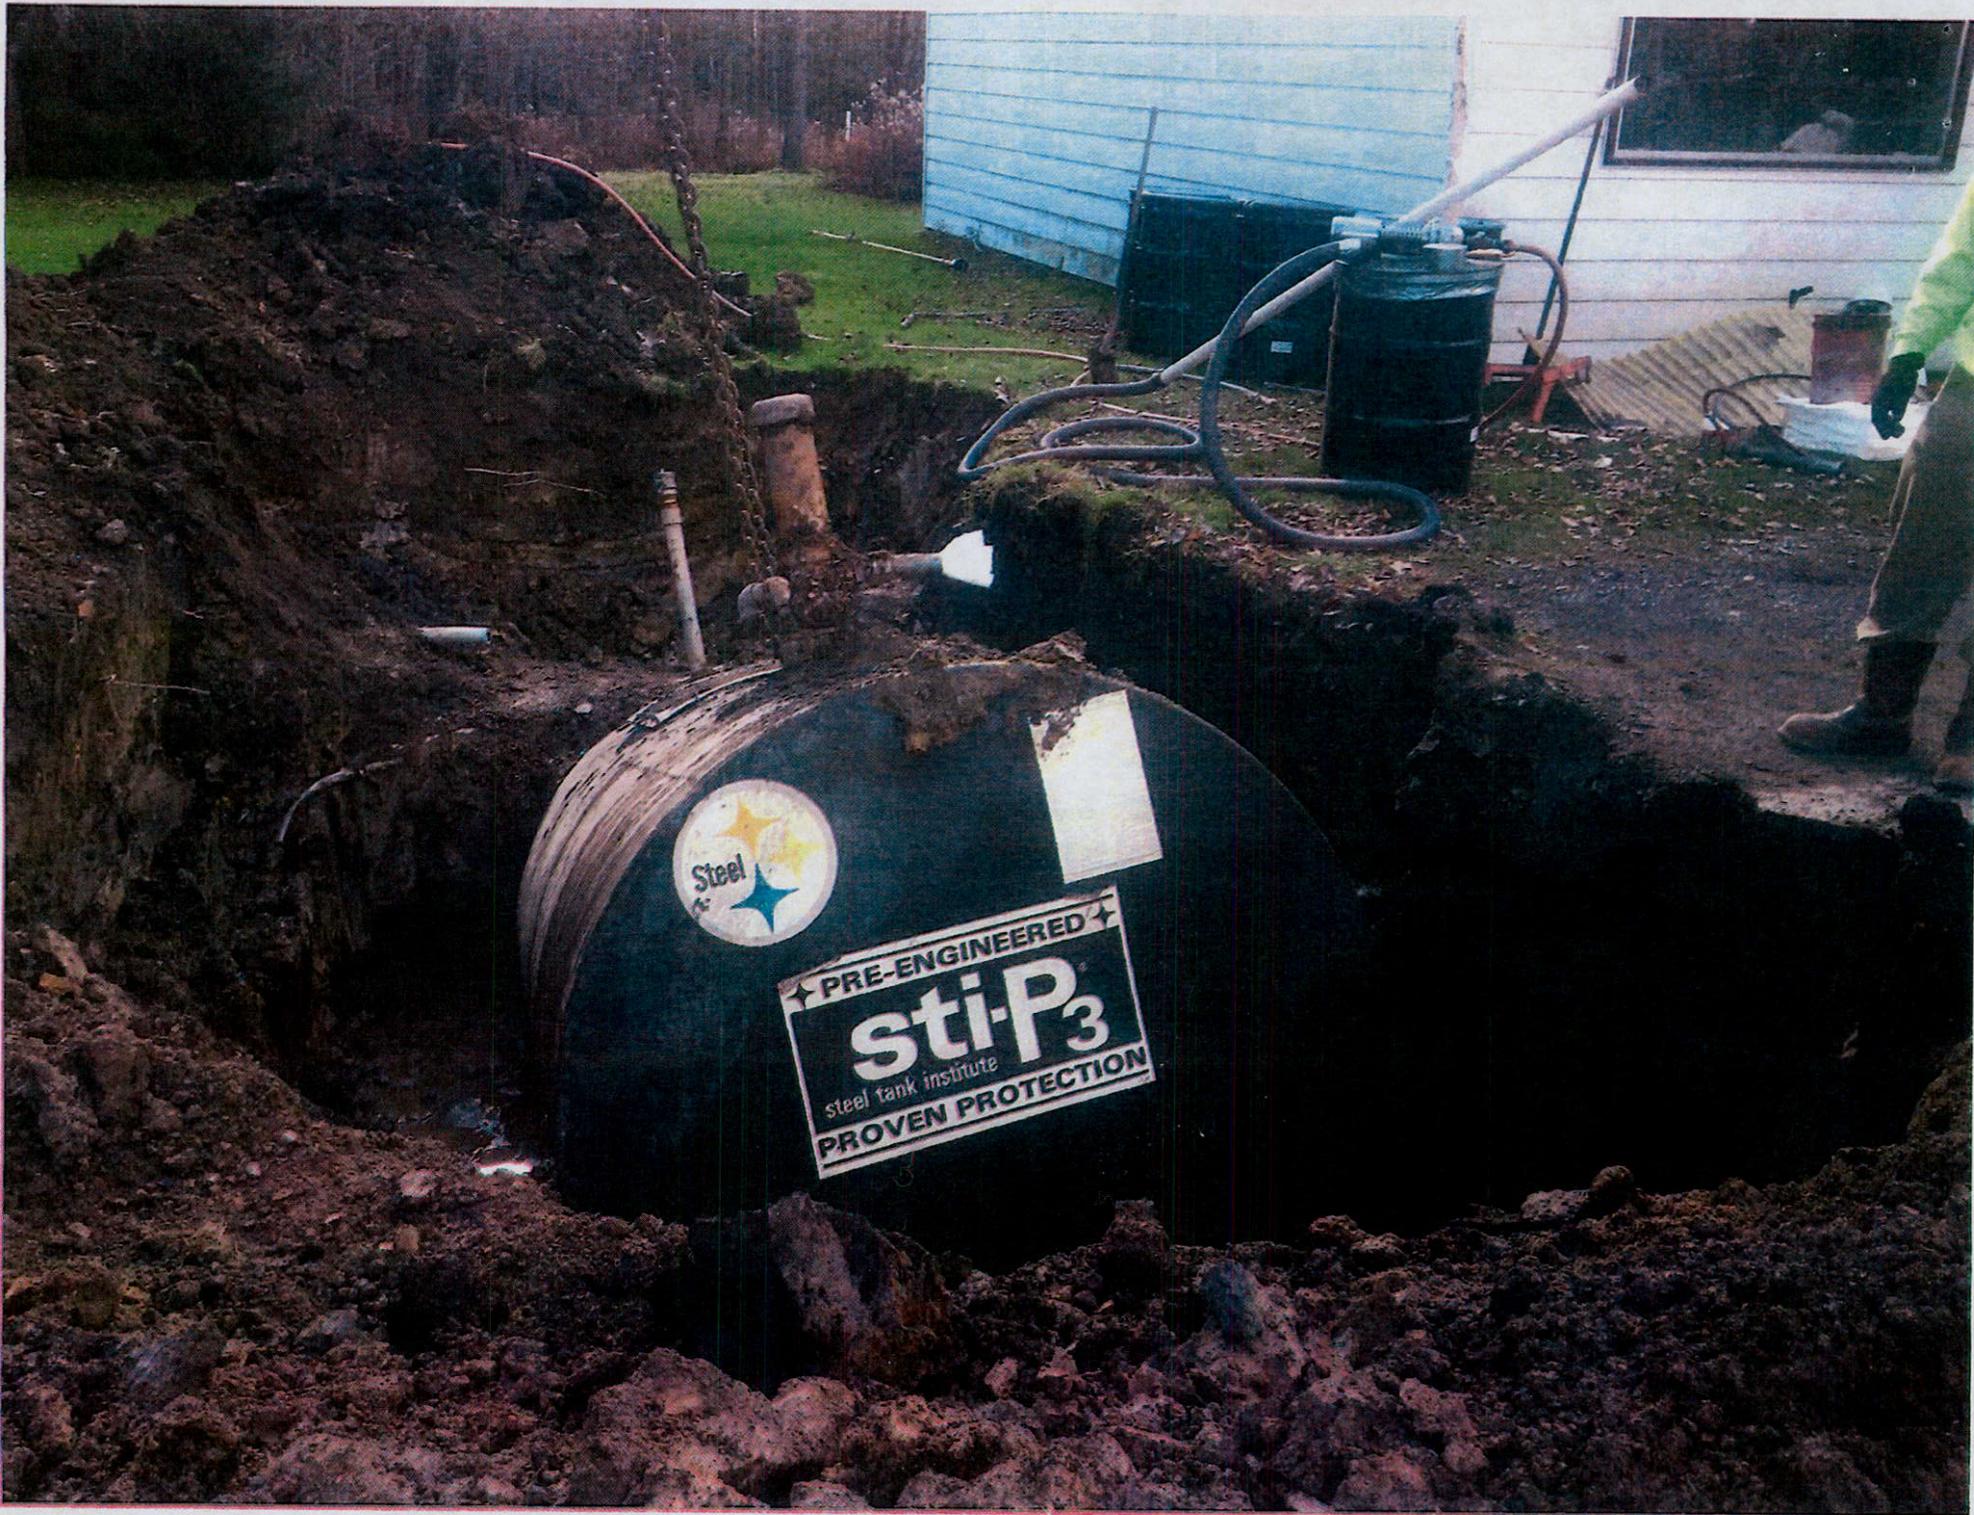
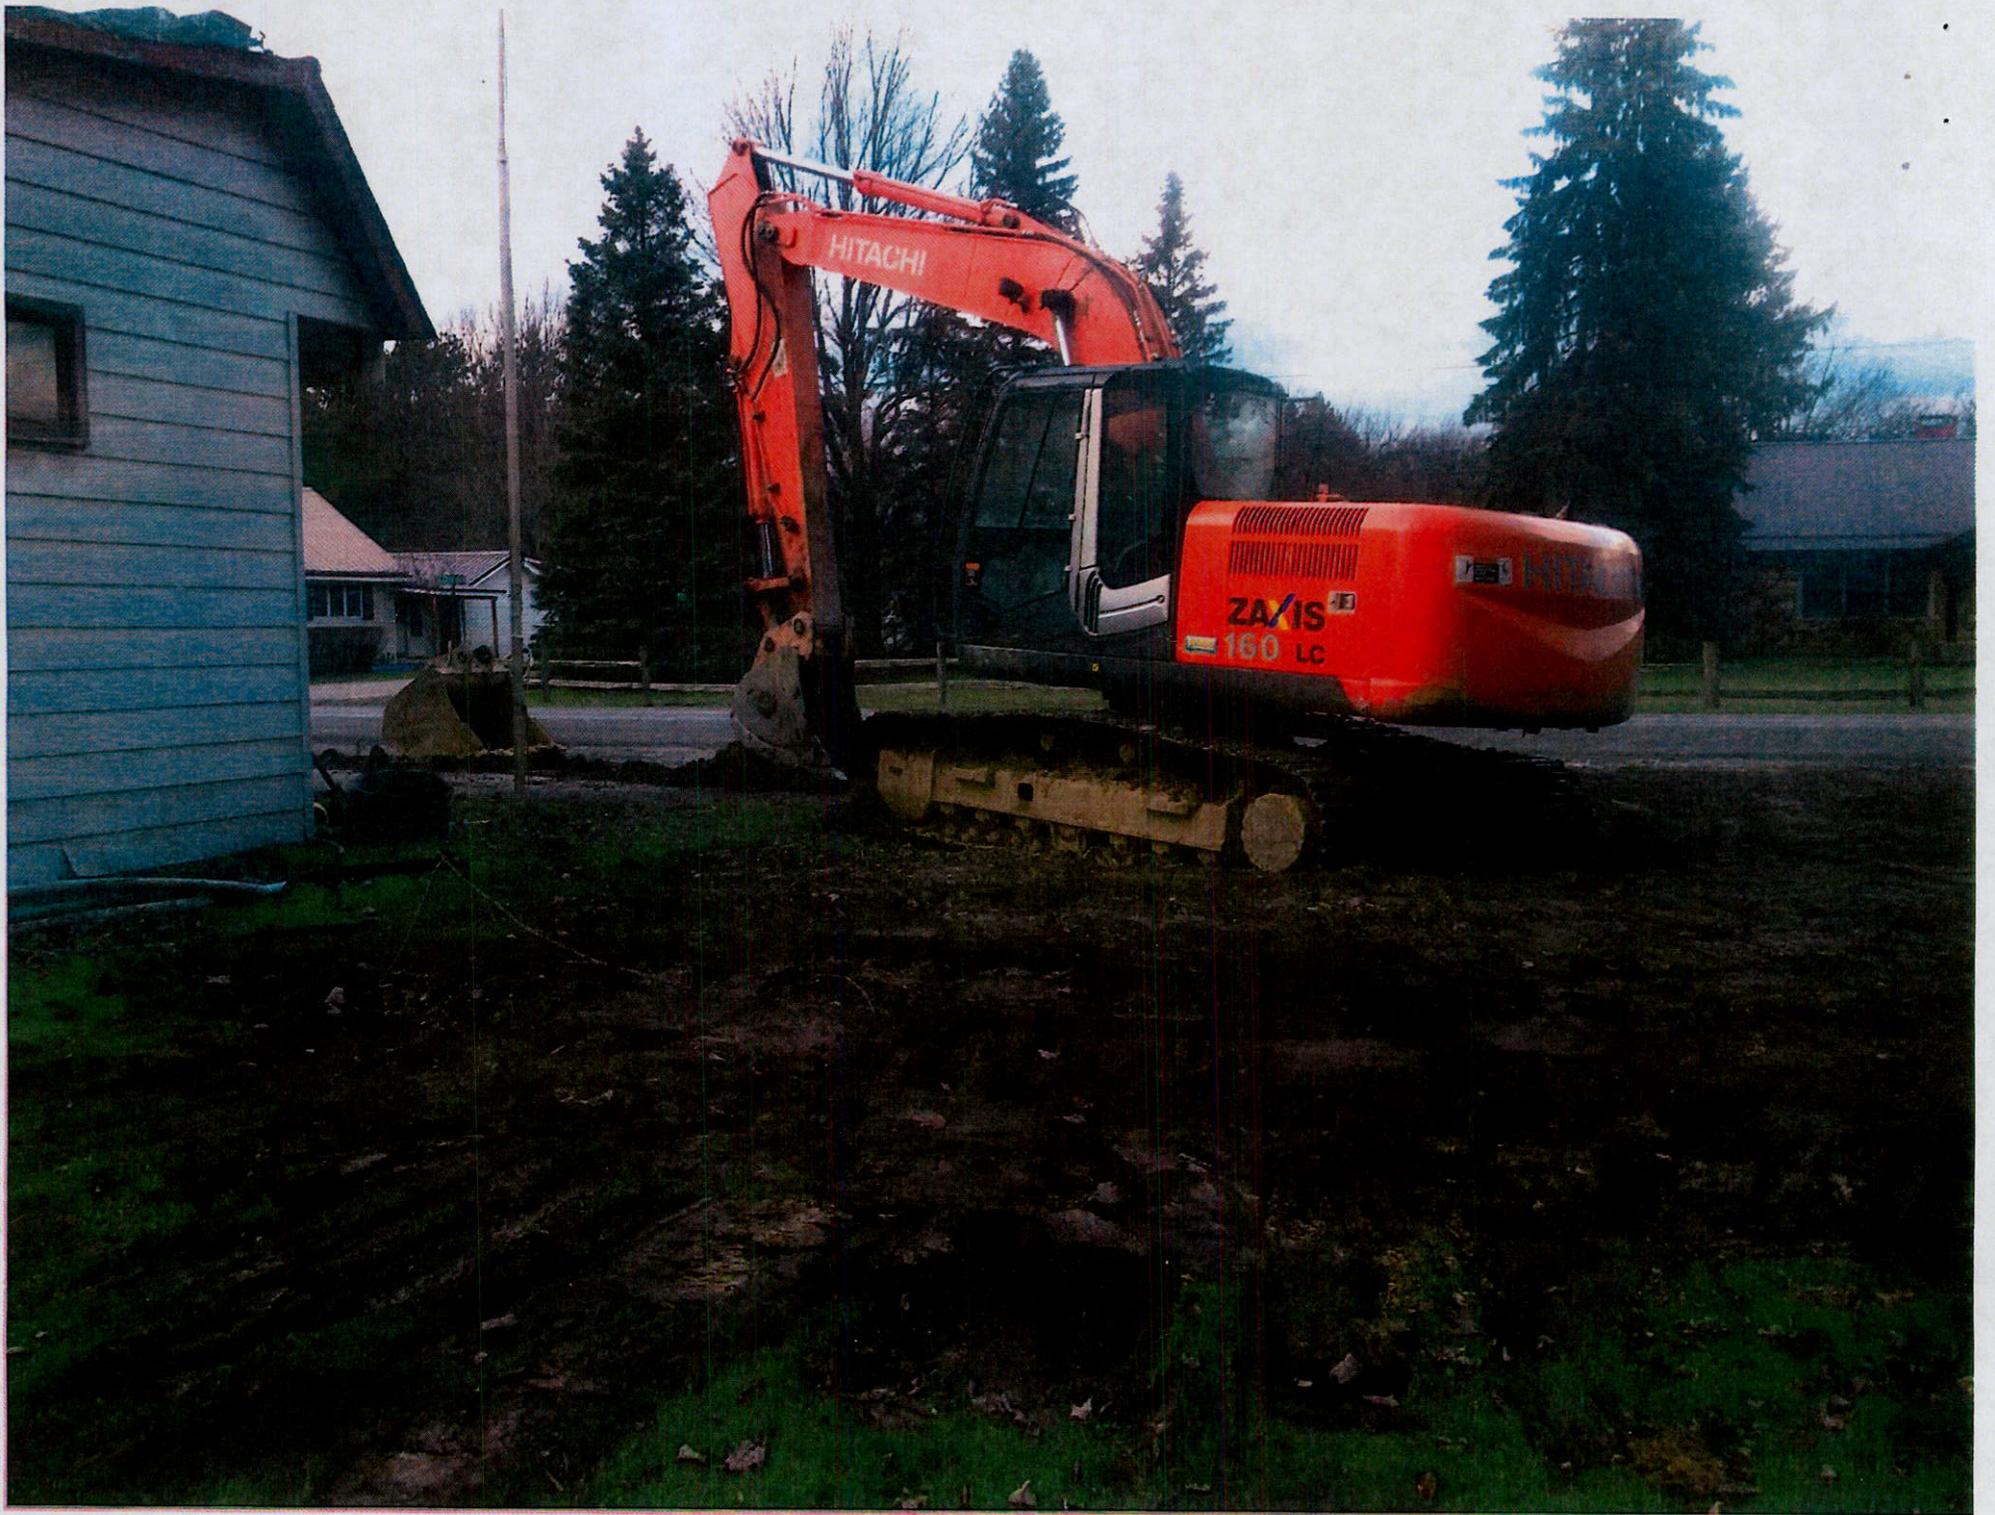
SEE ATTACHED FIGURE 1 AND 2

12. A site location and sampling map of the site, drawn to scale, is attached. Figure 1 & 2 of the UST Closure Report.

Contamination was only observed below the dispensers.

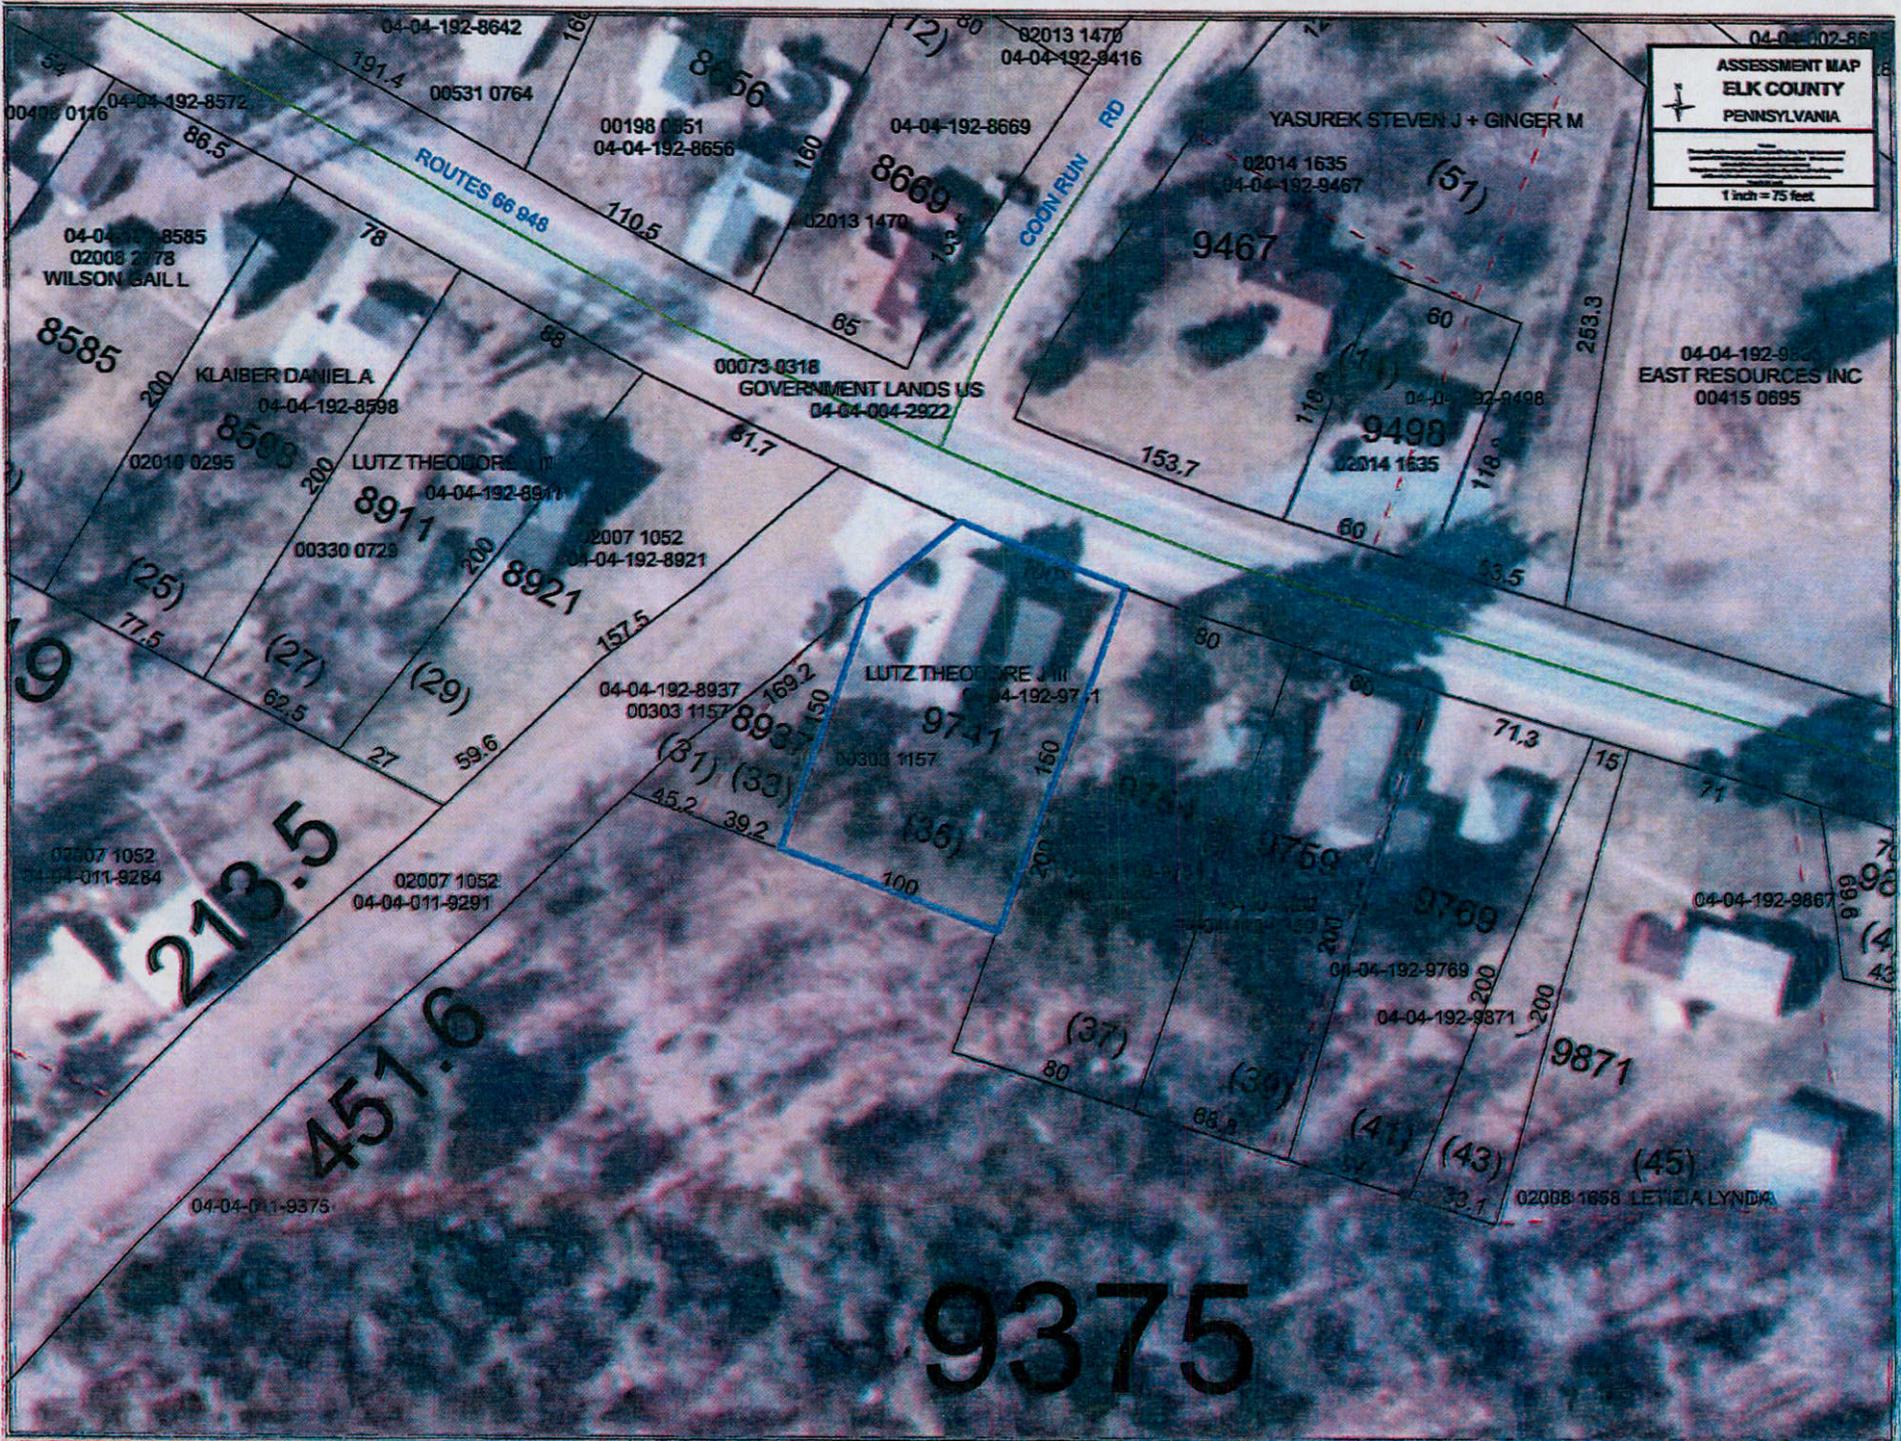
ASSESSMENT MAP
ELK COUNTY
PENNSYLVANIA

1 inch = 75 feet
