**Re: Site Characterization Report  
Sohail's Store  
835 South Eisenhower Boulevard  
Middletown, PA 17057  
PADEP Facility ID #22-16012/PAUSTIF Claim #2020-0014**

# SITE CHARACTERIZATION REPORT

**PADEP Facility ID #22-16012**  
**PAUSTIF Claim #2020-0014**

**Sohail's Store**  
**835 South Eisenhower Boulevard**  
**Middletown, PA 17057**

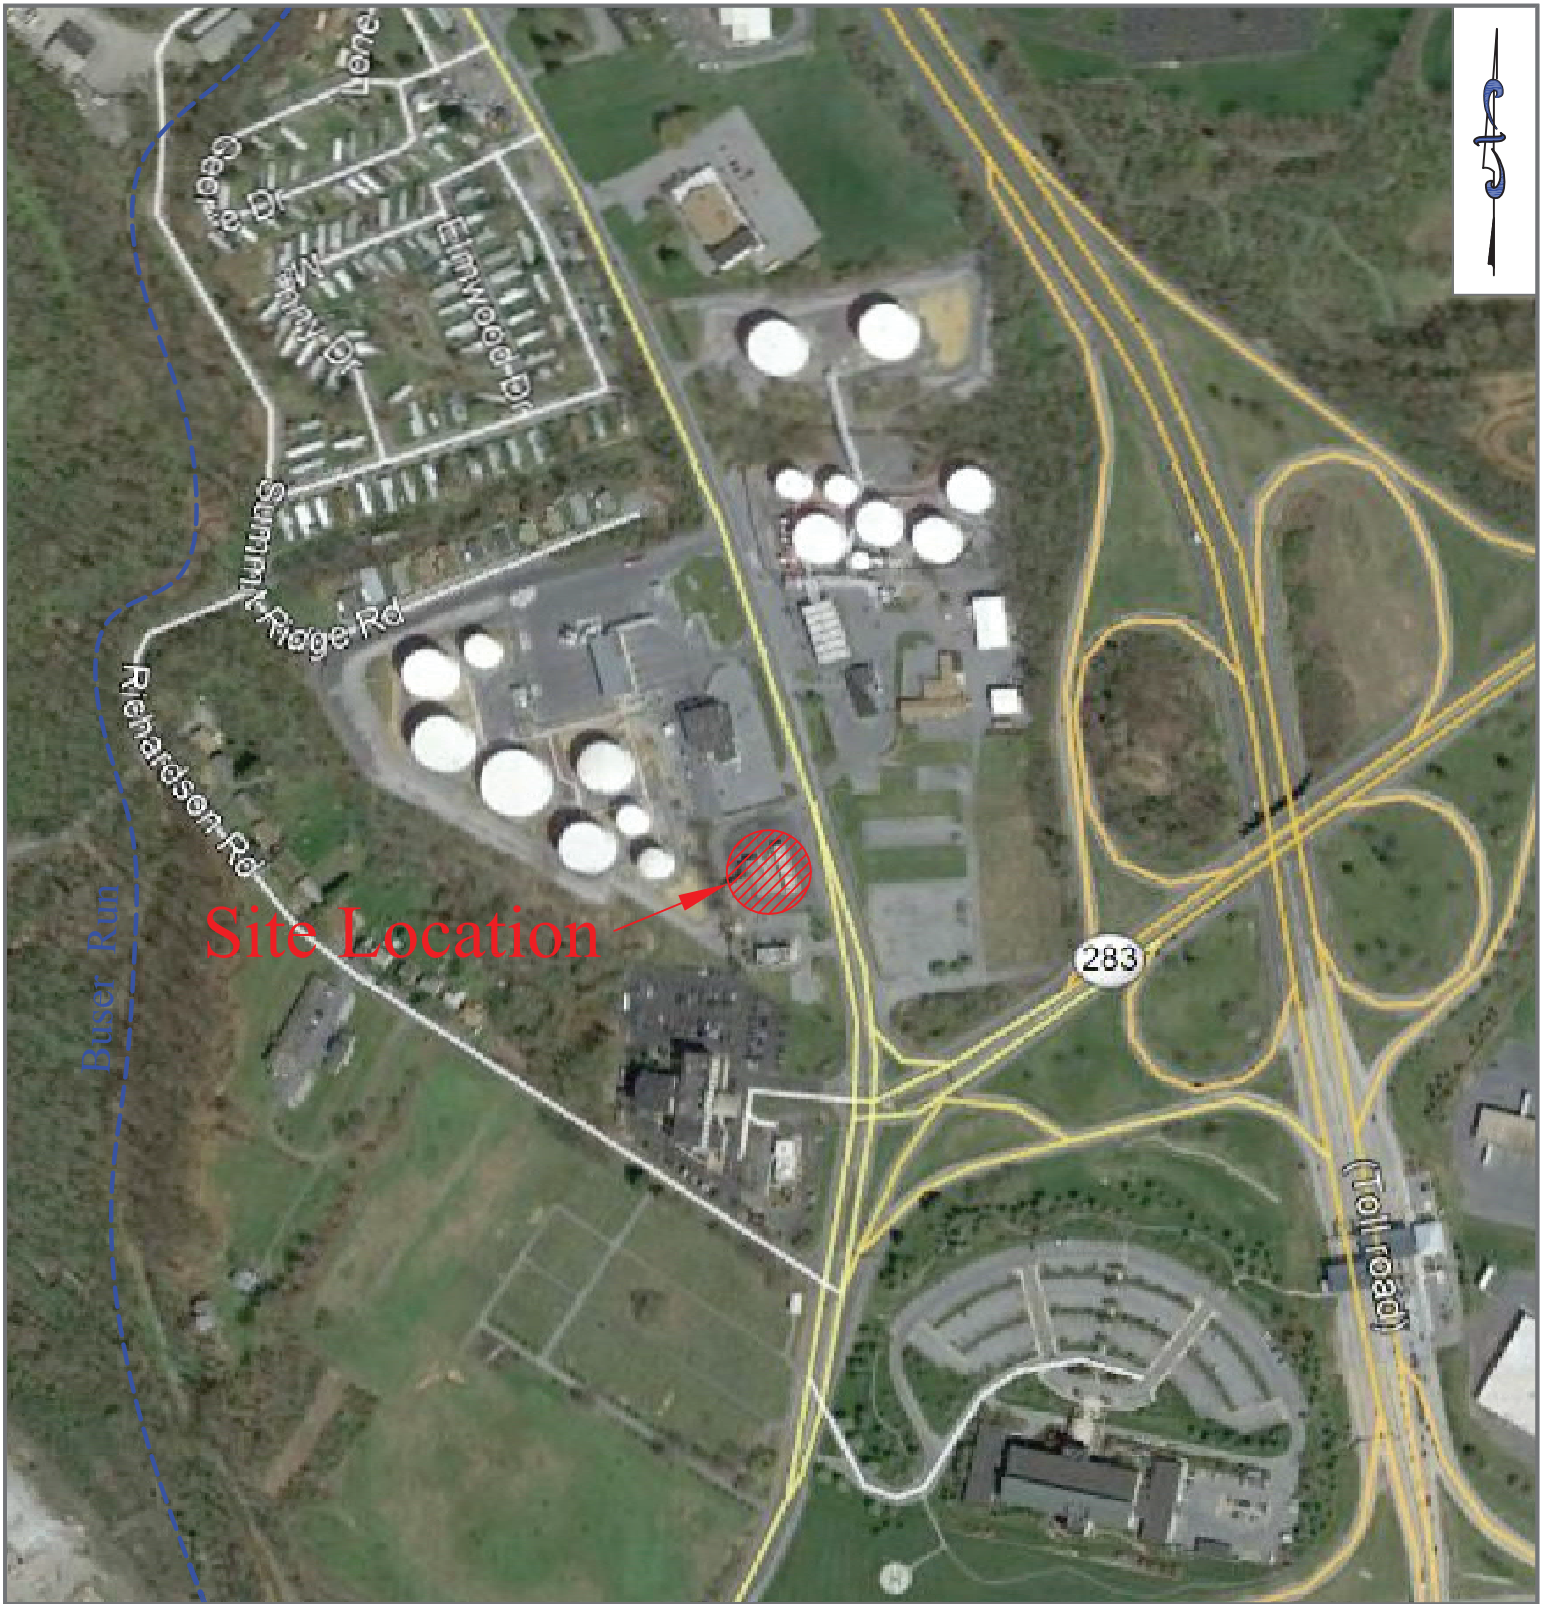
Reference: Mapping based upon aerial image taken from Google Earth. Date of aerial image is April 2, 2020.

The site location is depicted on the USGS 7.5-minute Topographical Quadrangle of Steelton, PA as presented in **Figure 1**. The latitude of the site is reported to be 40° 13' 08.50" N and the longitude is reported to be -76° 47' 28.85" W. The site reportedly exists at an approximate elevation of 395 ft-amsl. Site topography is generally flat. An aerial view of the site and surrounding area is presented as **Figure 2**. A more detailed site layout map, which fully depicts the site area, is presented as **Figure 3**.

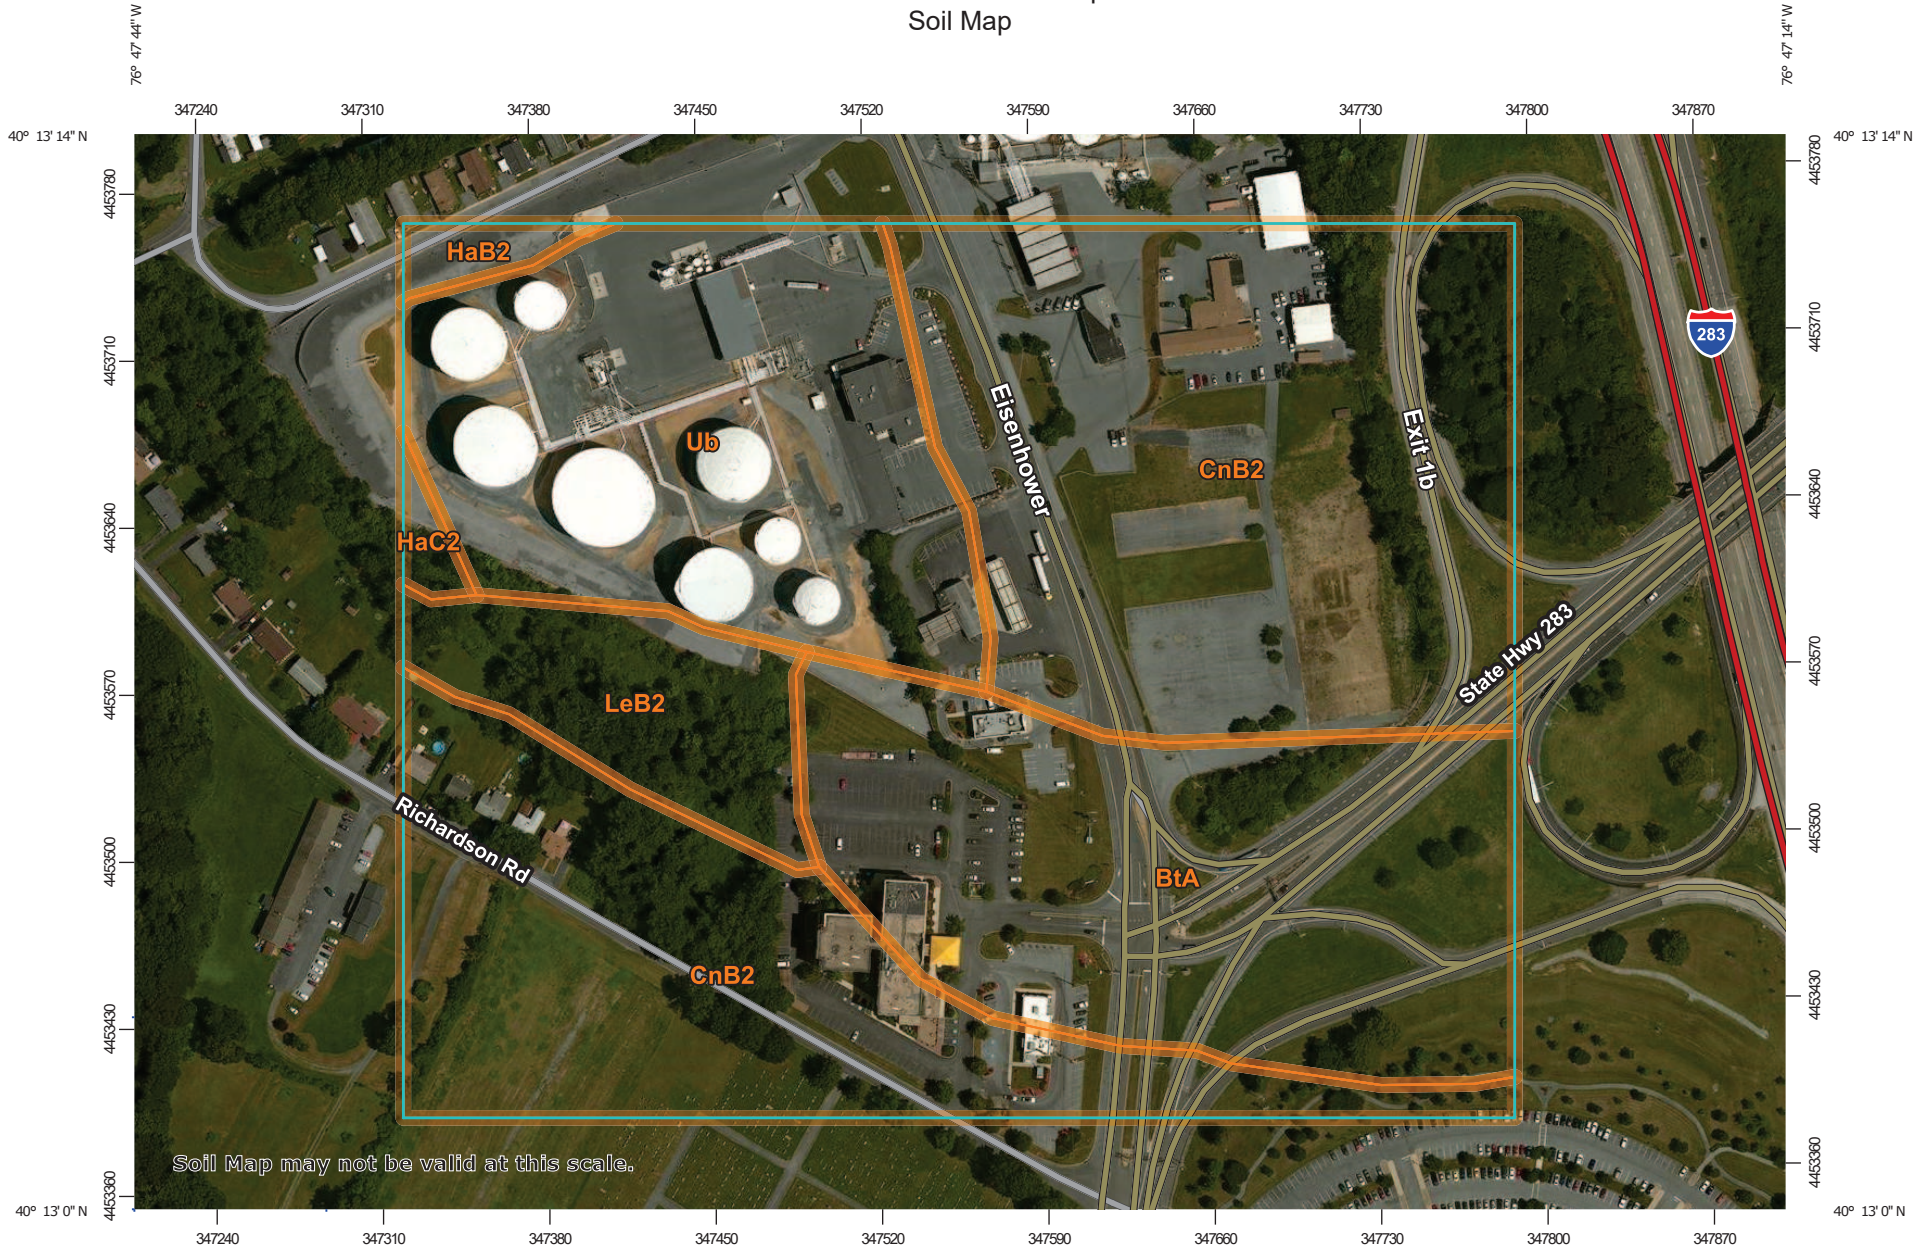
# Custom Soil Resource Report Soil Map

The soil map section includes the soil map for the defined area of interest, a list of soil map units on the map and extent of each map unit, and cartographic symbols displayed on the map. Also presented are various metadata about data used to produce the map, and a description of each soil map unit.
