**COMPREHENSIVE ENVIRONMENTAL SITE
CHARACTERIZATION**

Facility ID #26-18711
Former Route 119 Amoco
1809 University Drive
Dunbar, Pennsylvania 15431

September 2006

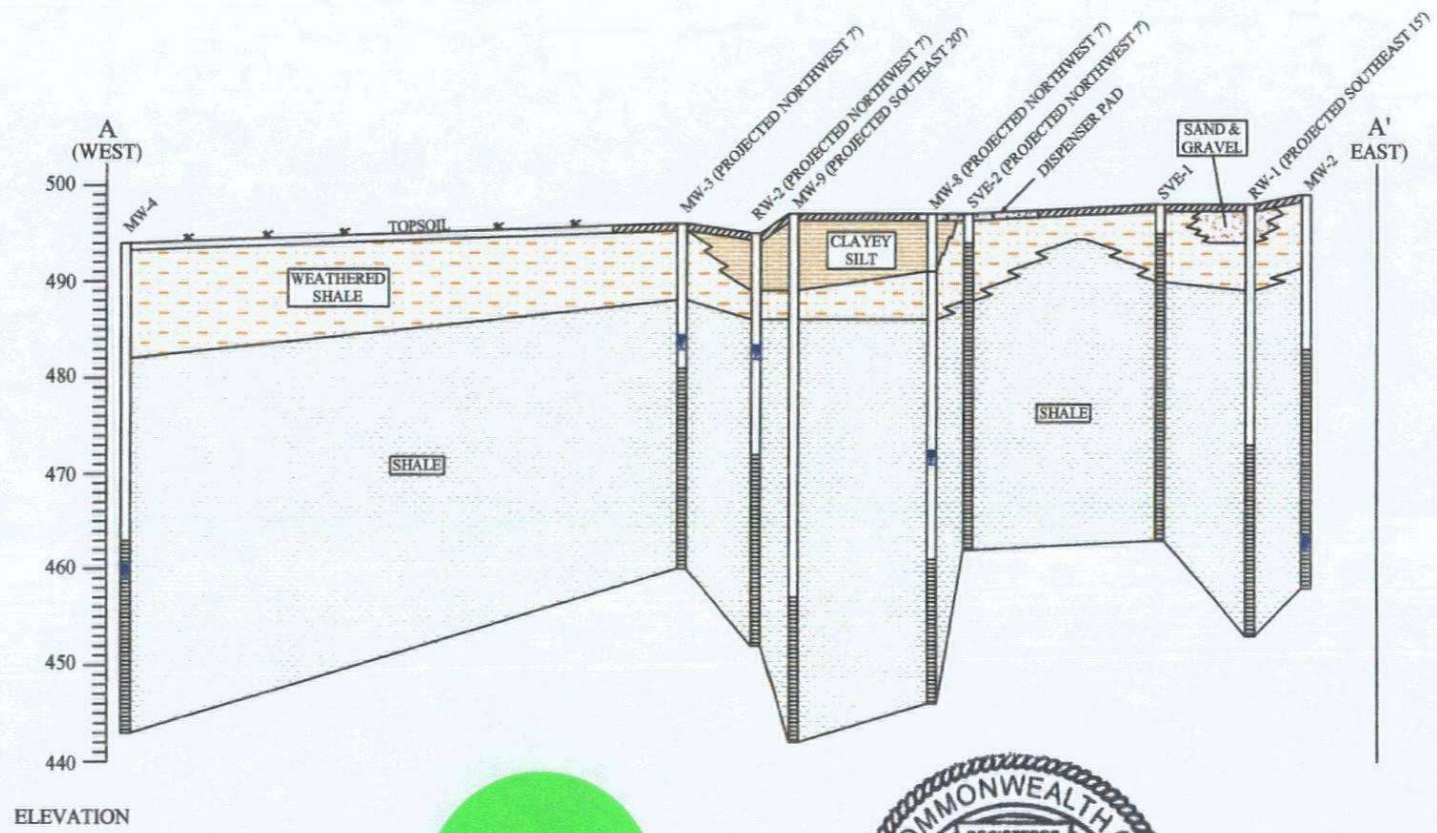
DWG: GEO	BY: PMW	CK: MSV	APP: LJL
SCALE HORIZONTAL 1" = 40' VERTICAL 1" = 20'		FIGURE 5

GEOLOGIC CROSS-SECTION A TO A'

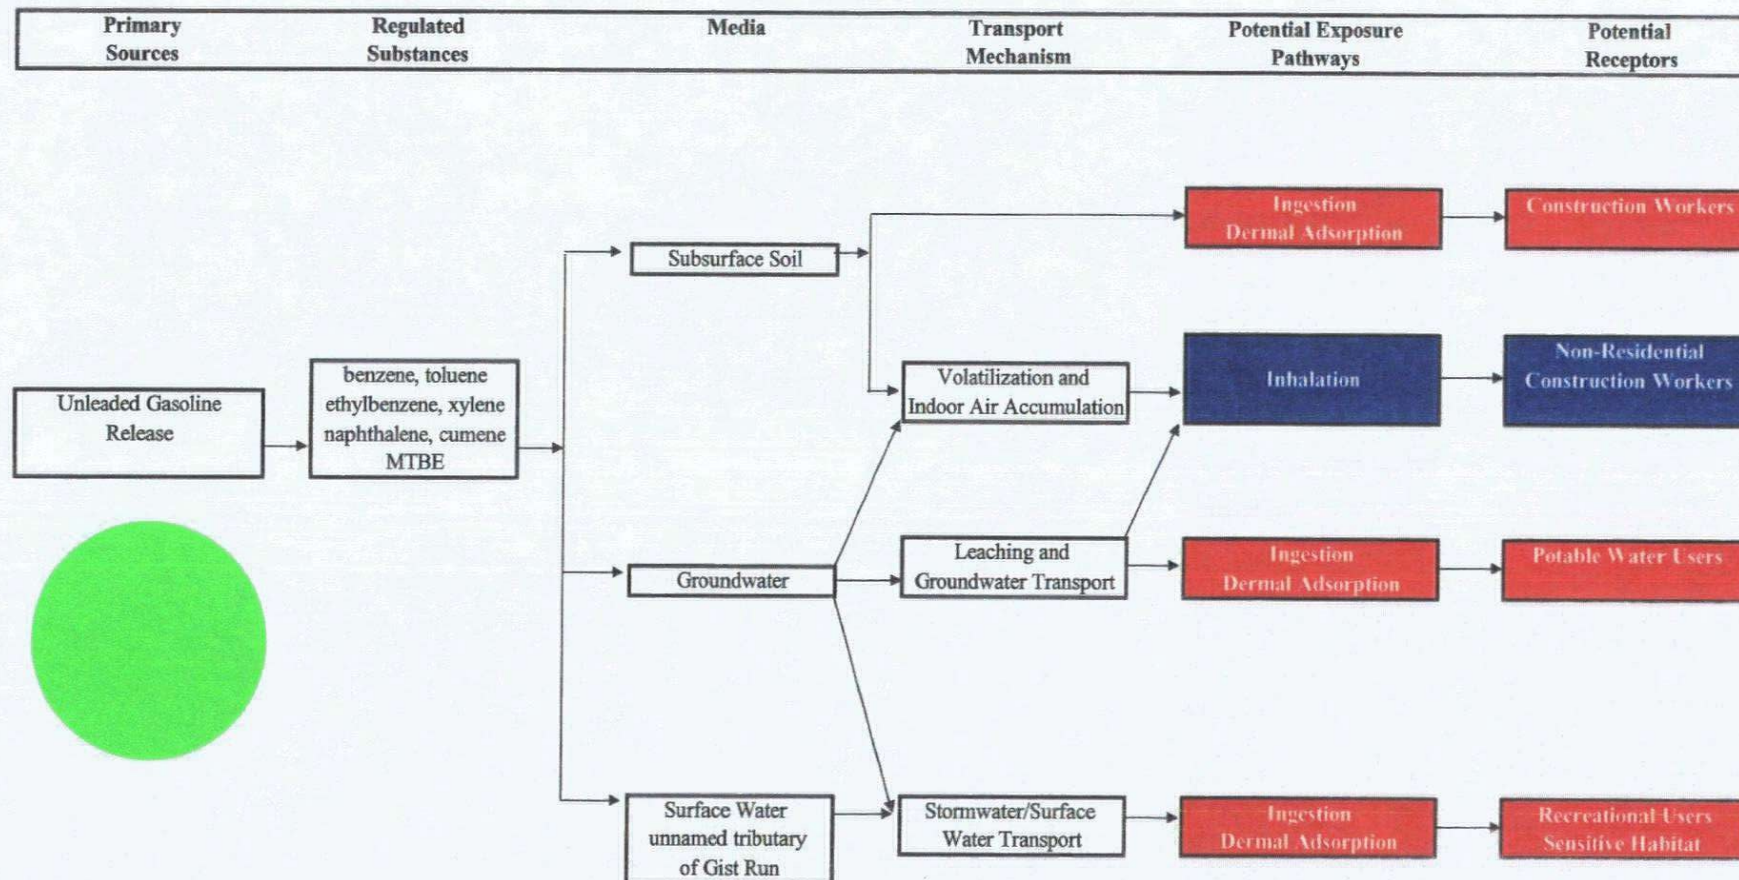
Figure 13
Former Rt. 119 Amoco
Conceptual Site Model

Incomplete exposure pathways are indicated in Red
Potentially complete exposure pathways are indicated in Blue

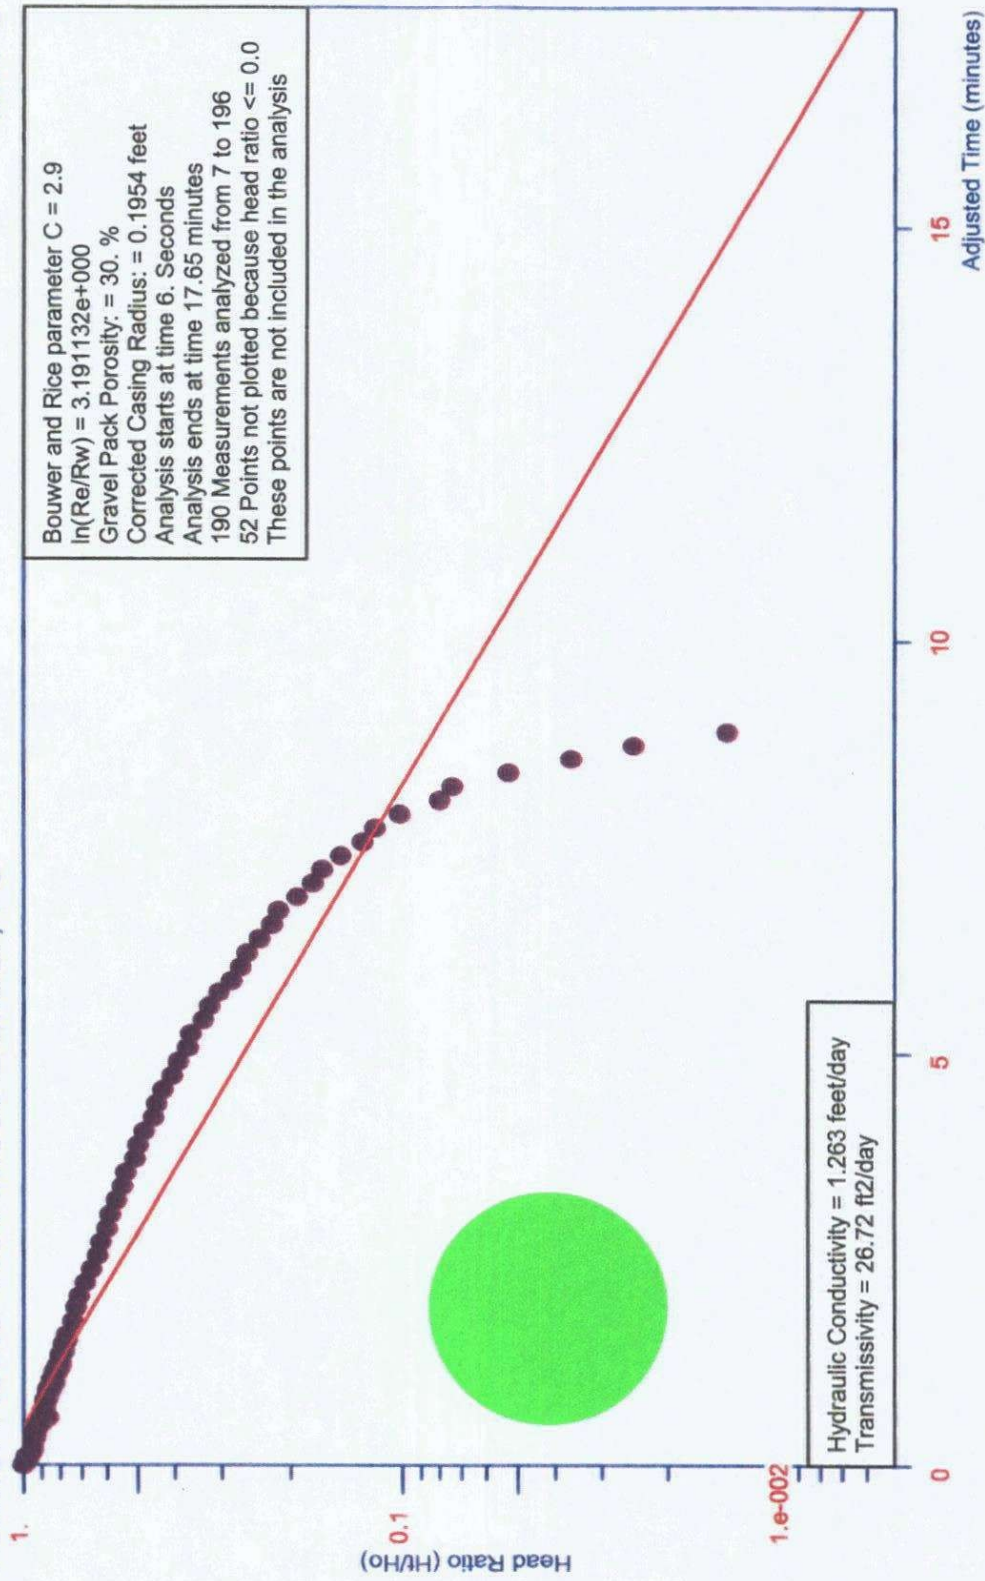
MW-3

Bouwer and Rice Graph

The slug test procedure consisted of lowering a pressure transducer into the water column, which was connected to a programmed data logger. A solid slug was then placed in the well and fully submerged within the water column. The water column was permitted time to recover to near static conditions prior to starting the slug test. The test was initiated when the slug was removed from the well while the data logger simultaneously activated. The data logger was programmed to collect the dynamic water levels until equilibrium was reached.

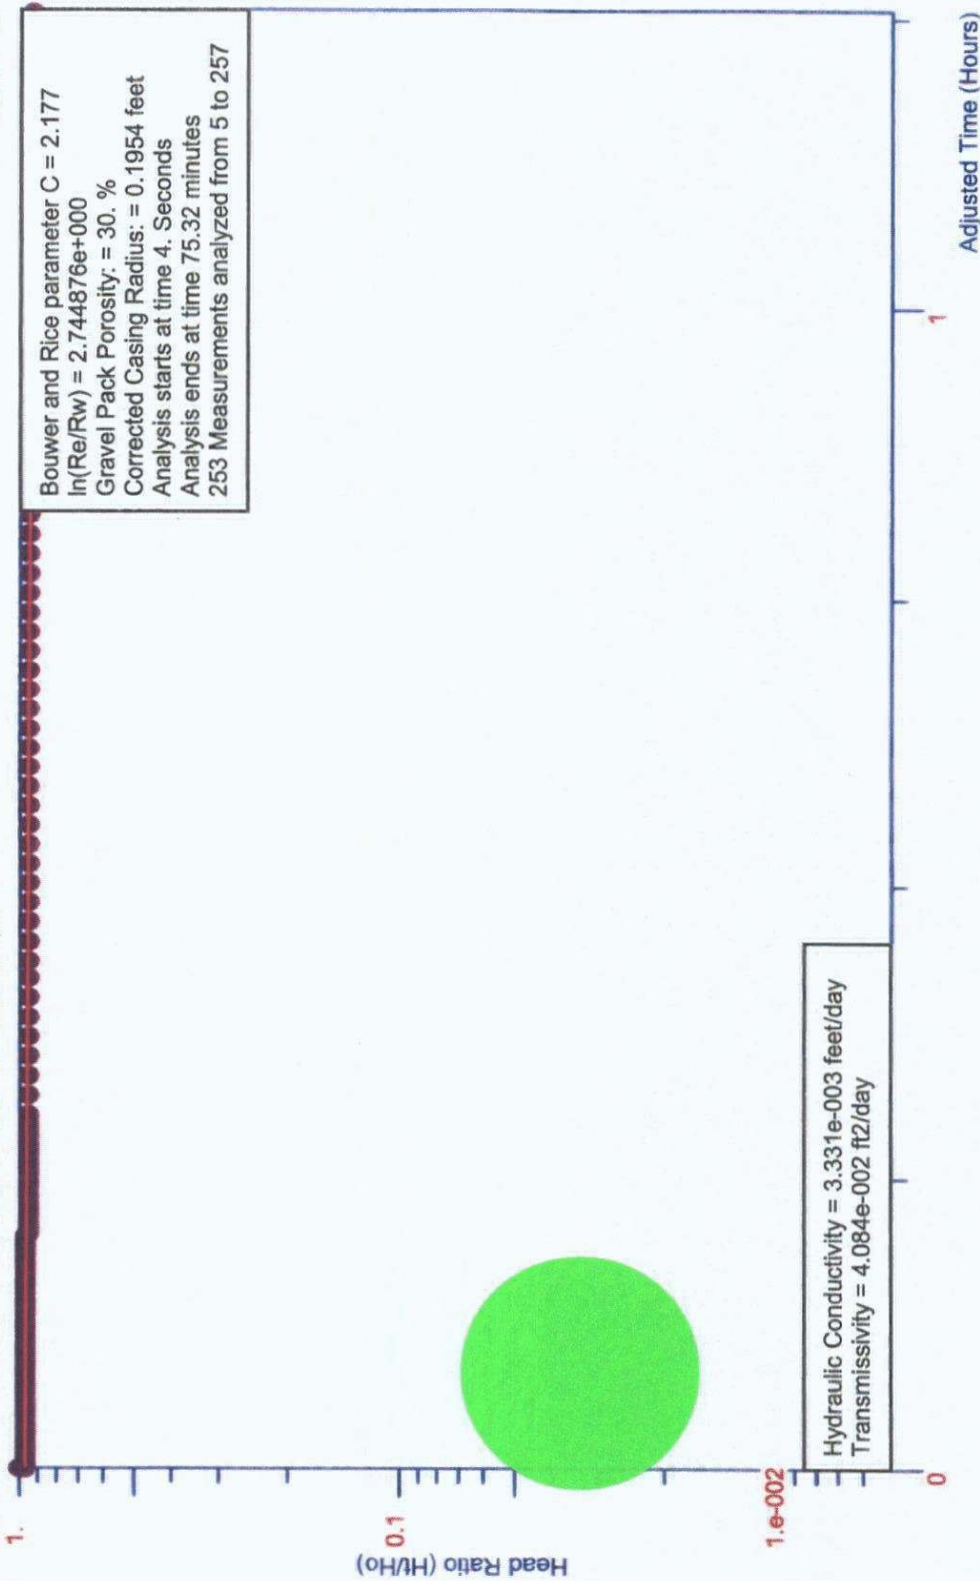
MW-8

Bouwer and Rice Graph

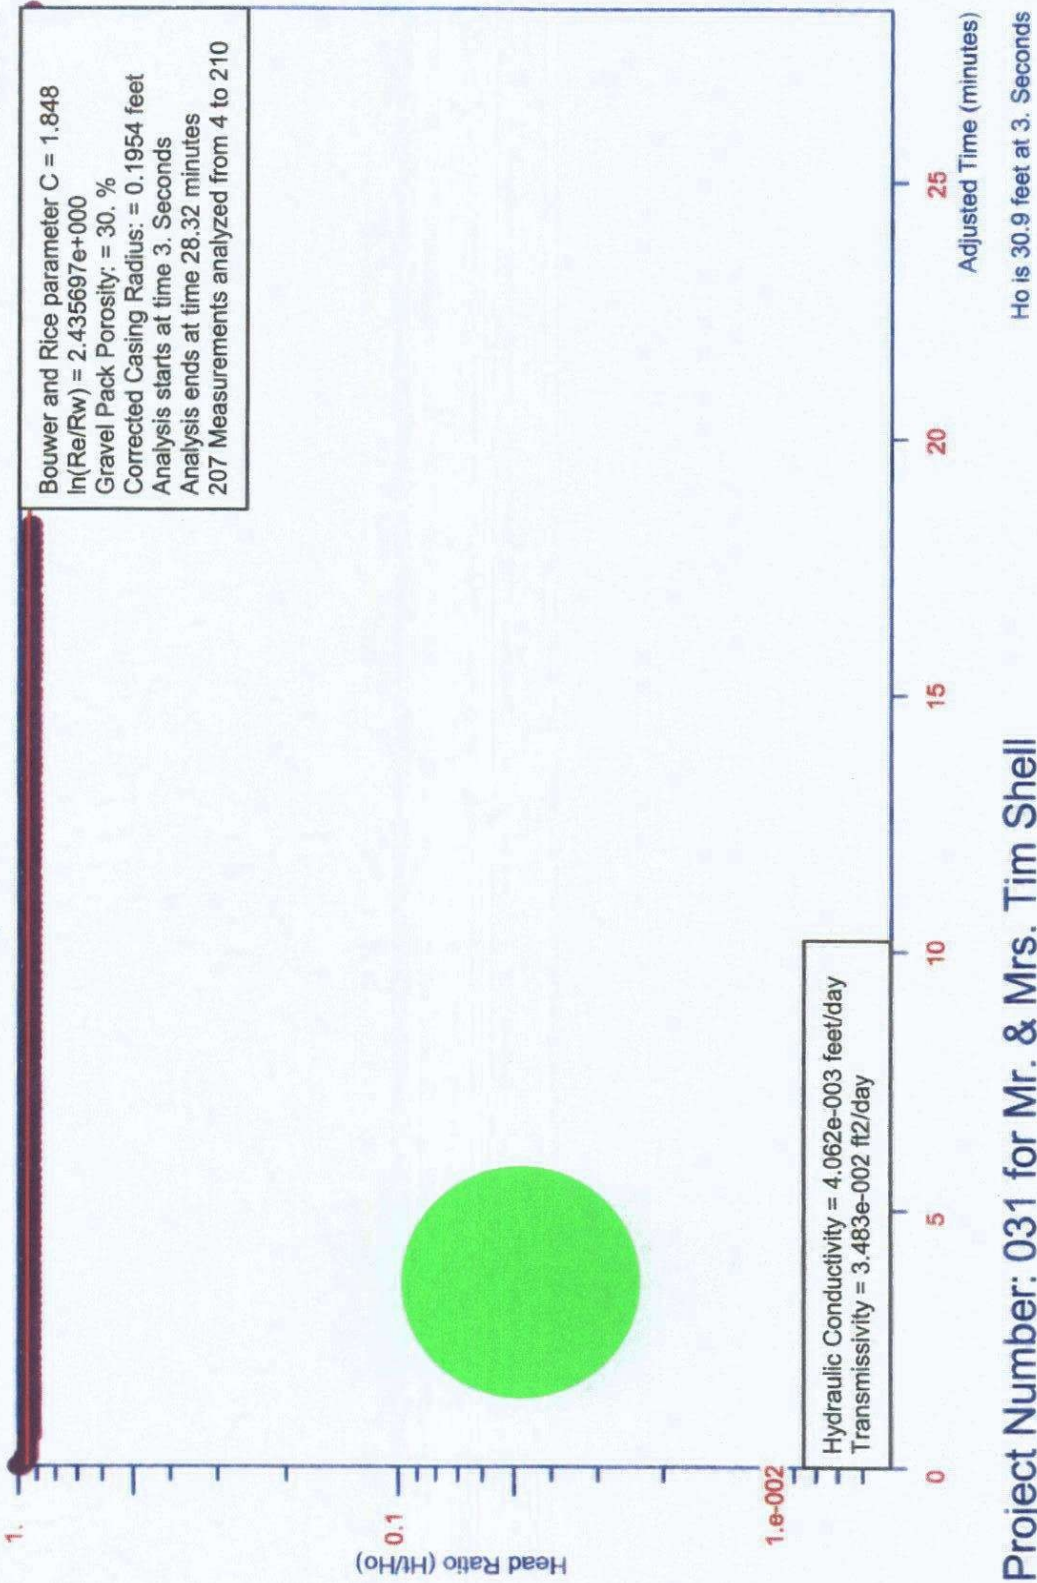
MW-9

Bouwer and Rice Graph
