# Site Characterization Report Under the Statewide Health Standard

Gatz Auto  
2899 Holme Ave  
Philadelphia, Philadelphia County, Pennsylvania  
Facility ID # 51-30277

Synergy Project No. 24-01483  
June 2025

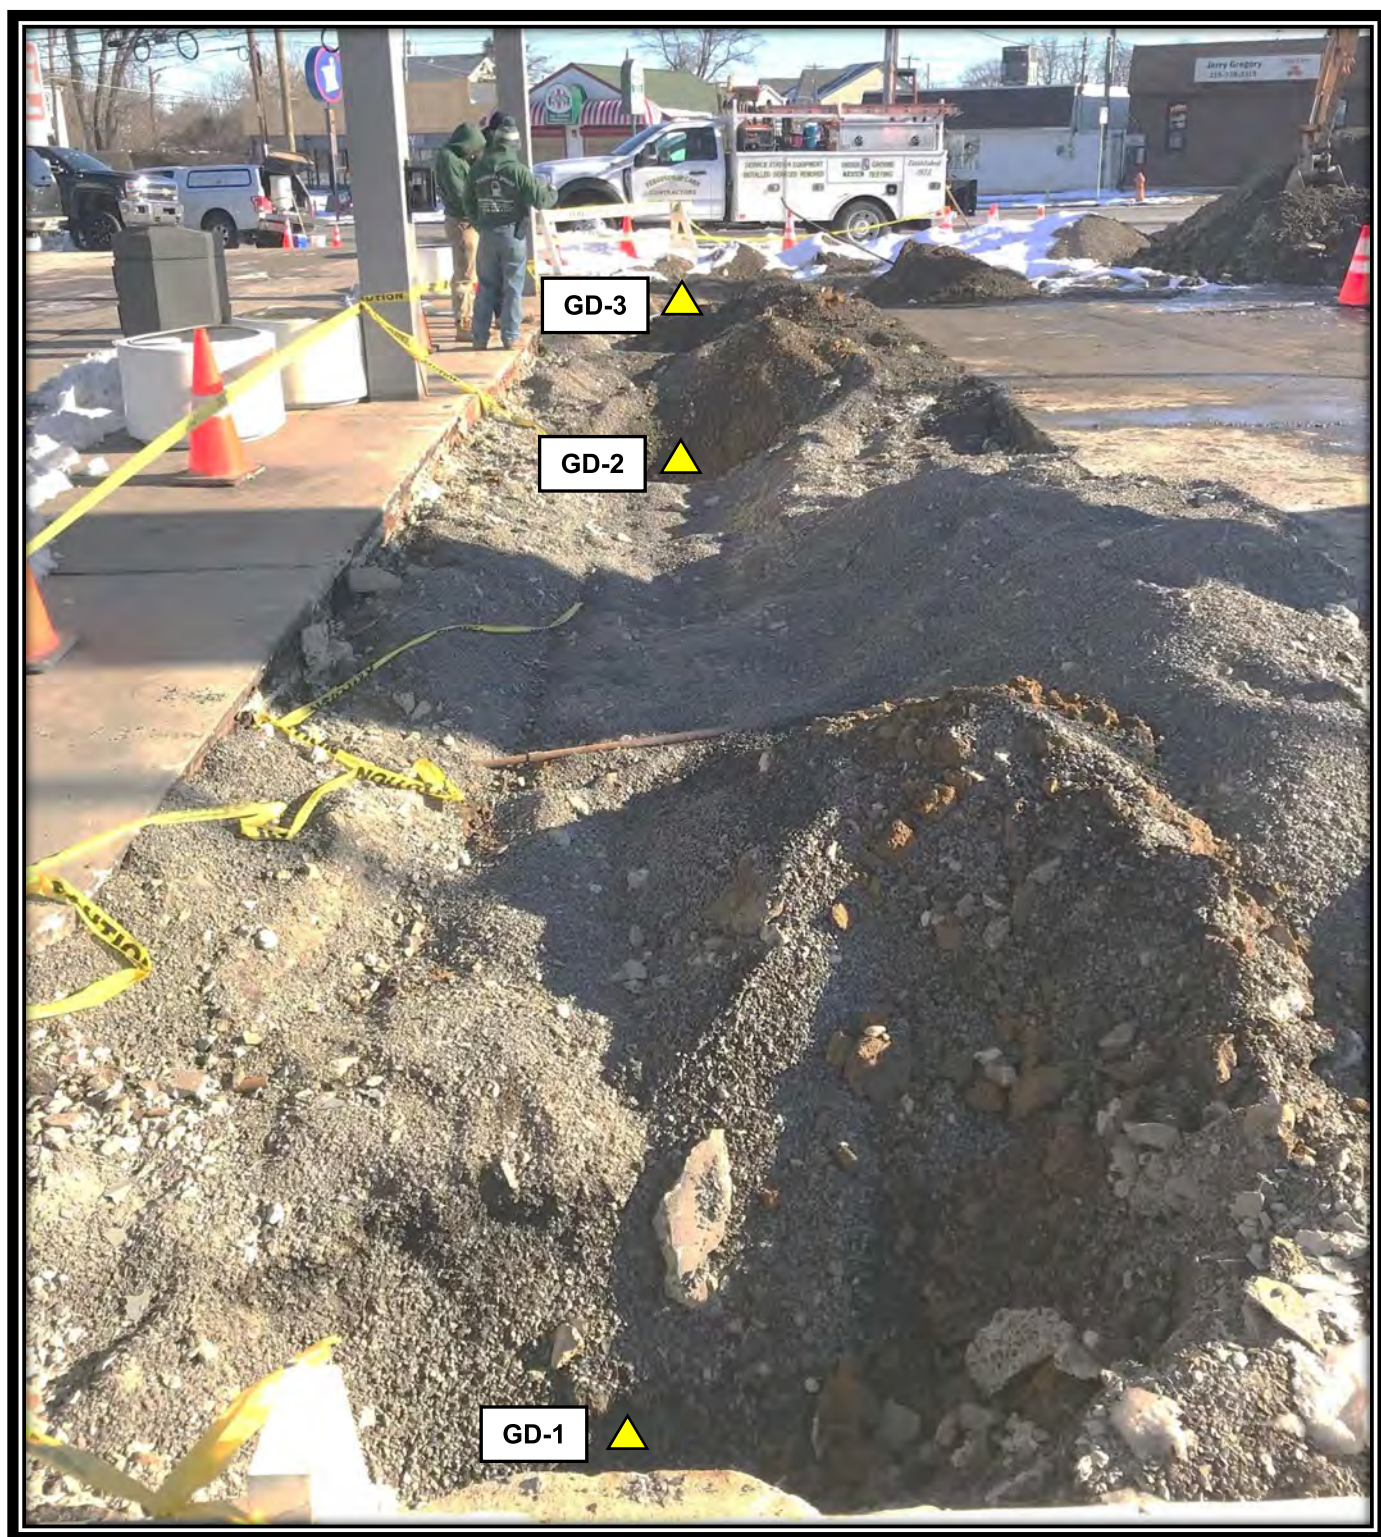
View of Product Dispenser Areas.

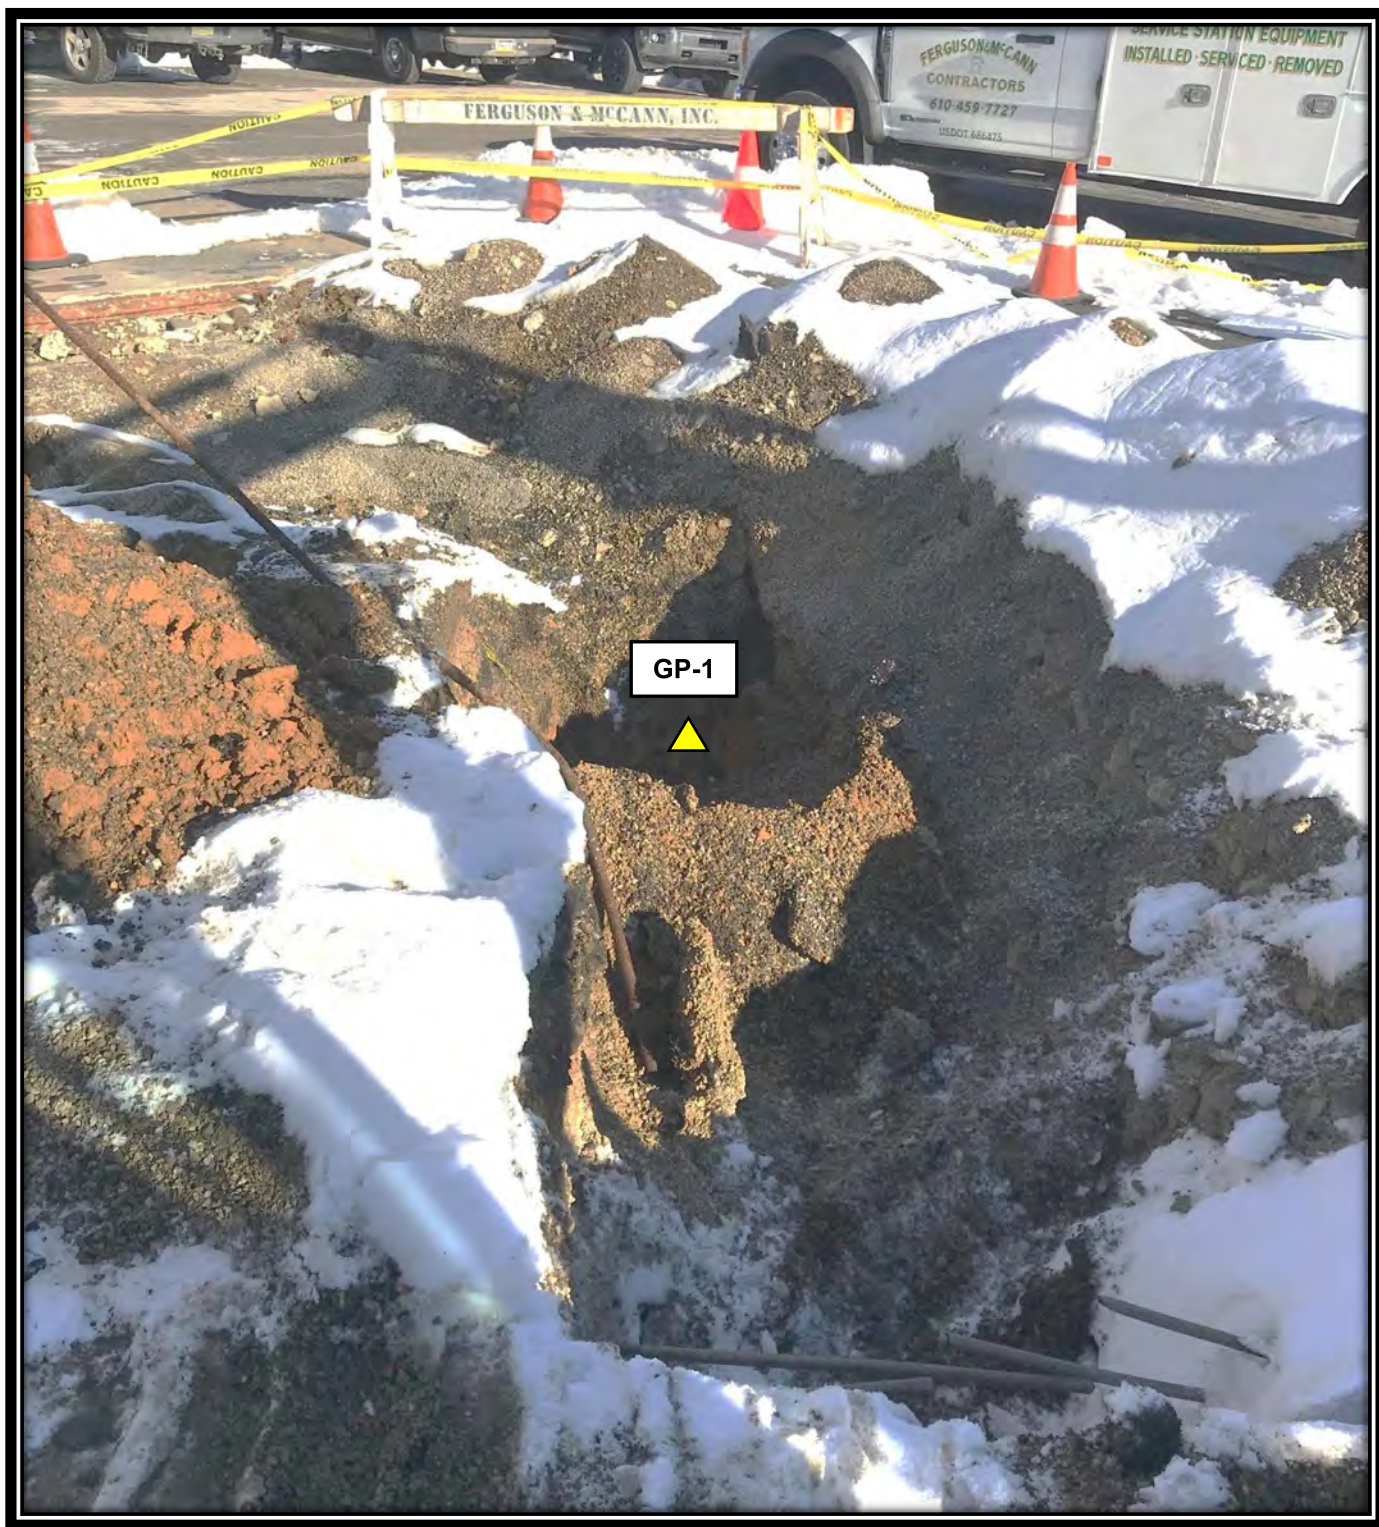
View of Product Piping Trench from  
Tank Field to Product Dispensers.

2. Briefly describe the method of piping system closure and the closure of the piping systems, including the quantity and condition of the piping:  
ALL PIPING WAS IN GOOD CONDITION AND REMOVED FOR PERMANENT CLOSURE.

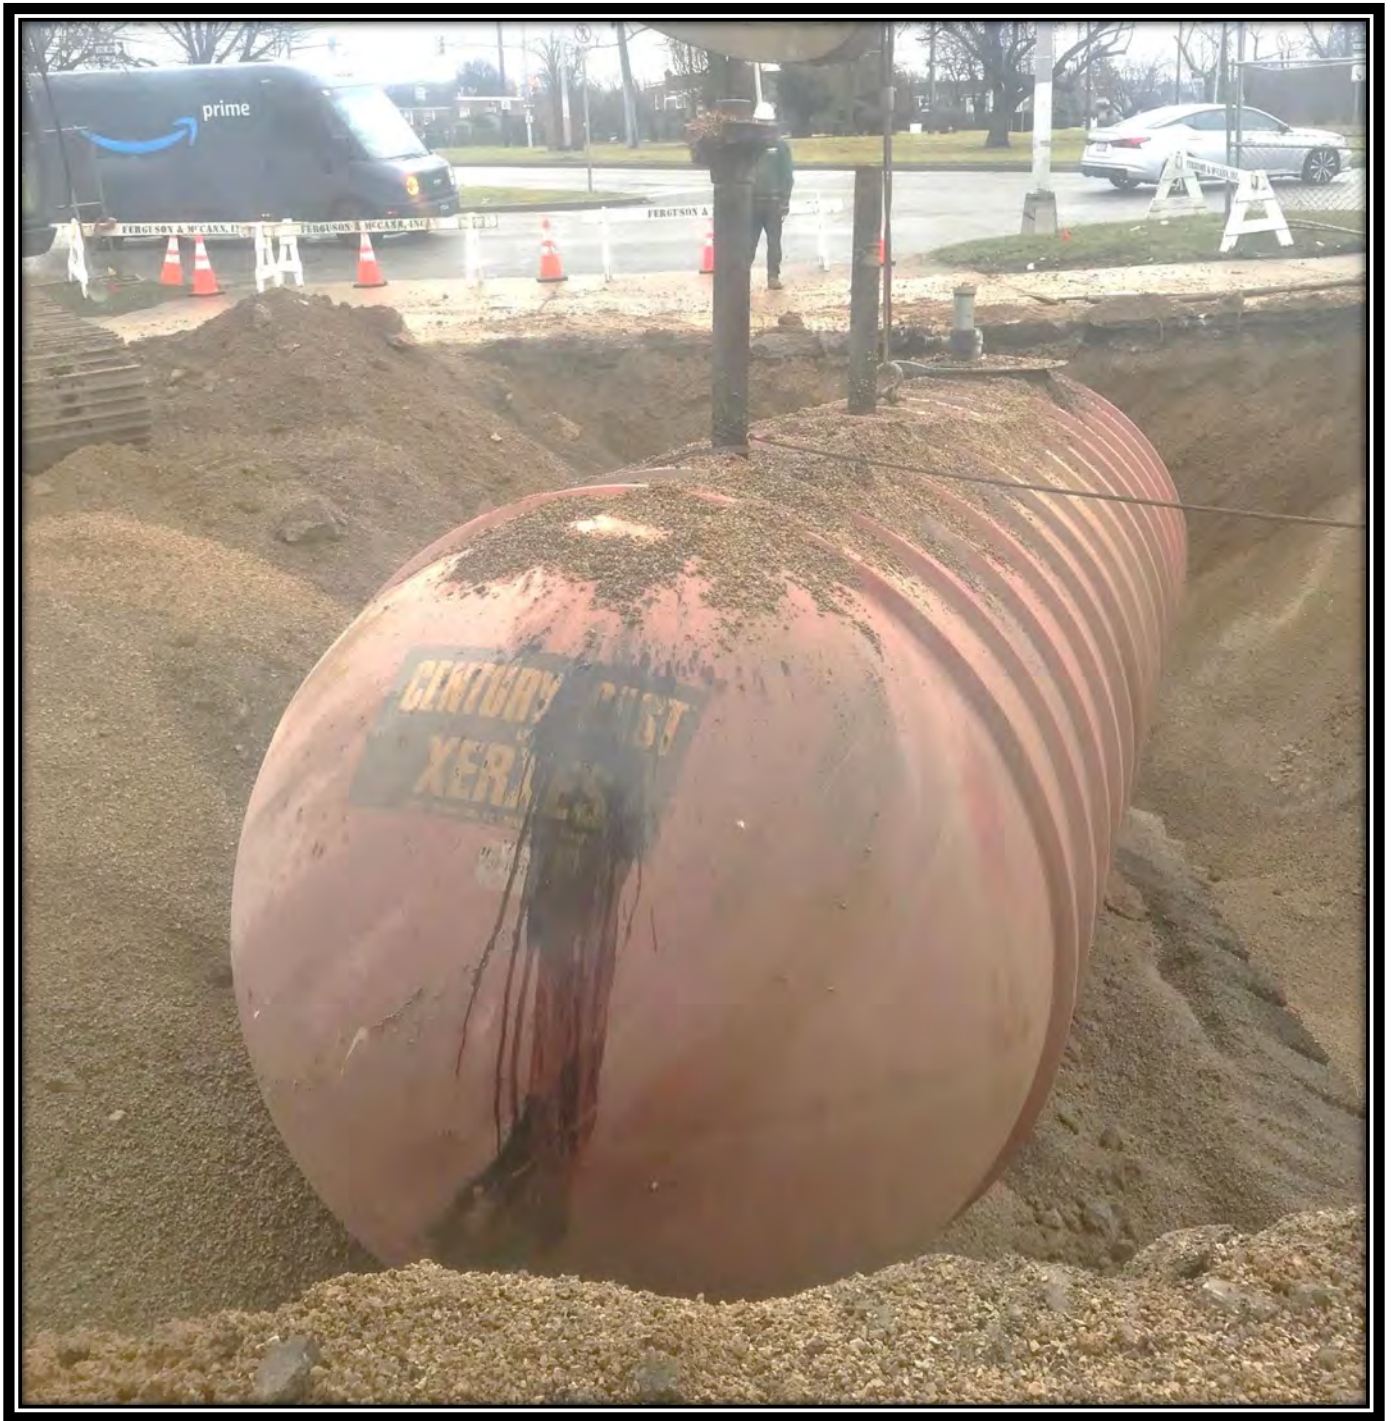
Removing UST 001.

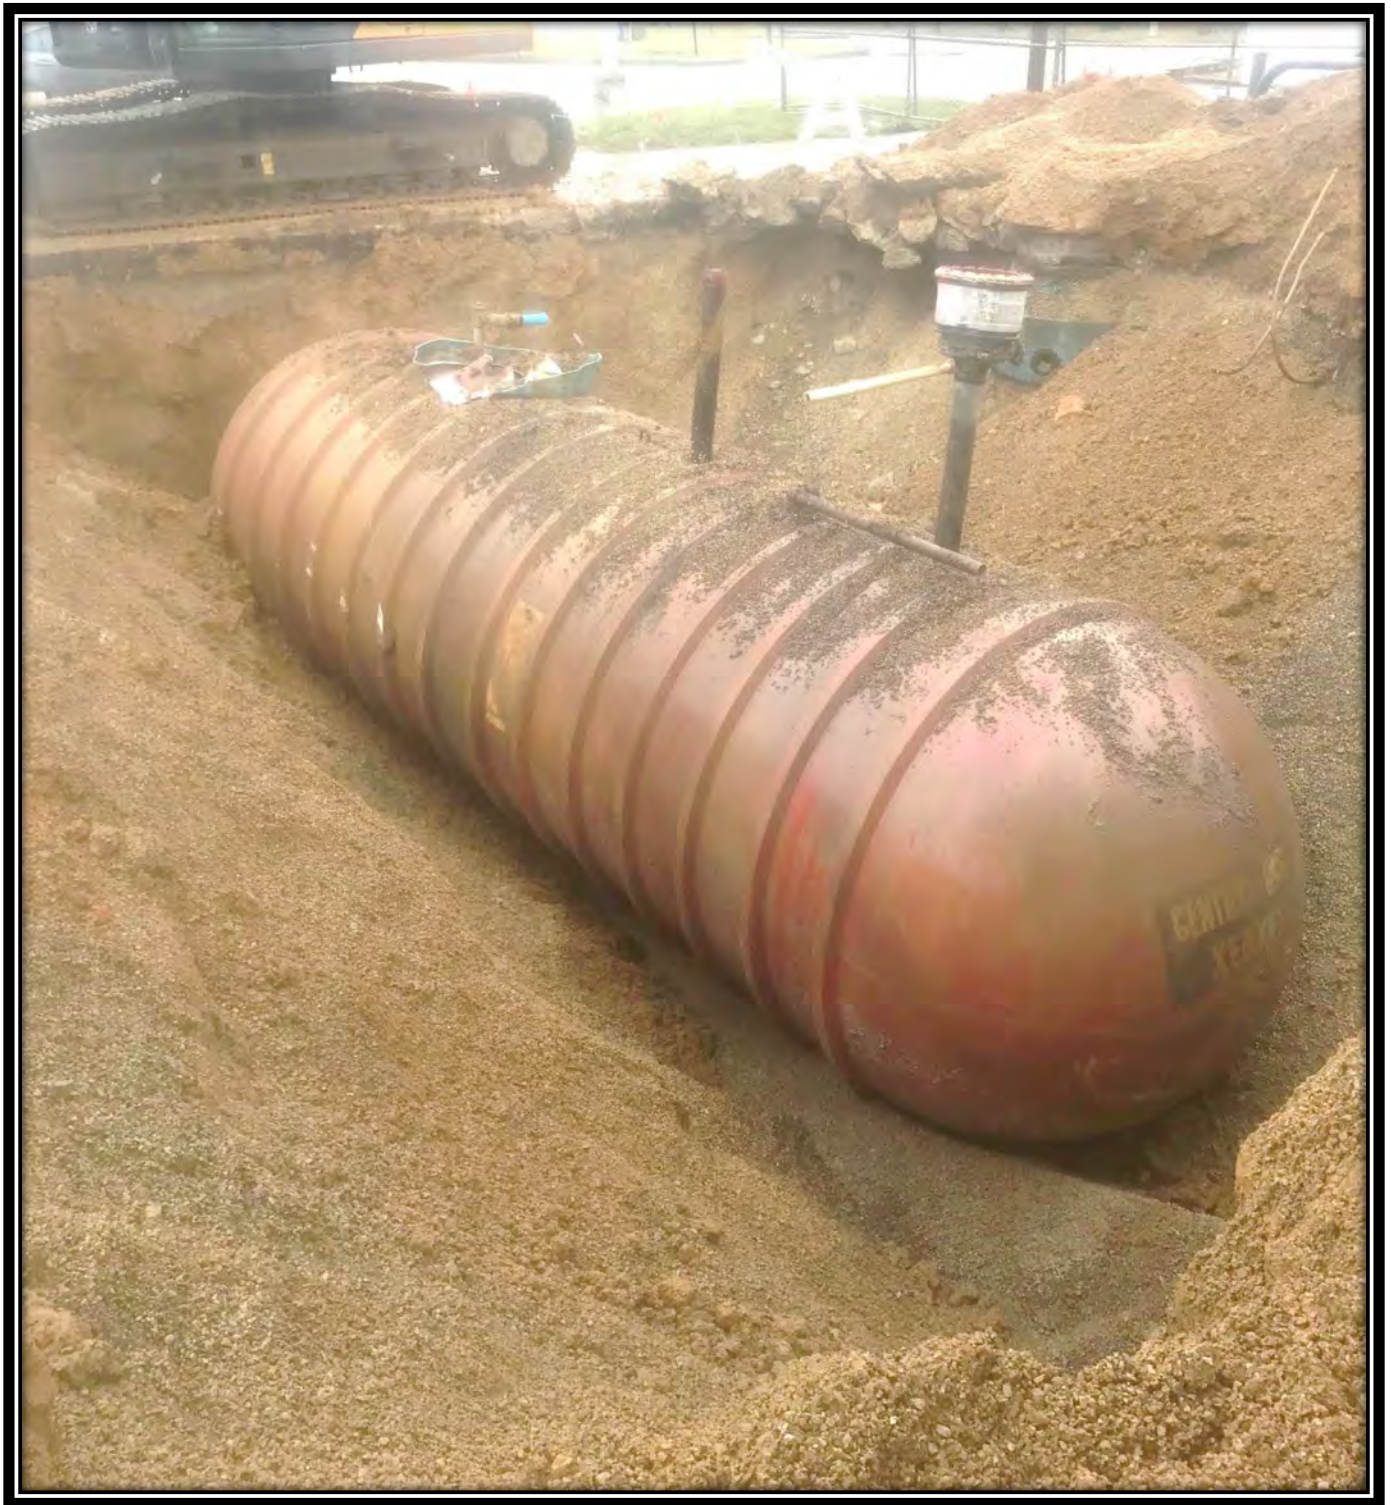
Removing UST 002.

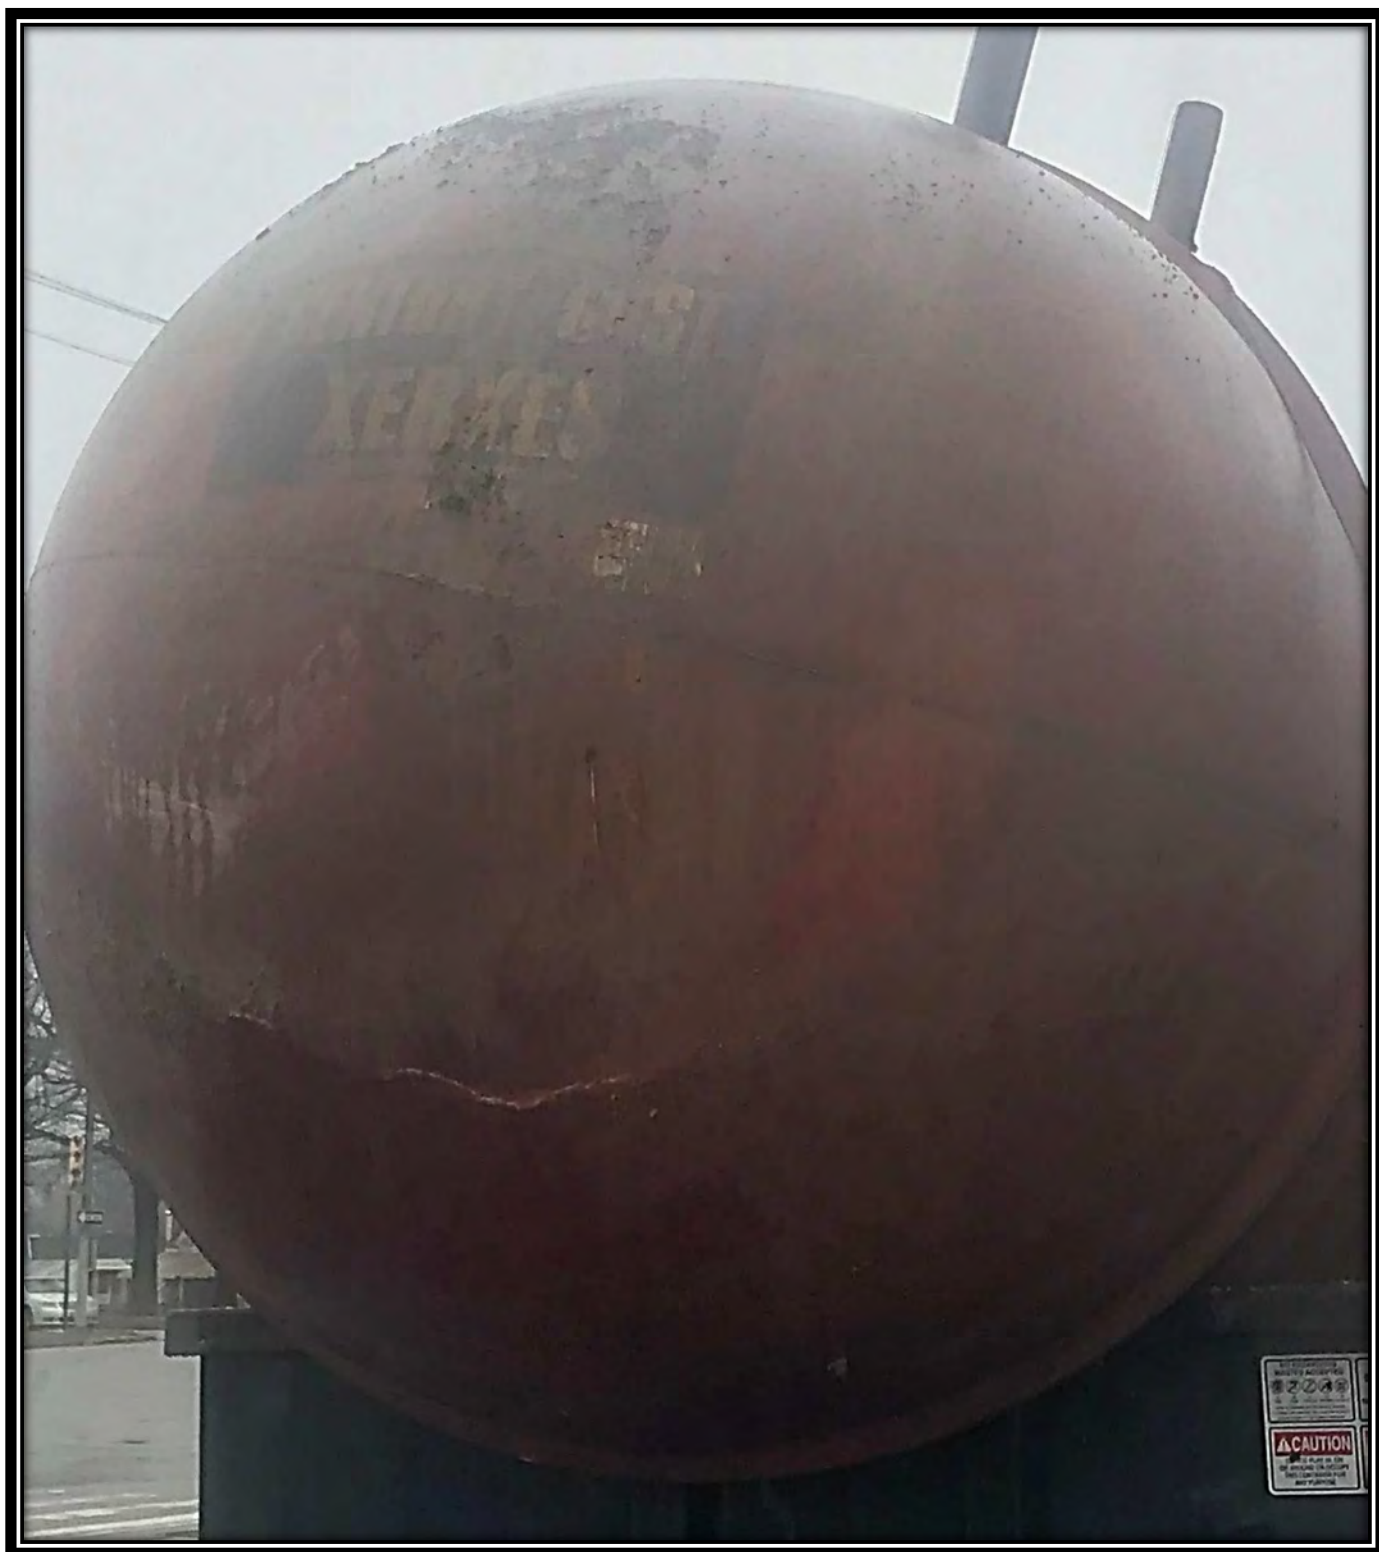
Crack at North End of UST 002.  
No Evidence of a Release.

3. Briefly describe the condition of the tanks and any problems encountered during tank handling or tank removal activities:  
UST 001: GOOD CONDITION. UST 002: CIRCUMFERENTIAL CRACK AT NORTH END OF TANK, BUT NO EVIDENCE OF A RELEASE. UST 003: CIRCUMFERENTIAL CRACK AT NORTH END OF TANK WITH EVIDENCE OF RELEASE (PADEP NOTIFIED).

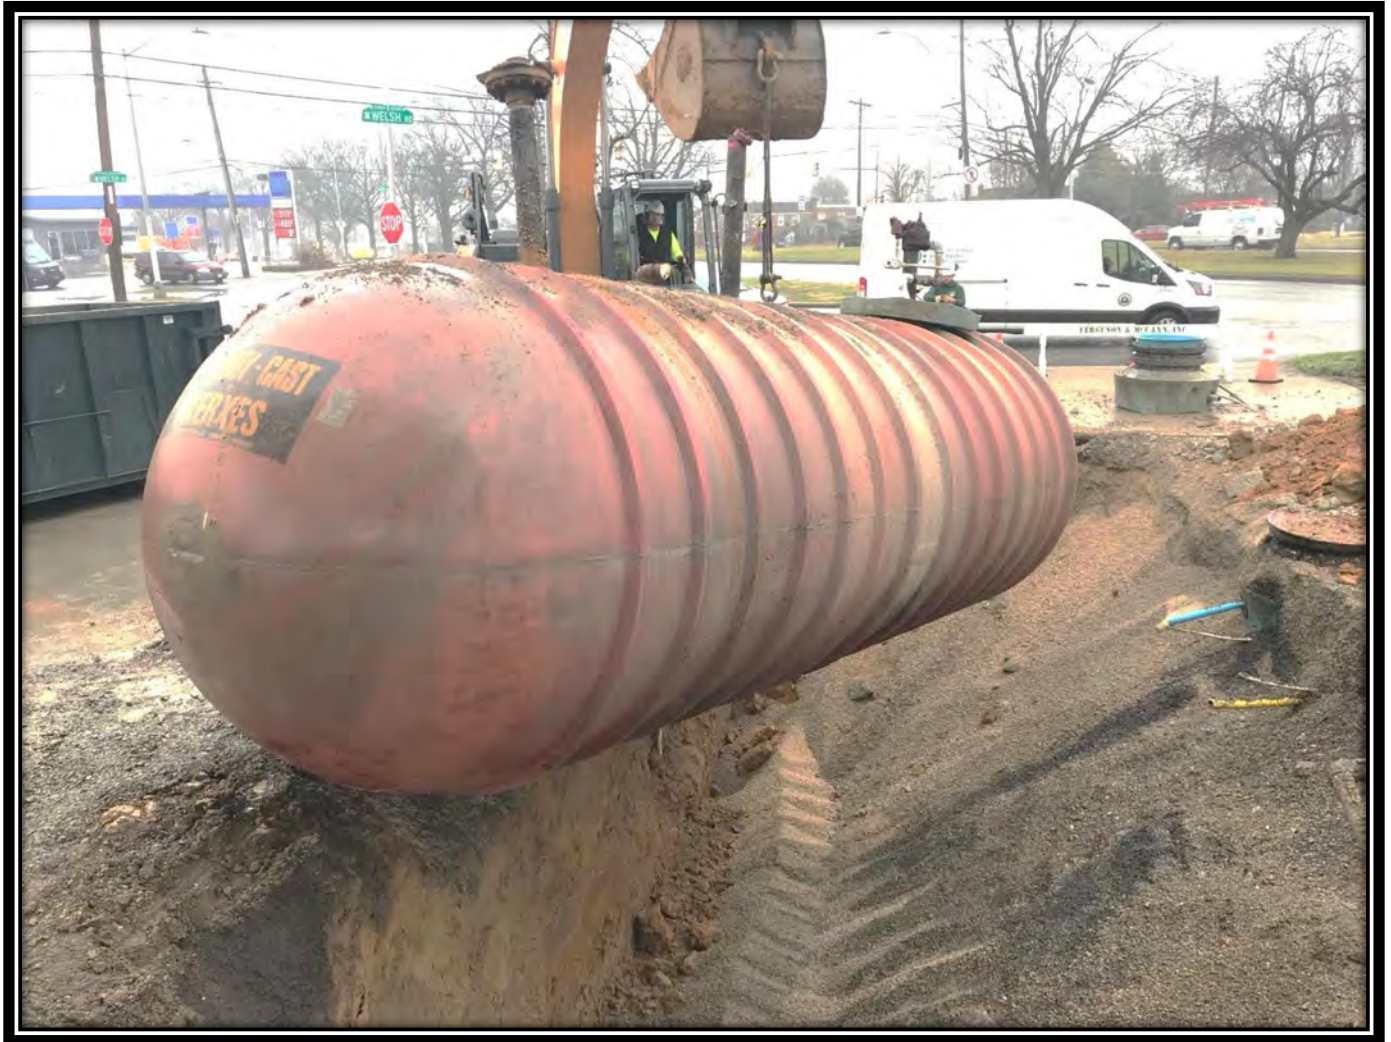
Removing UST 003.

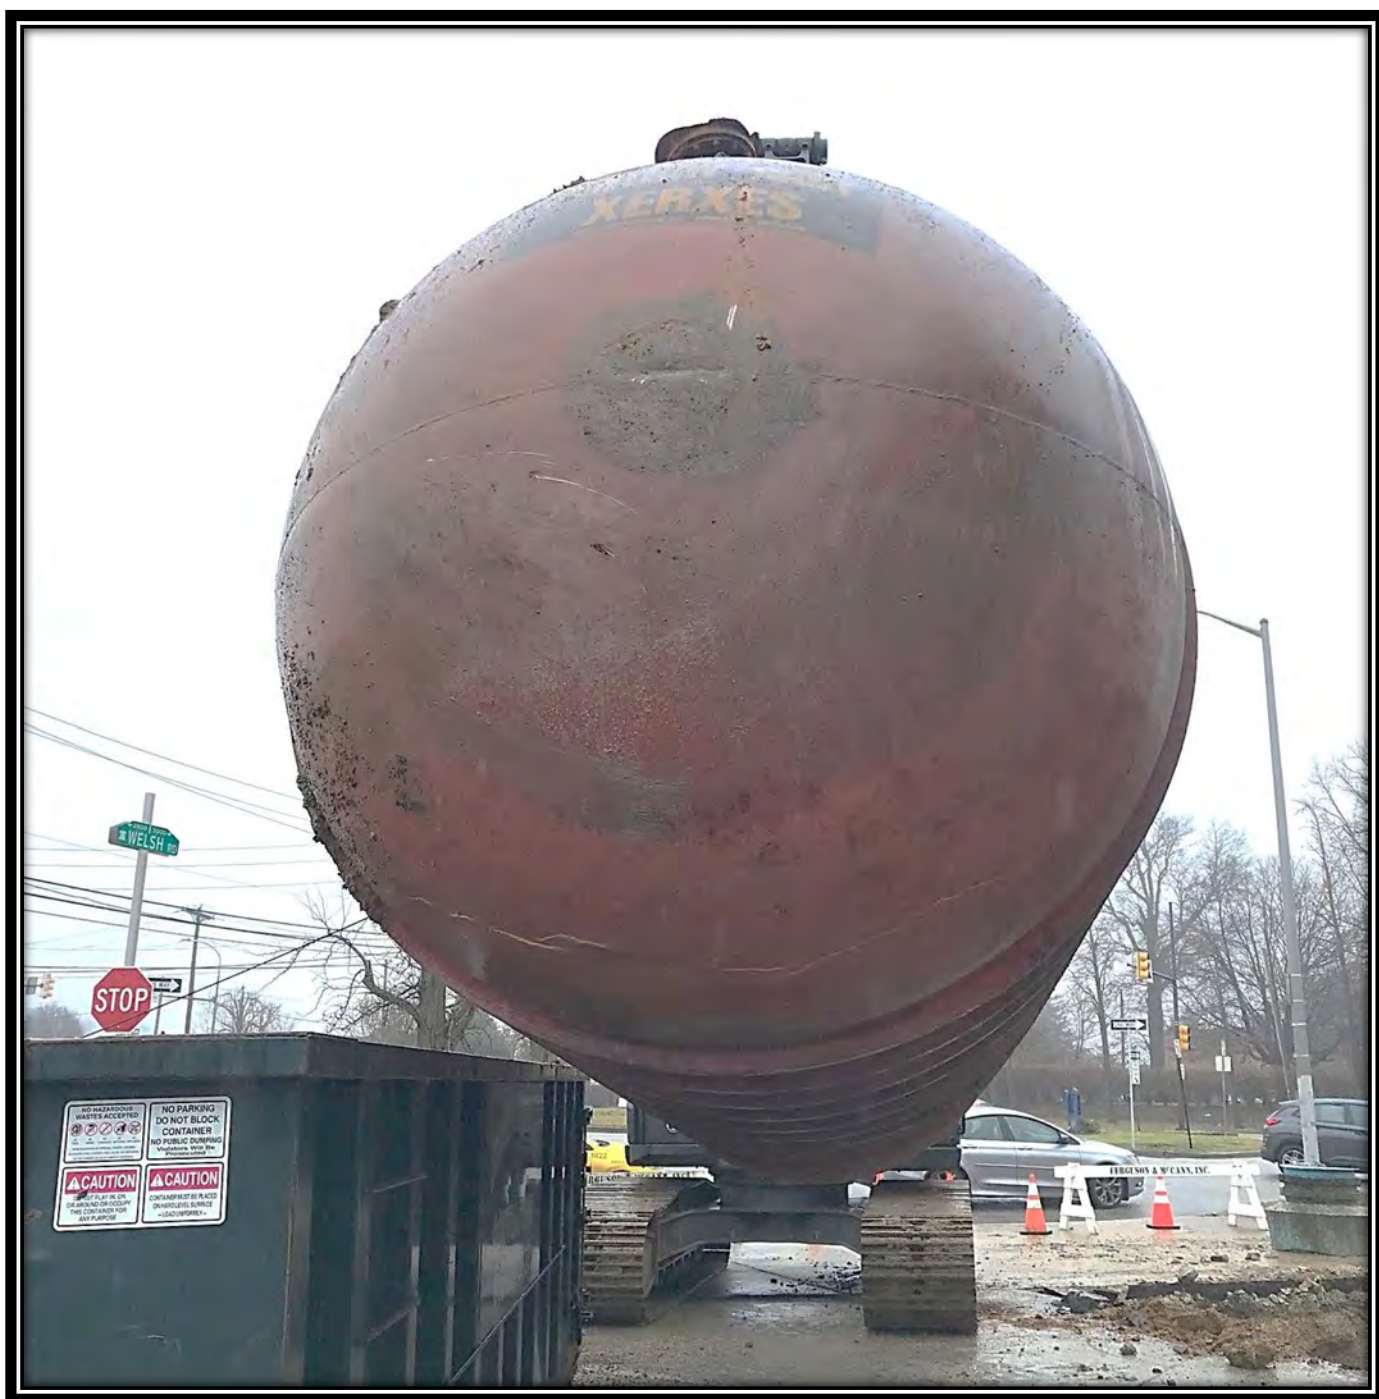
Crack at North End of UST 003.  
Evidence of a Release Observed.

DURING THE REMOVAL FOR PERMANENT CLOSURE OF UST 003, A CIRCUMFERENTIAL CRACK WAS IDENTIFIED ALONG THE BOTTOM OF THE NORTH END OF THE SINGLE-WALL FIBERGLASS TANK. OBVIOUS GASOLINE-IMPACTED SOIL WAS ALSO OBSERVED (PID FIELD-SCREENING) BENEATH THE NORTH END OF UST 003. NO IMPACTS TO WATER SUPPLIES, BUILDINGS OR UNDERGROUND UTILITIES WERE IDENTIFIED DURING THE CLOSURE ASSESSMENT.

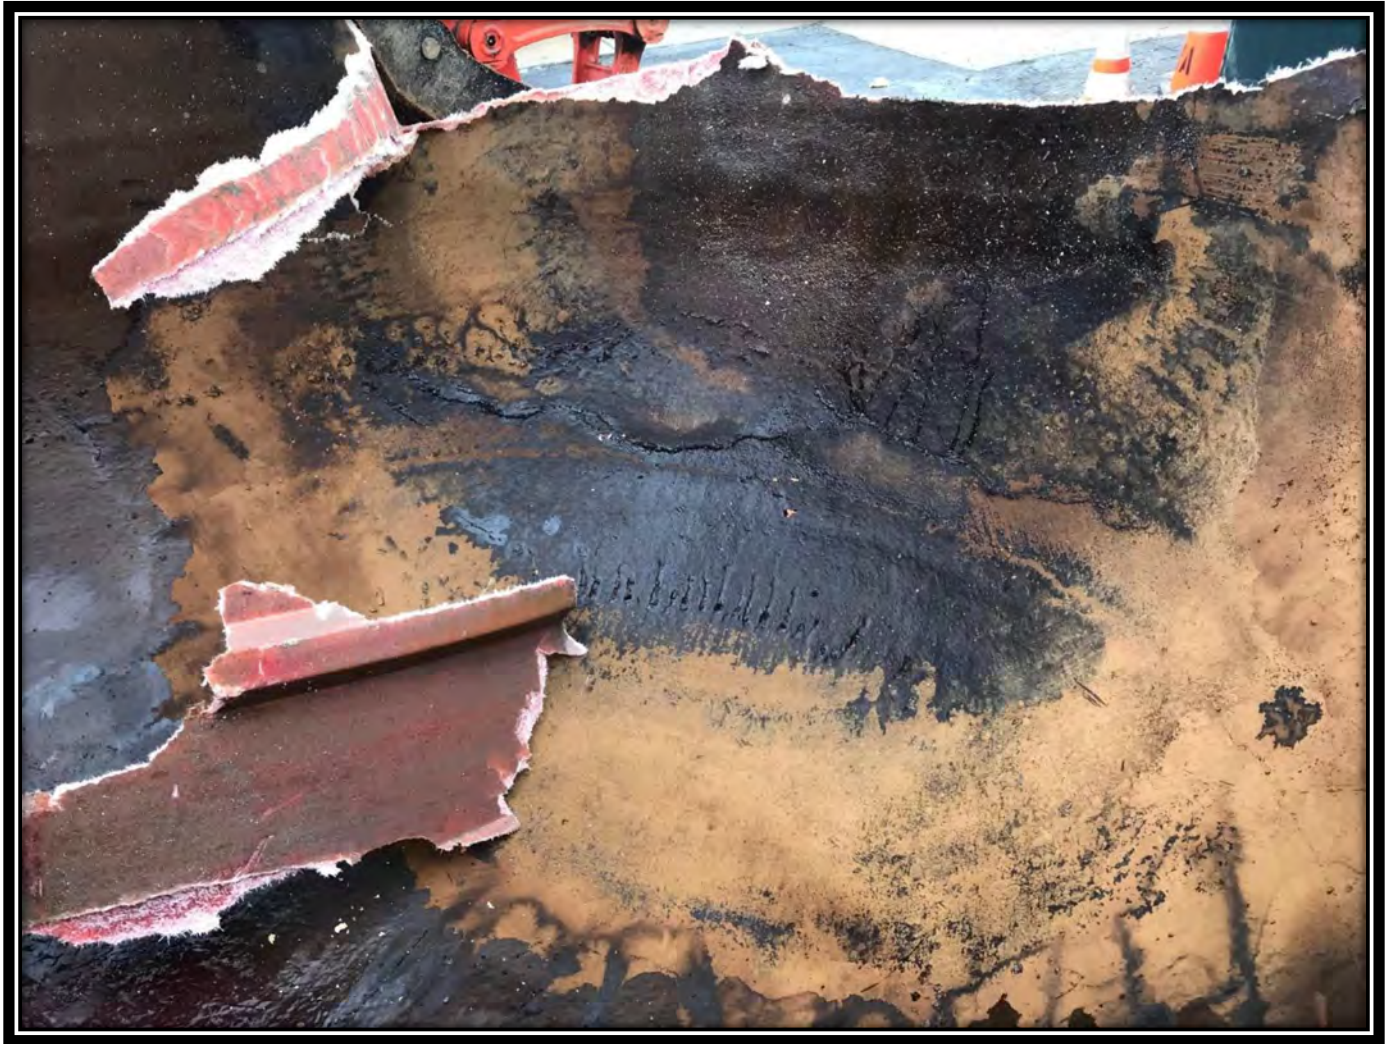
Interior View of Crack in UST 003.
