**RE: Final Site Characterization Report:
Lewis Brothers Garage Property;
PA Route 347
Scott Township, Lackawanna County, Pennsylvania
PADEP Facility ID#35-10233
USTIF Claim #2007-0053(F)
Pennsylvania Tectonics Project Number: 27058**

Enclosed, please find one (1) bound copy of the Final Site Characterization Report associated with the above referenced Lewis Brothers Garage Property.

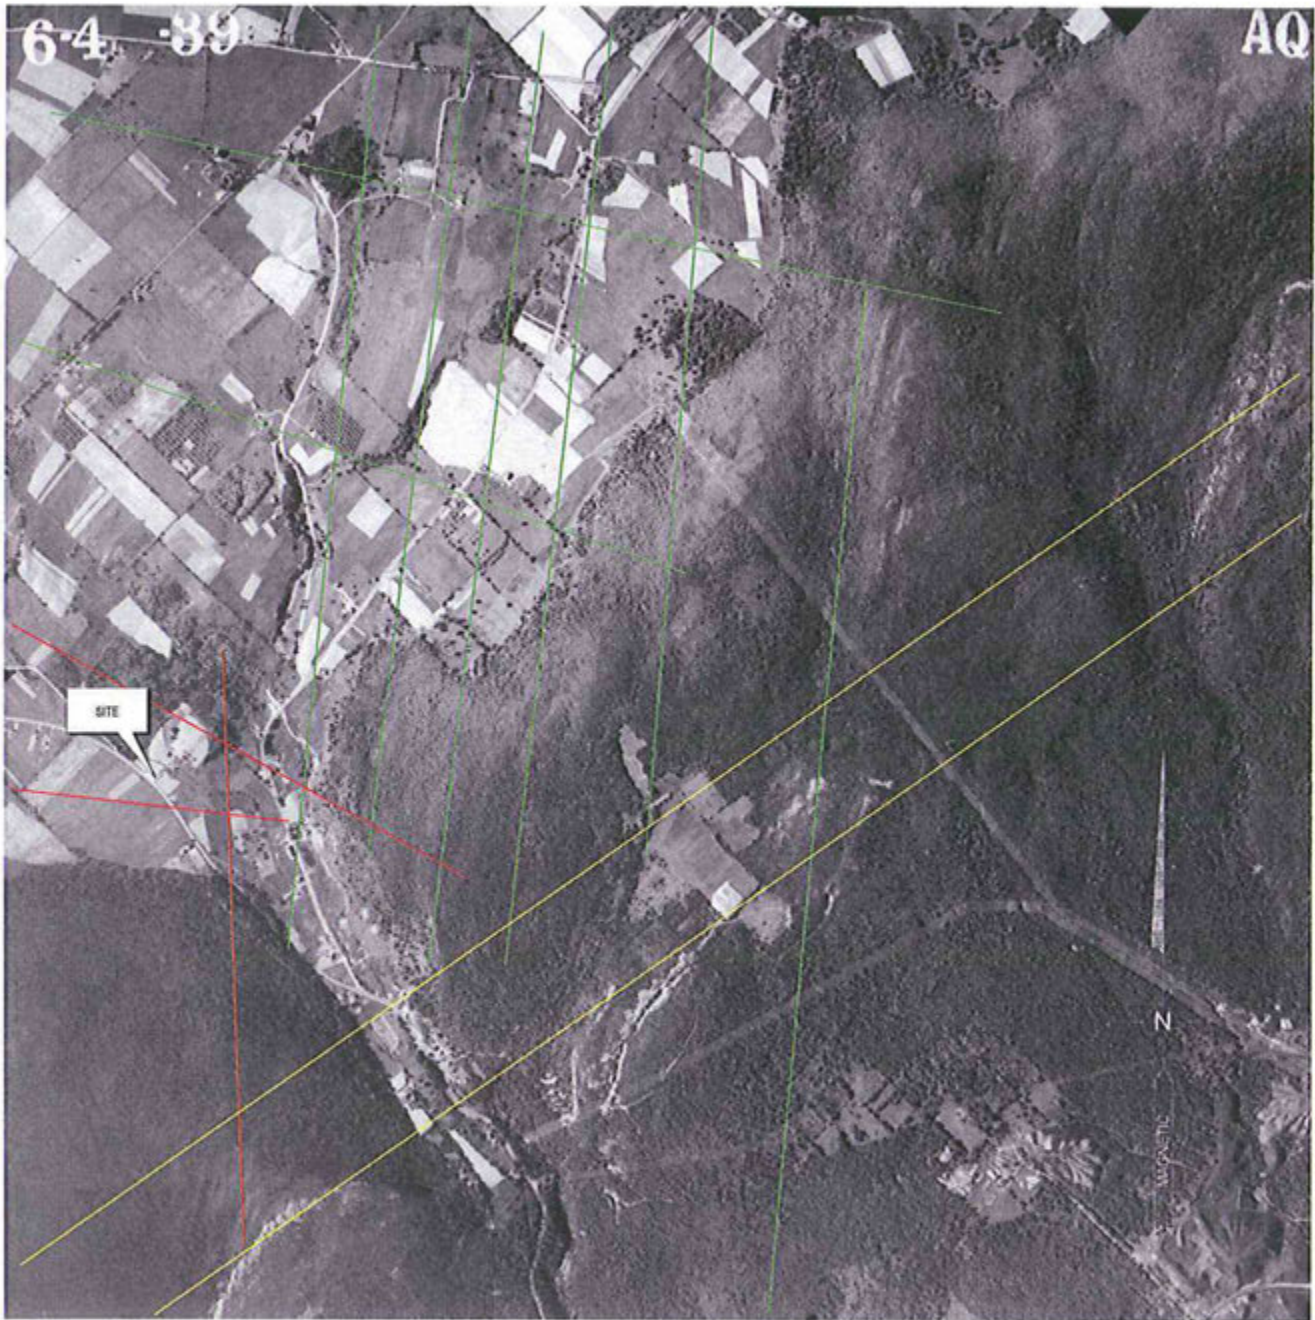
FIGURE NUMBER:
1

FIGURE NAME: FRACTURE TRACE/LINEAMENT ANALYSIS

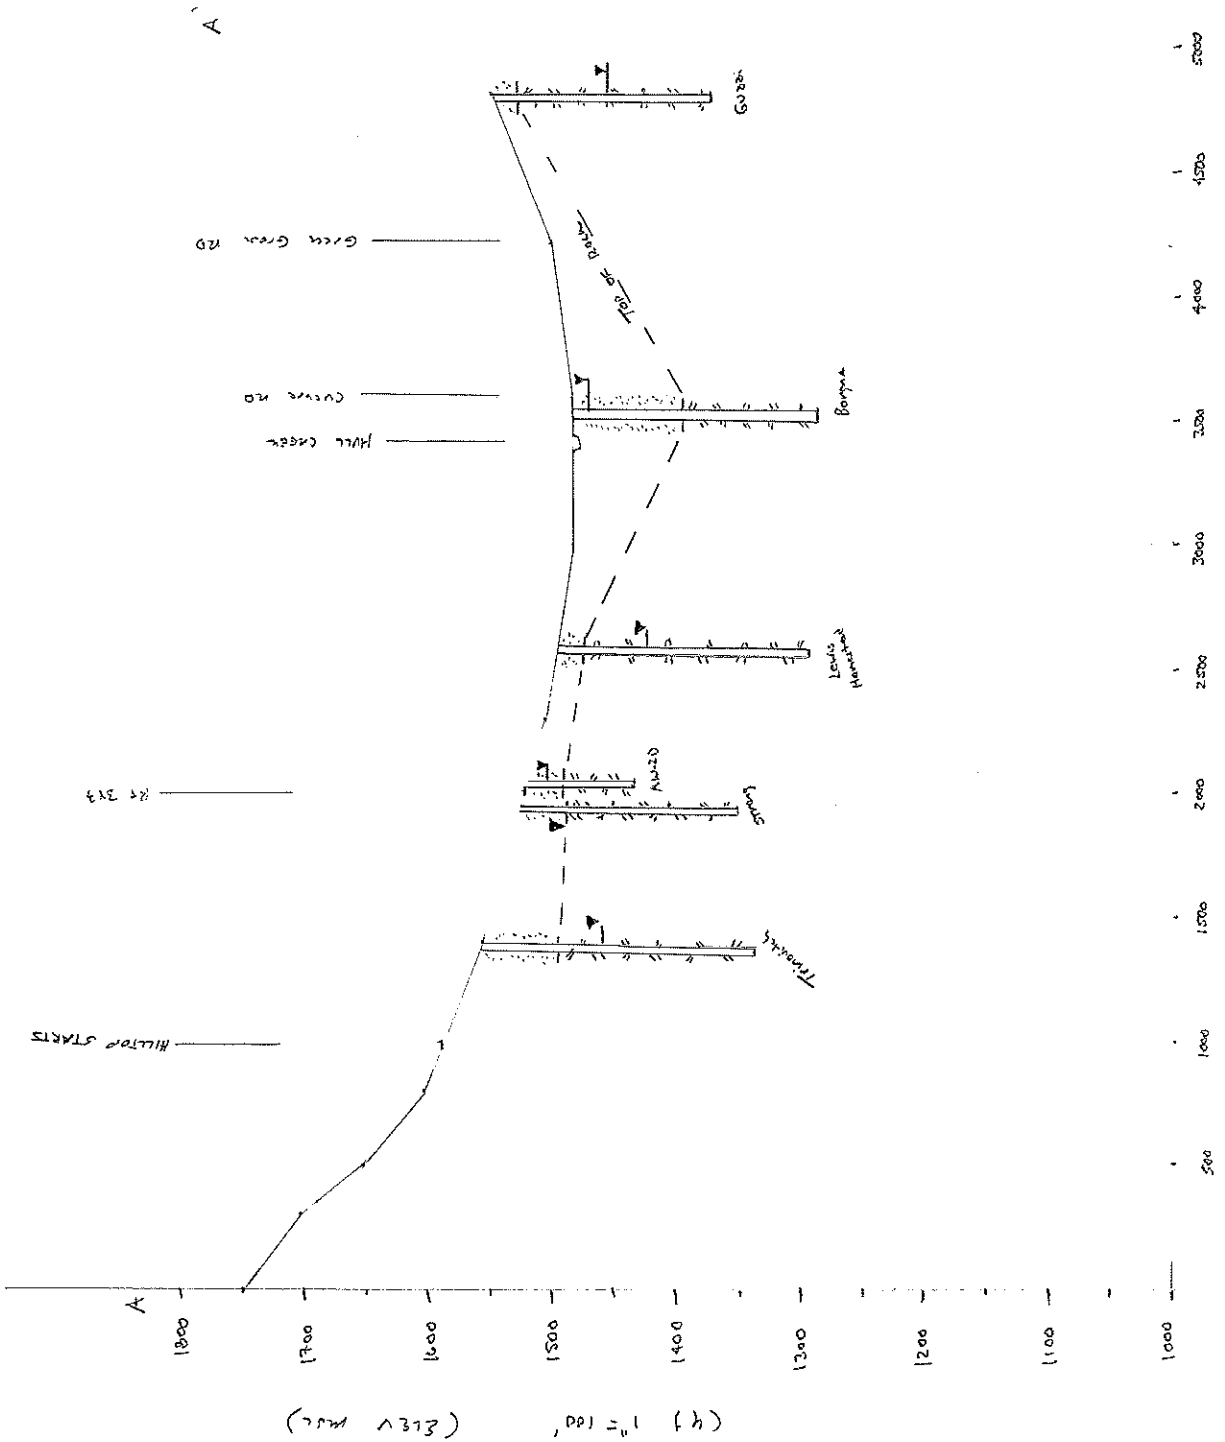
CROSS SECTION A
 FACING NW ALONG
 X-ST HILLTOP

X = 1" = 500'

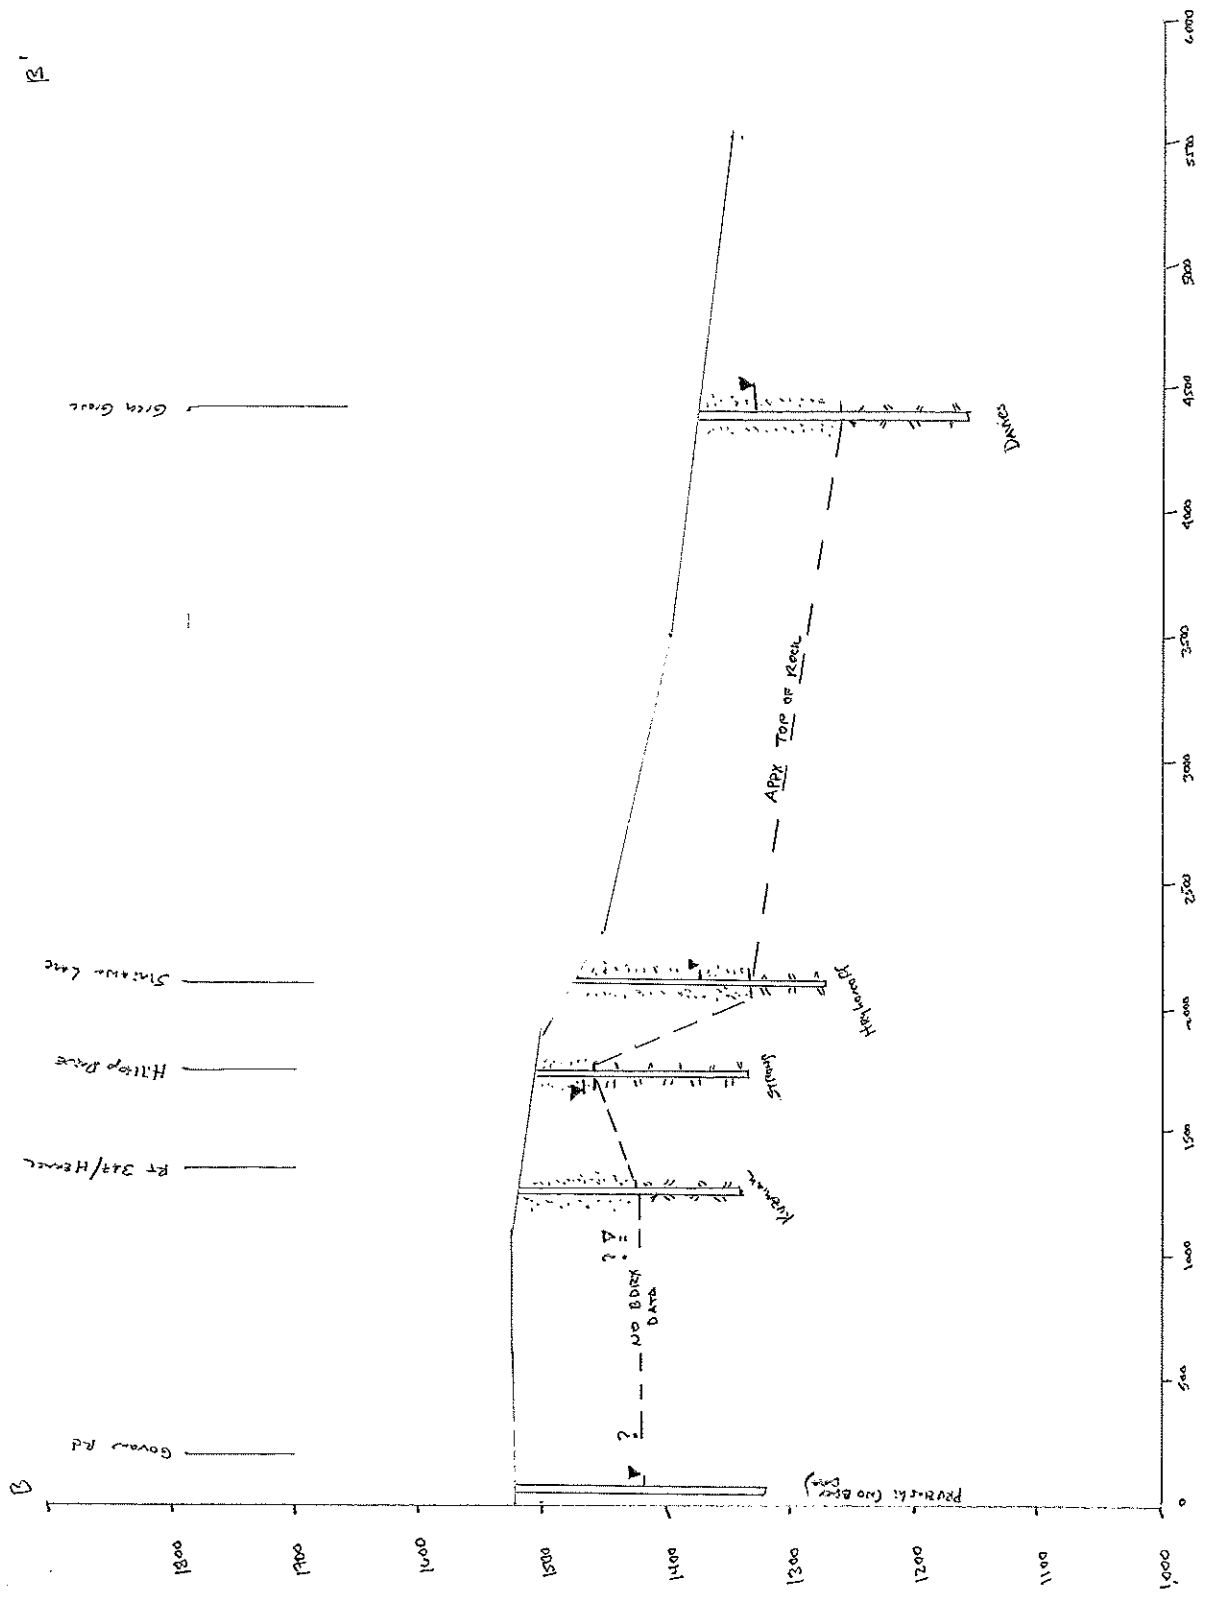
CROSS SECTION B
 FACING NE ALONG HILTOP
 X-ST RAVER 347

(X) 1" = 500'
