Underground Storage Tank
Closure Assessment
of
Chuck's Stop
737 PA Route 56
Apollo, Pennsylvania 15613

PADEP Facility #03-24734
PAUSTIF Claim #2014-0132

UST Removal and Sample Collection Dates:
September 22 - 24, 2014

Report Date:
October 16, 2014

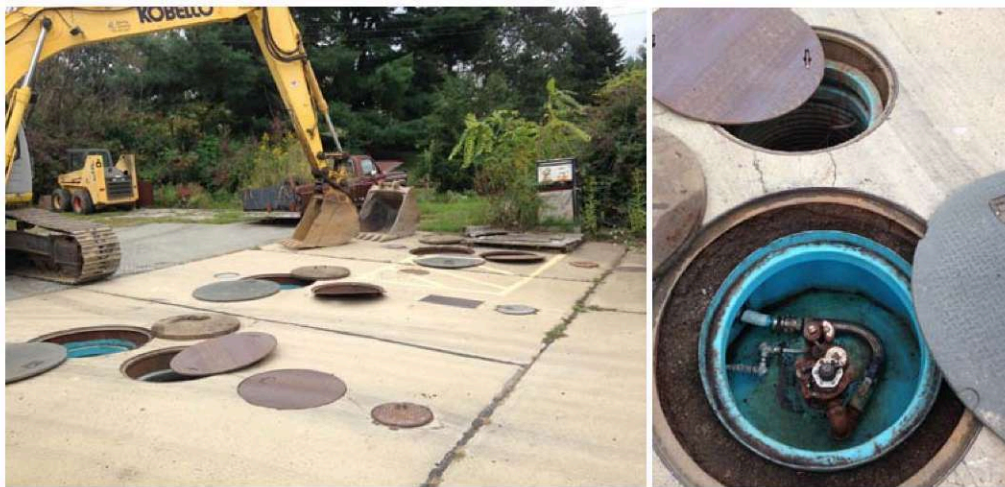
Photos 2&3 (9/22/2014): View over the tank cavity prior to excavation activities. UST systems #1, 2, and 3 utilized pressurized pumps with containment sumps at the pump heads on top of the tanks. Product lines were disconnected inside the sumps and all product was recovered from the lines using a drum-top vacuum.

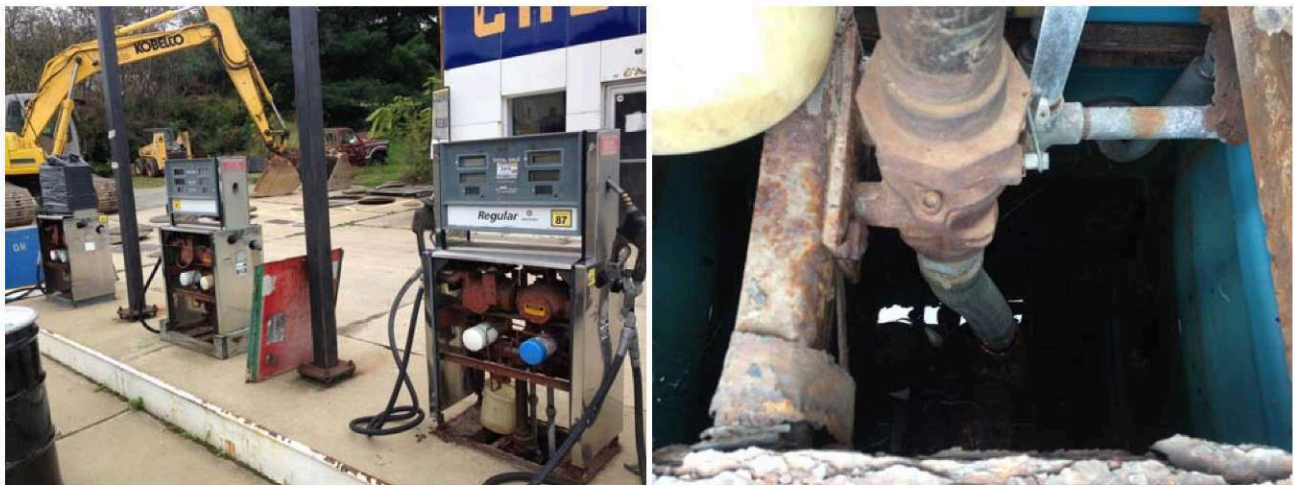
Photos 4&5 (9/22/2014): Gasoline dispensers associated with USTs #1 & 2 were fitted with under dispenser containment sumps (UDCs). All residual fluids were evacuated from the sumps using a drum-top vacuum prior to excavation activities.

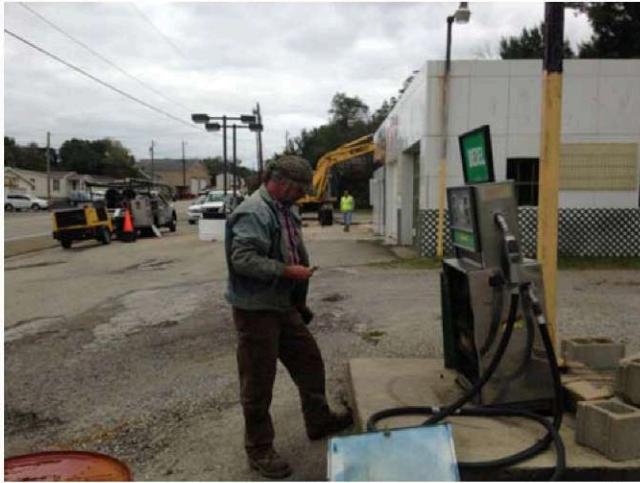
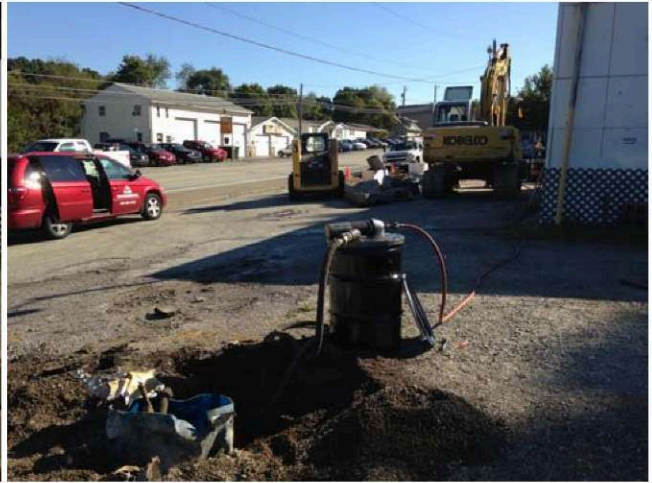
Photos 6&7 (9/22/2014): The diesel dispenser associated with UST #3 was fitted with a plastic drum used as an under dispenser containment sump (UDC). All residual fluids were evacuated from the sump using a drum-top vacuum prior to excavation activities.

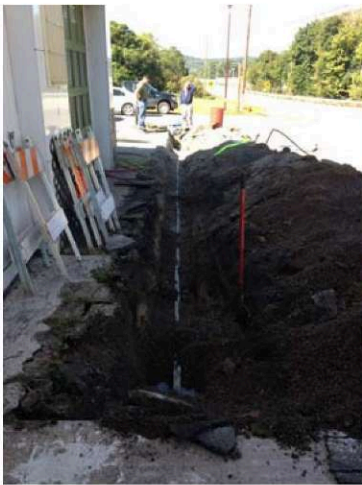
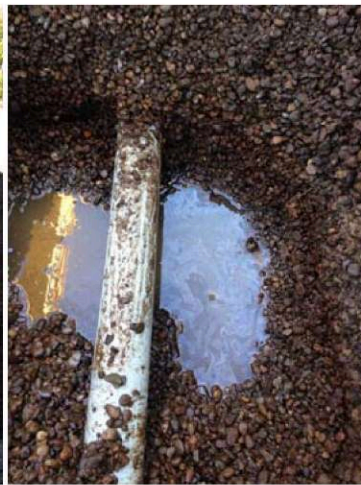
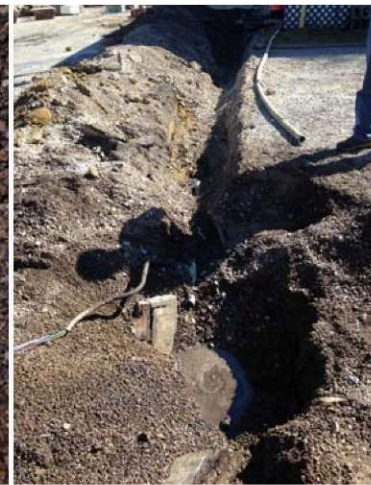
Shallow water was encountered at approximately 2.5 to 3 feet below grade below the diesel product line and the dispensers. Water below the diesel product line and dispenser appeared with a heavy sheen and was sampled at *W-1*. Water below the gasoline dispenser island (associated with USTs #001 and 002) showed no obvious indication of petroleum impact; it was sampled at *W-2* and *W-3*.

Photos 8,9&10 (9/22/2014): The diesel product line and dispenser area were excavated for visual inspection. Potentially perched water was identified below the product line and dispenser which appeared visibly impacted. However, water sample *W-1* was collected at the diesel dispenser, and laboratory analysis reported no detectable COC concentrations. The product line was then completely removed from the ground.

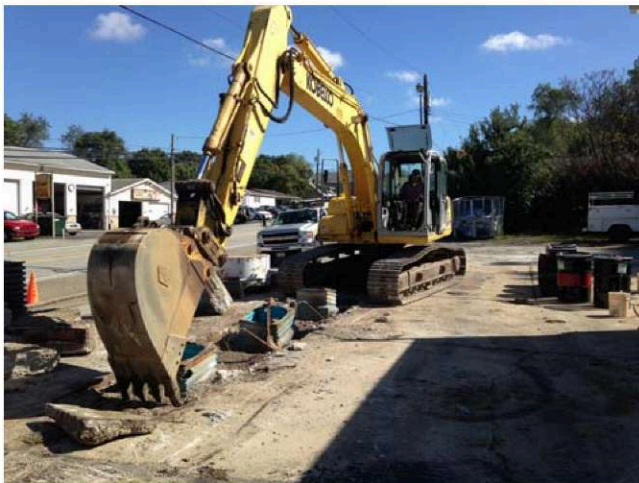
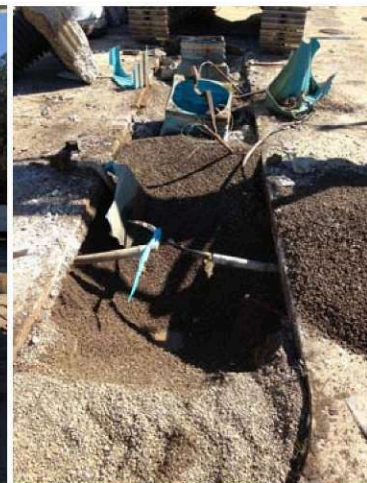
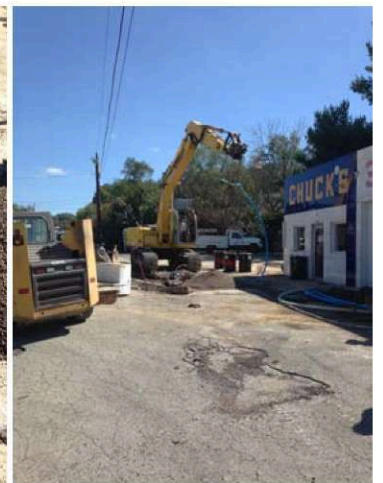
Photos 11,12&13(9/23/2014): The gasoline dispenser island was excavated and product lines were completely removed from the ground by pulling. Potentially perched water below the dispenser island showed no obvious indication of petroleum impact and was sampled as *W-2* and *W-3*.

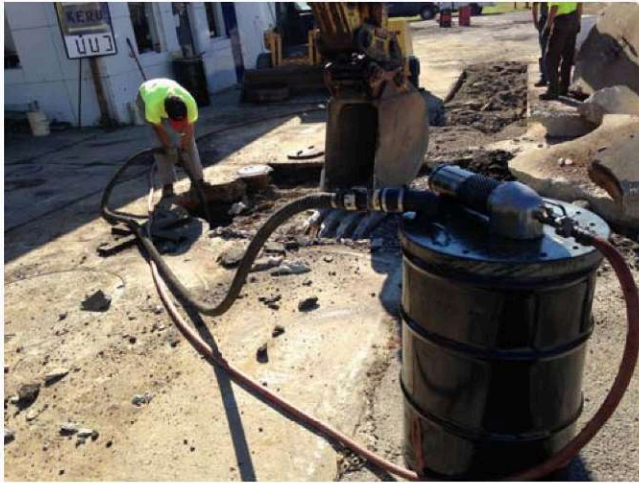
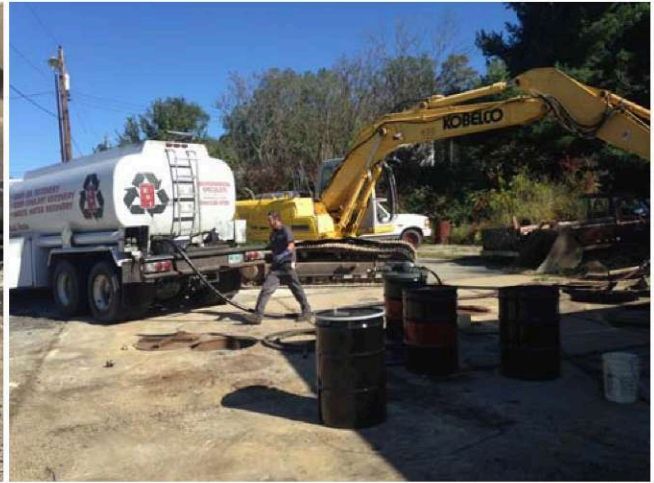
Photos 14&15 (9/23/2014): The drum-top vacuum was used to recover all fluids from tank top sumps, and a pump truck from Environmental Specialists, Inc. was employed to recover a total of 1,075 gallons of residual fluids from the tanks.

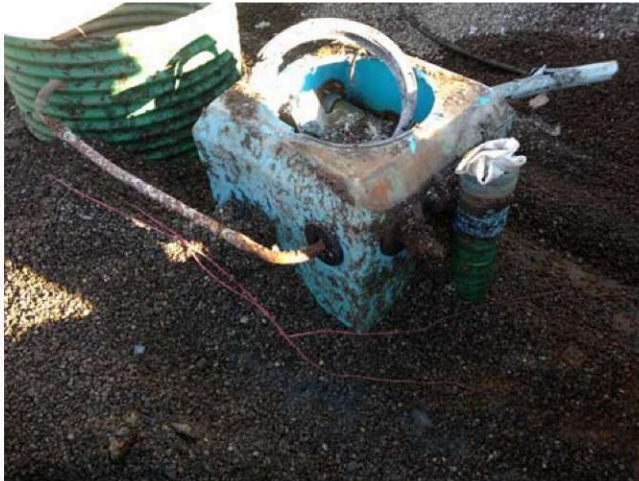
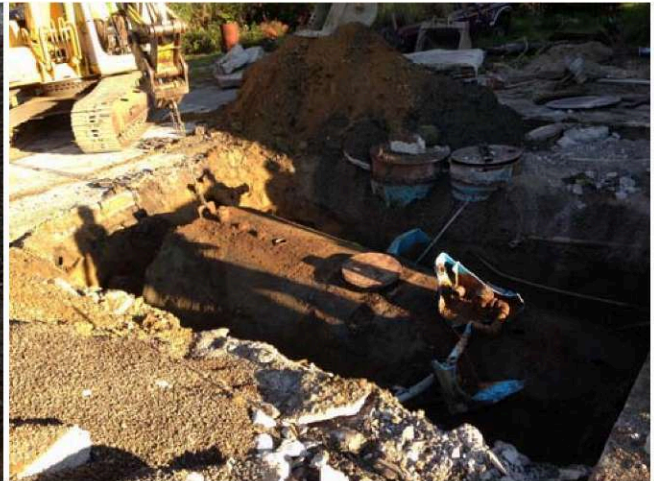
Tank cavity backfill material consisted of pea gravel and sand. Excavated material showed no obvious indication of petroleum impact. However, dark staining was observed on top of tank #001 near the fill riser and a containment sump which housed vapor piping manifolds.

Photos 15&16 (9/23/2014): Concrete paving was removed from over the tanks, and Tank #1 was uncovered. Dark staining was noted on top of the tank near the fill riser and a containment sump which housed vent and vapor recovery piping junctions (left).

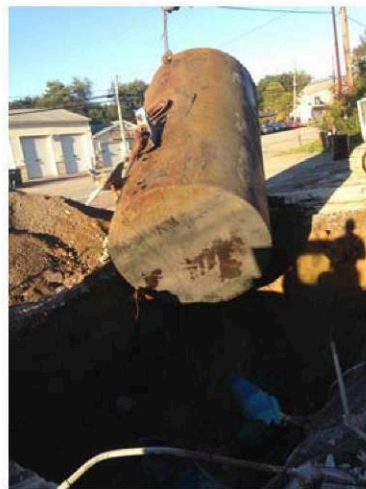
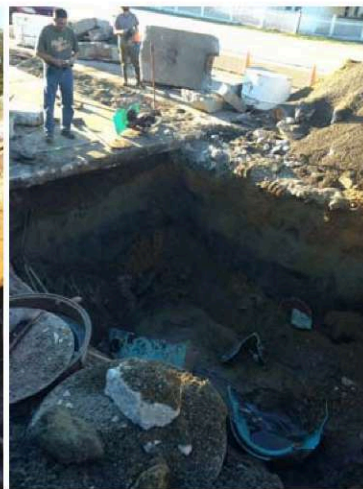
Dark staining was also observed on the sidewalls of the northwest corner of the cavity and sand backfill material below Tank #001. Soil was sampled from just above the soil-water interface along each long wall of the tank cavity per PADEP UST Closure Guidelines at *SW-E*, *SW-W*, and *SW-W-2*. Soil was also sampled between Tank #003 and UST #007 at *SW-S*. None of the collected soil samples produced significant PID readings, though sample *SW-W* did produce a slightly elevated reading.

Photos 17&18(9/23/2014): Tank #1 was removed from the cavity. Water in the cavity was observed which exhibited a heavy sheen and produced petroleum odors, and dark staining of the cavity sidewalls was noted. The tank was found in poor condition with deep corrosive pitting, though no obvious holes were observed.

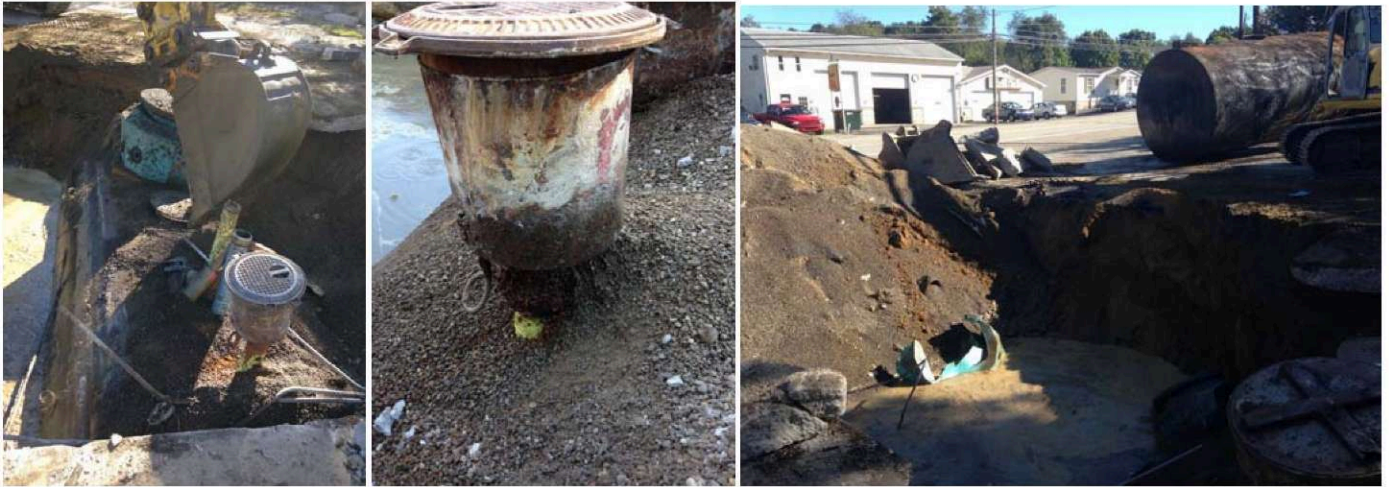
cavity (samples *W-4* and *W-5*) measured concentrations of COCs benzene, ethylbenzene, naphthalene, 1,2,4-trimethylbenzene and / or 1,3,5-trimethylbenzene which exceed regulatory action levels for samples collected at UST closure sites (see Table 1). Observations of dark staining on Tank #001 suggest that the source of the release may have been a faulty spill bucket at the fill riser.

Photos 19,20&21 (9/24/2014): Tank #2 was uncovered and removed from the cavity. Significant corrosion was noted on the metal spill bucket at the fill riser with rusty staining below. The tank was found in poor condition with deep corrosive pitting, though no obvious holes were observed.

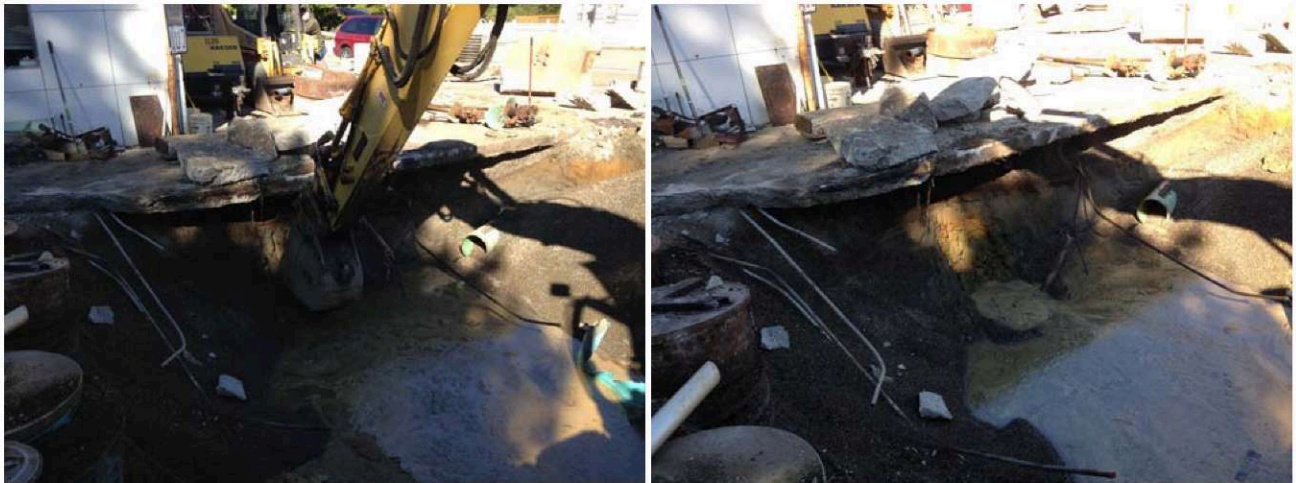
Photos 22&23 (9/24/2014): Showing collection of soil sample *SW-W-2* (left) and soil of the sidewall which exhibited no obvious staining.

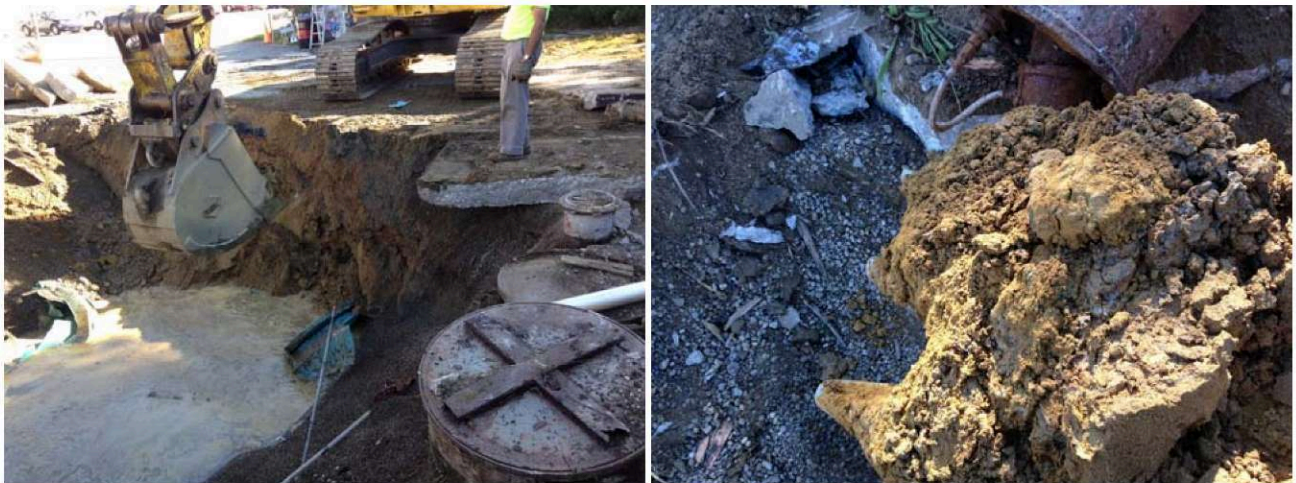
Photos 24&25 (9/24/2014): Showing collection of soil sample *SW-E* (left) and soil of the sidewall which exhibited no obvious staining.

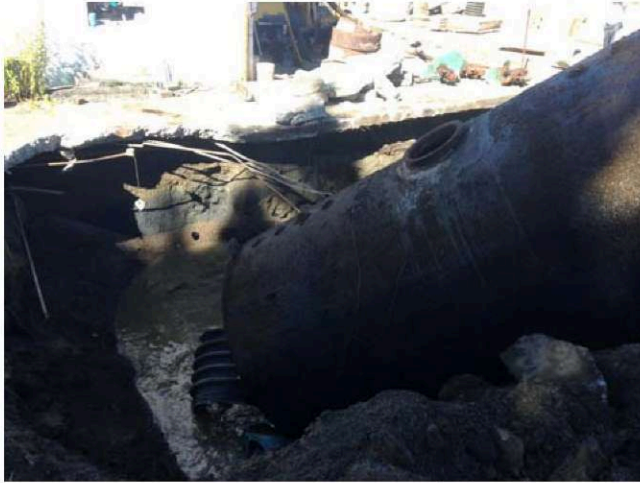
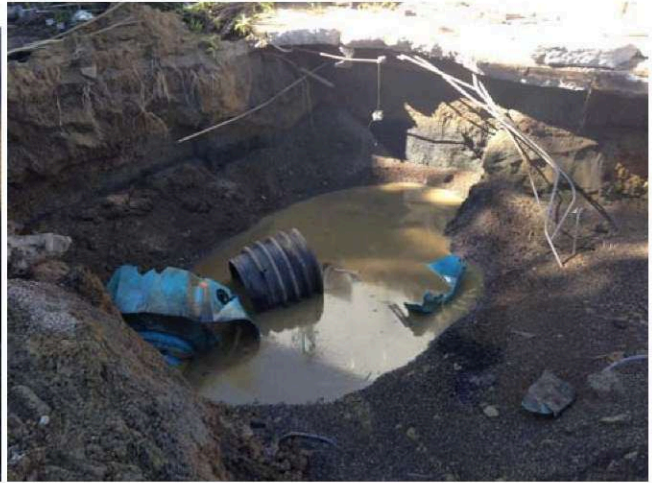
Photos 26&27 (9/24/2014): Showing removal of Tank #3. Dark staining was noted on cavity sidewalls, and water within the cavity carried a light film. Soil samples *SW-W* and *SW-S* were collected from these areas of the sidewalls, though field-screening and analytical data suggest that they were not significantly petroleum-impacted. The tank was found in poor condition with deep corrosive pitting, though no obvious holes were observed.

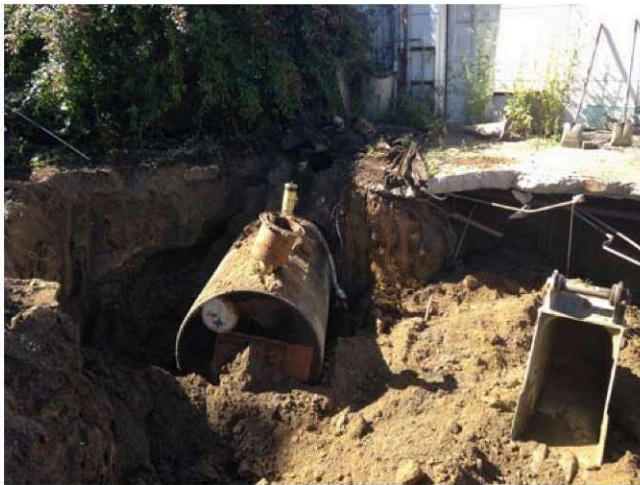
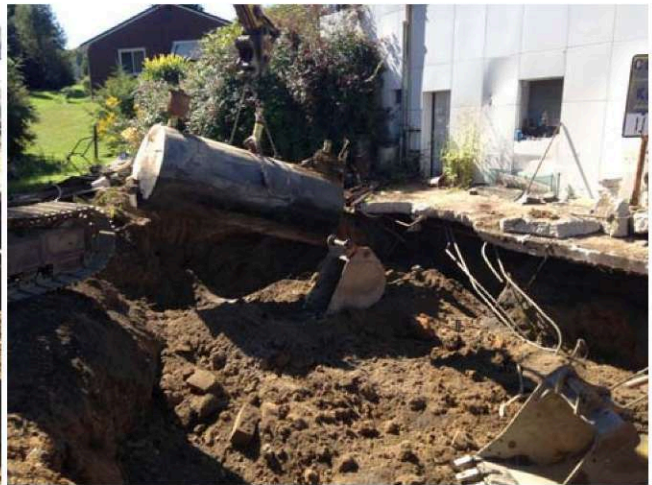
Tank #007 had not been previously cleaned. It was removed and placed above ground without incident. An access hole was cut into the tank for Flynn personnel to enter, and then all remaining liquids, sediments, and sludges were hand-shoveled into one (1) 55-gallon drum for off-site disposal. This tank was found in excellent condition.

Photos 28&29 (9/24/2014): The Kerosene UST system (UST #007) was found in good condition with no obvious failure points or any signs of contamination.

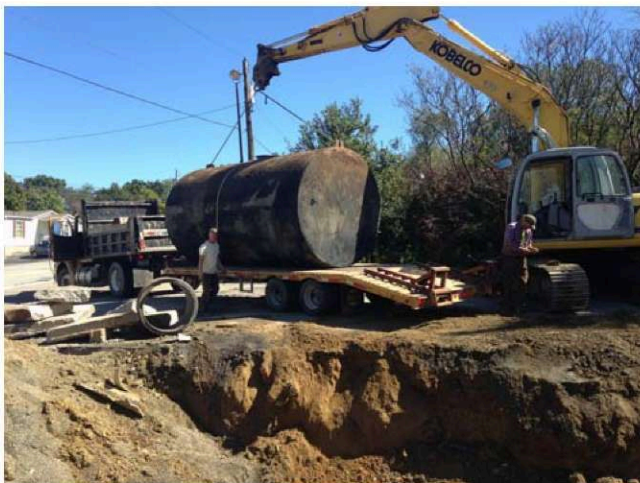
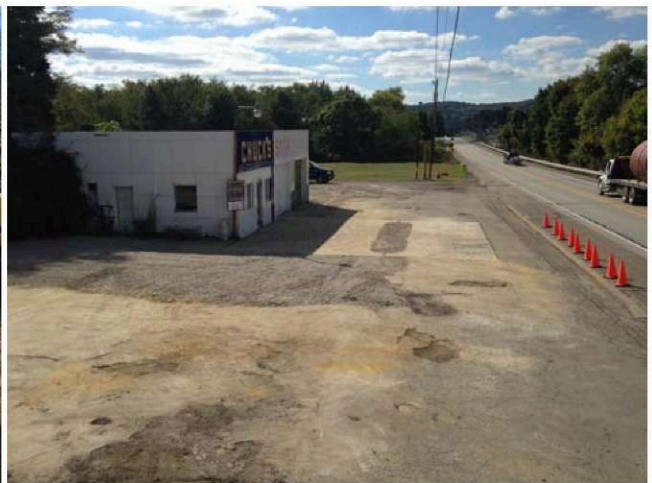
Photos 30&31 (9/24&25/2014): All tanks were verified to be clean and free of hazardous atmospheres then loaded and hauled by Shockey Excavating to Wilson's Scrap Metal in Saltsburg, PA to be recycled. The excavated areas were then backfilled to grade.
