RE: **Site Characterization Report**
Kwik Fill Station #M-061
PADEP ID #42-14809
227 East Main Street
Bradford, Pennsylvania

SITE CHARACTERIZATION REPORT

Kwik Fill Station #M-061
227 East Main Street
Bradford, Pennsylvania
PADEP ID #42-14809
USTIF Claim #2013-0035(F)

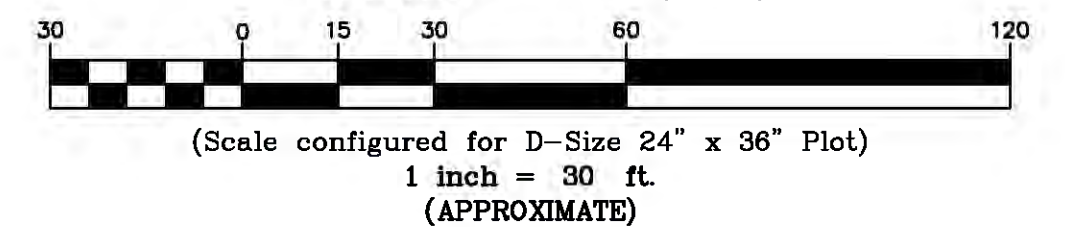
FIGURE
8

gradient estimated based on the four quarters of groundwater monitoring data. **Figure 8** illustrates the current groundwater flow direction observed in February 2015.

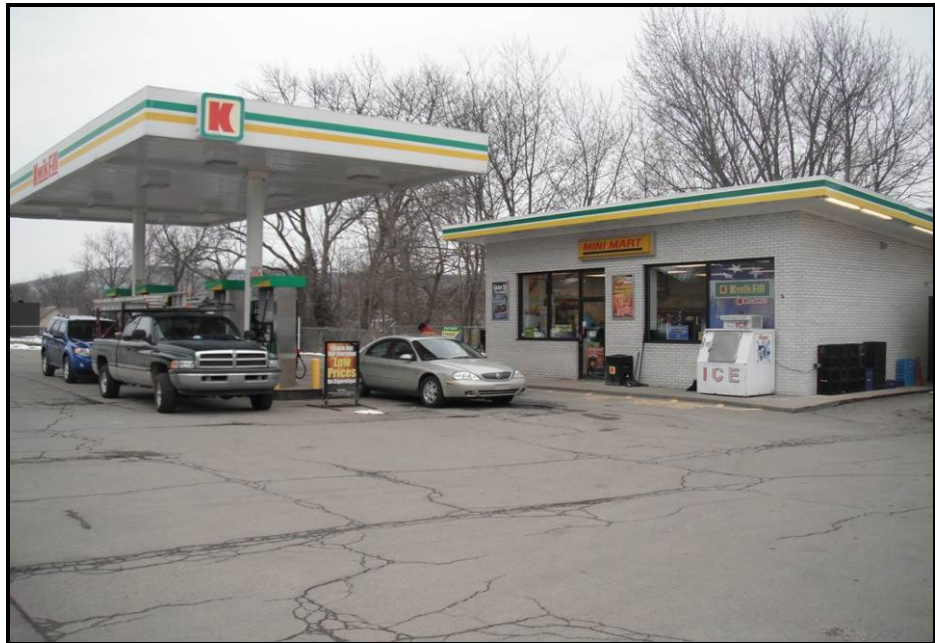
View of station building,
and dispensers.

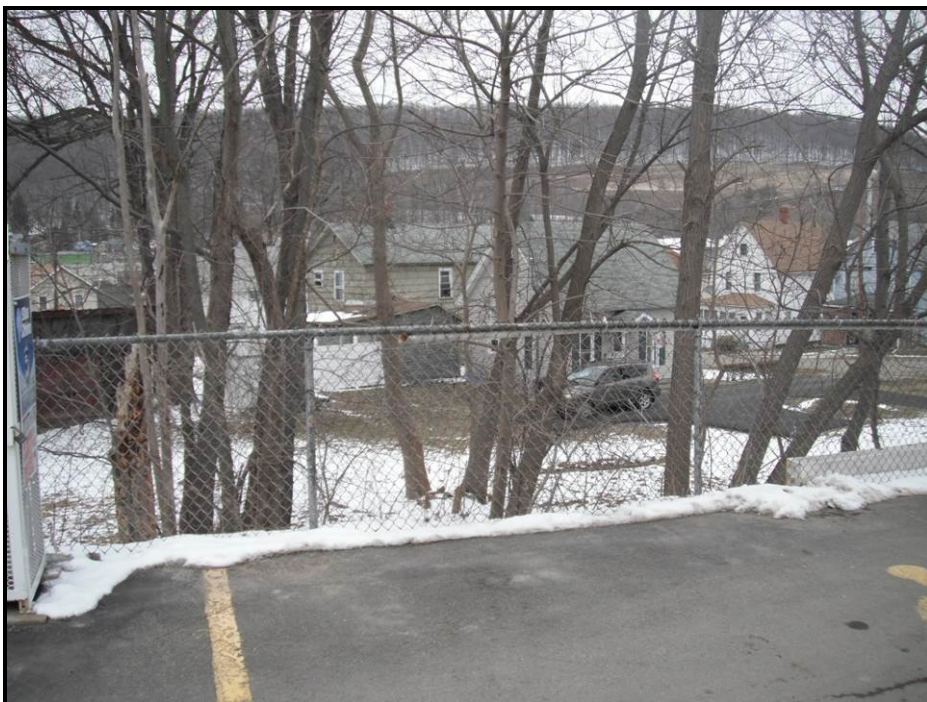
View of adjacent residential properties to the west of the facility (downgradient of the release).

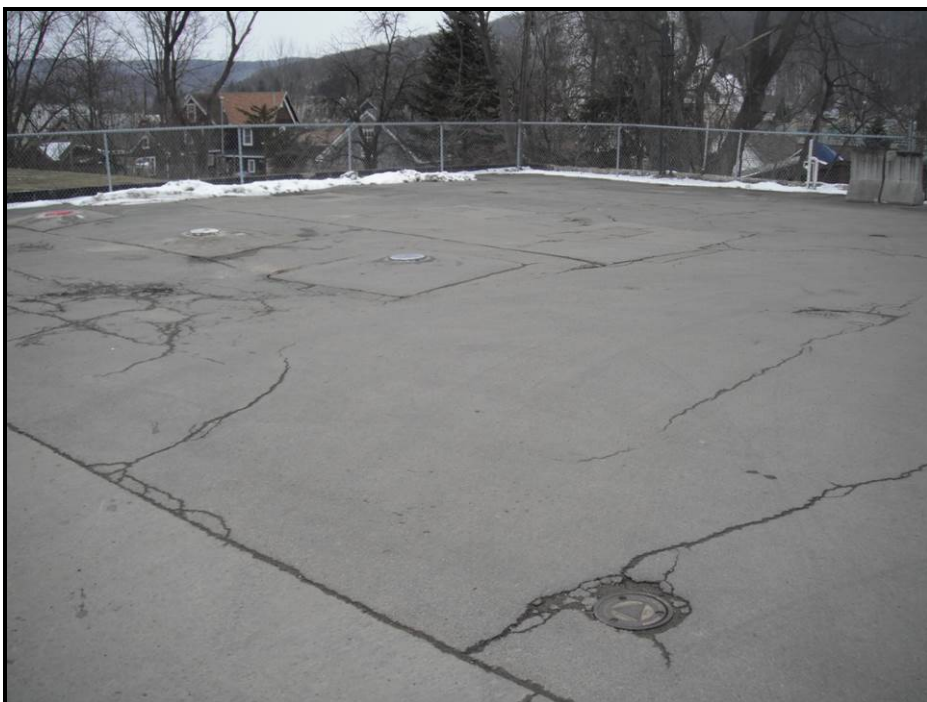
View of UST field located near southern property boundary.

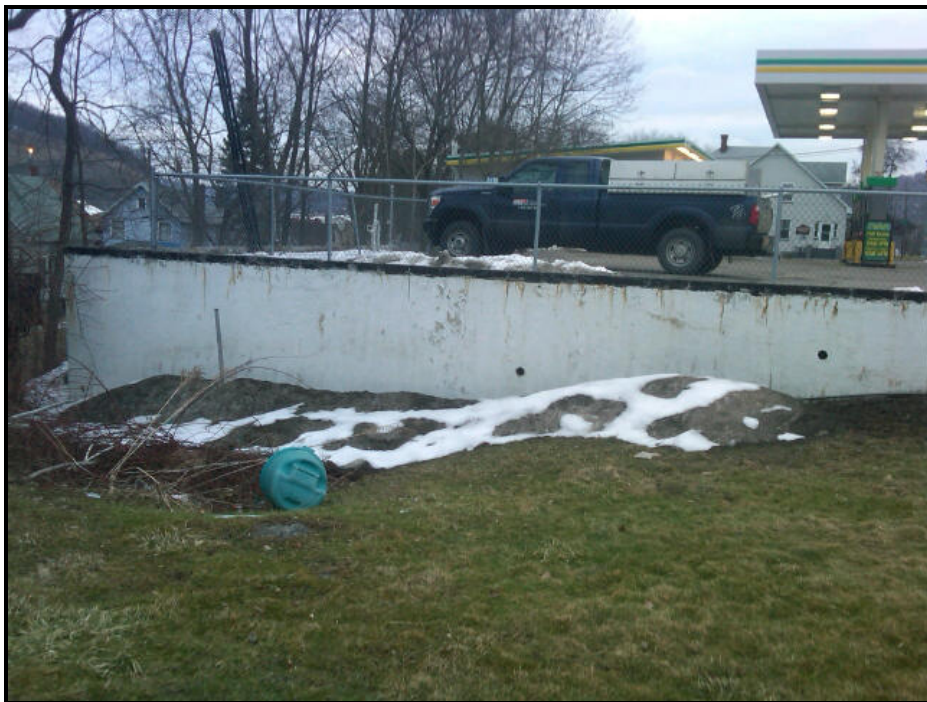
View of retaining wall located along the southern property boundary.

A retaining wall is located along the southern and western property boundaries. Based on overall depths of 12,000-gallon USTs ranging from 12 to 13 feet bgs, and unconsolidated fill material observed during site characterization activities to approximately 12 feet bgs at groundwater monitoring well MW-13 (near the UST field), the depth of the retaining wall along the western property boundary is estimated to be 12 feet bgs.

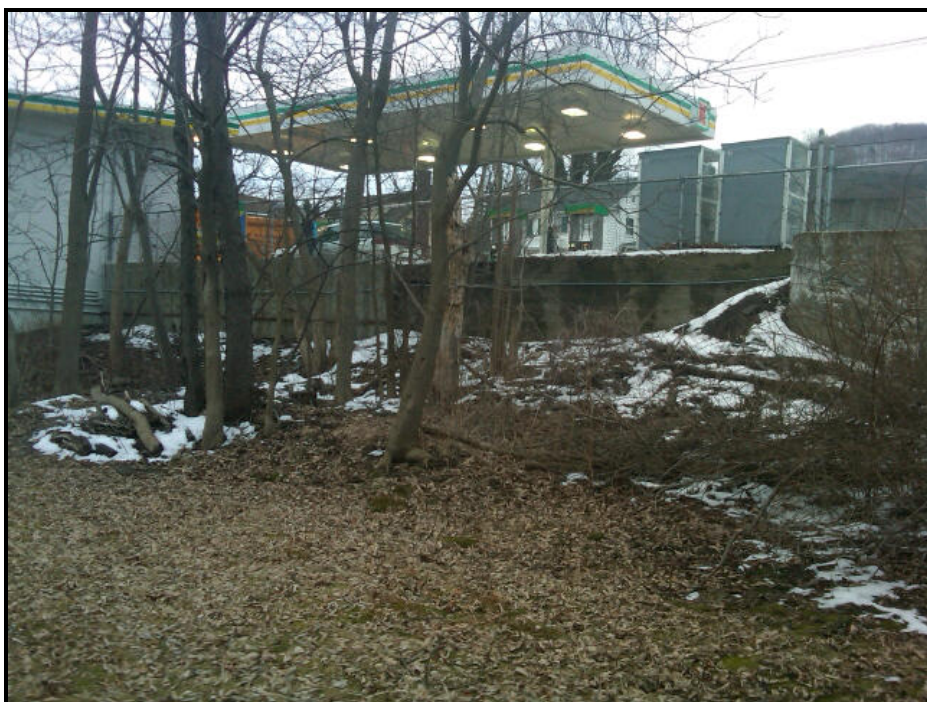
View of retaining wall located along the western property boundary.

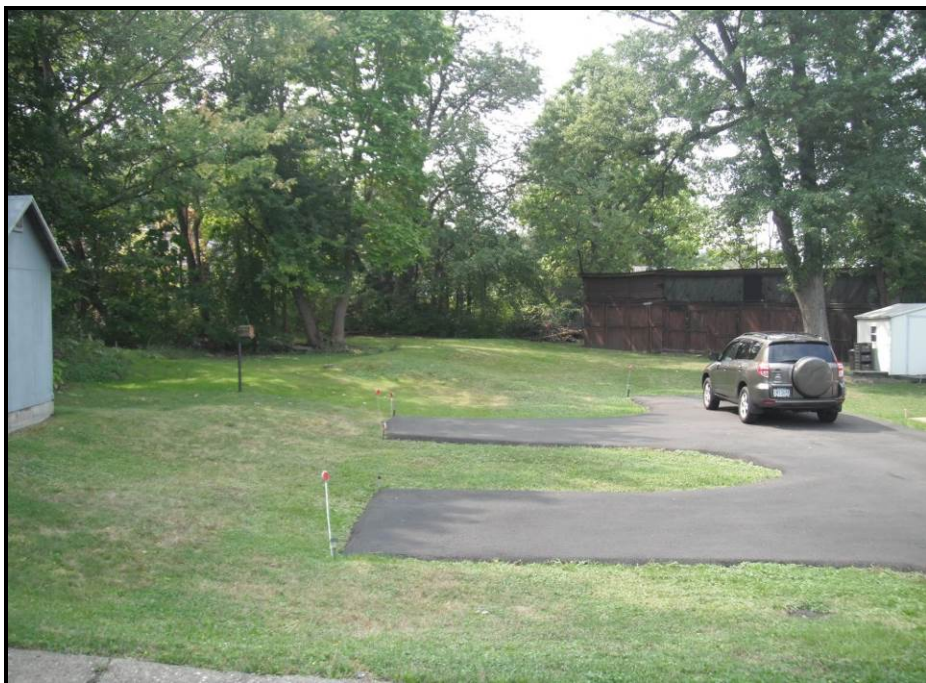
Residual shallow APH impacts were also observed in soil at an off-site, downgradient property (Carlough). Unleaded gasoline constituents were detected in soil between 2 and 3 feet bgs at concentrations above current Act 2 SHS used aquifer, residential (U/R) MSCs.

View of off-site
(Carlough) property
adjacent to the site.

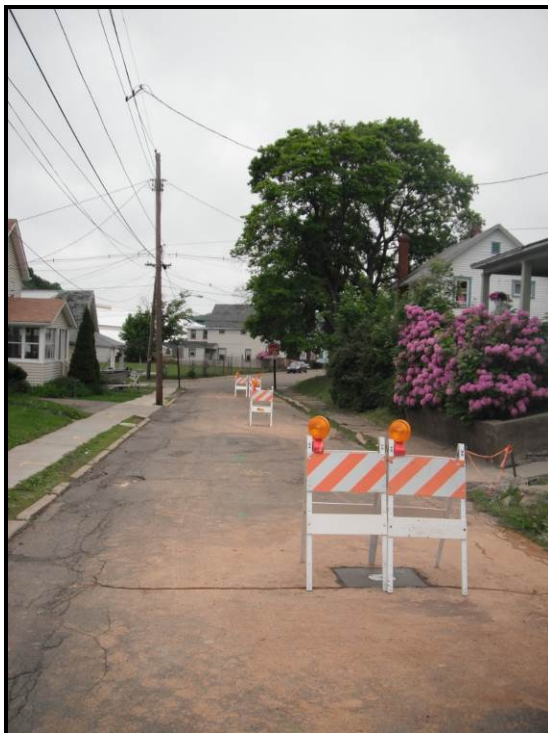
View of off-site
monitoring wells MW-17
through MW-19 in York
Street with residential
properties on either side.

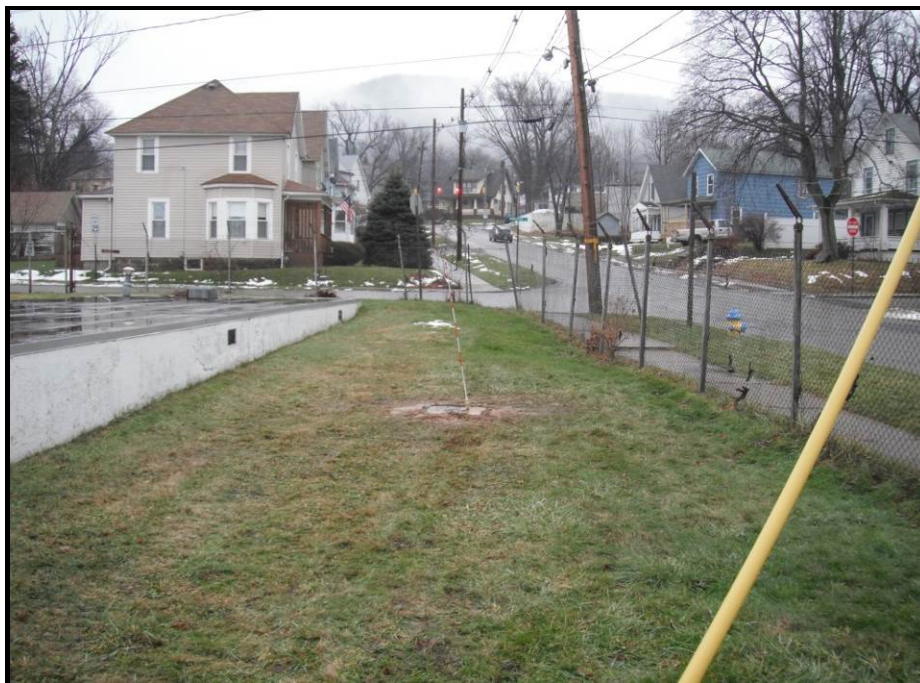
View of monitoring well MW-24 located on the off-site GE Dresser property along Mill Street.

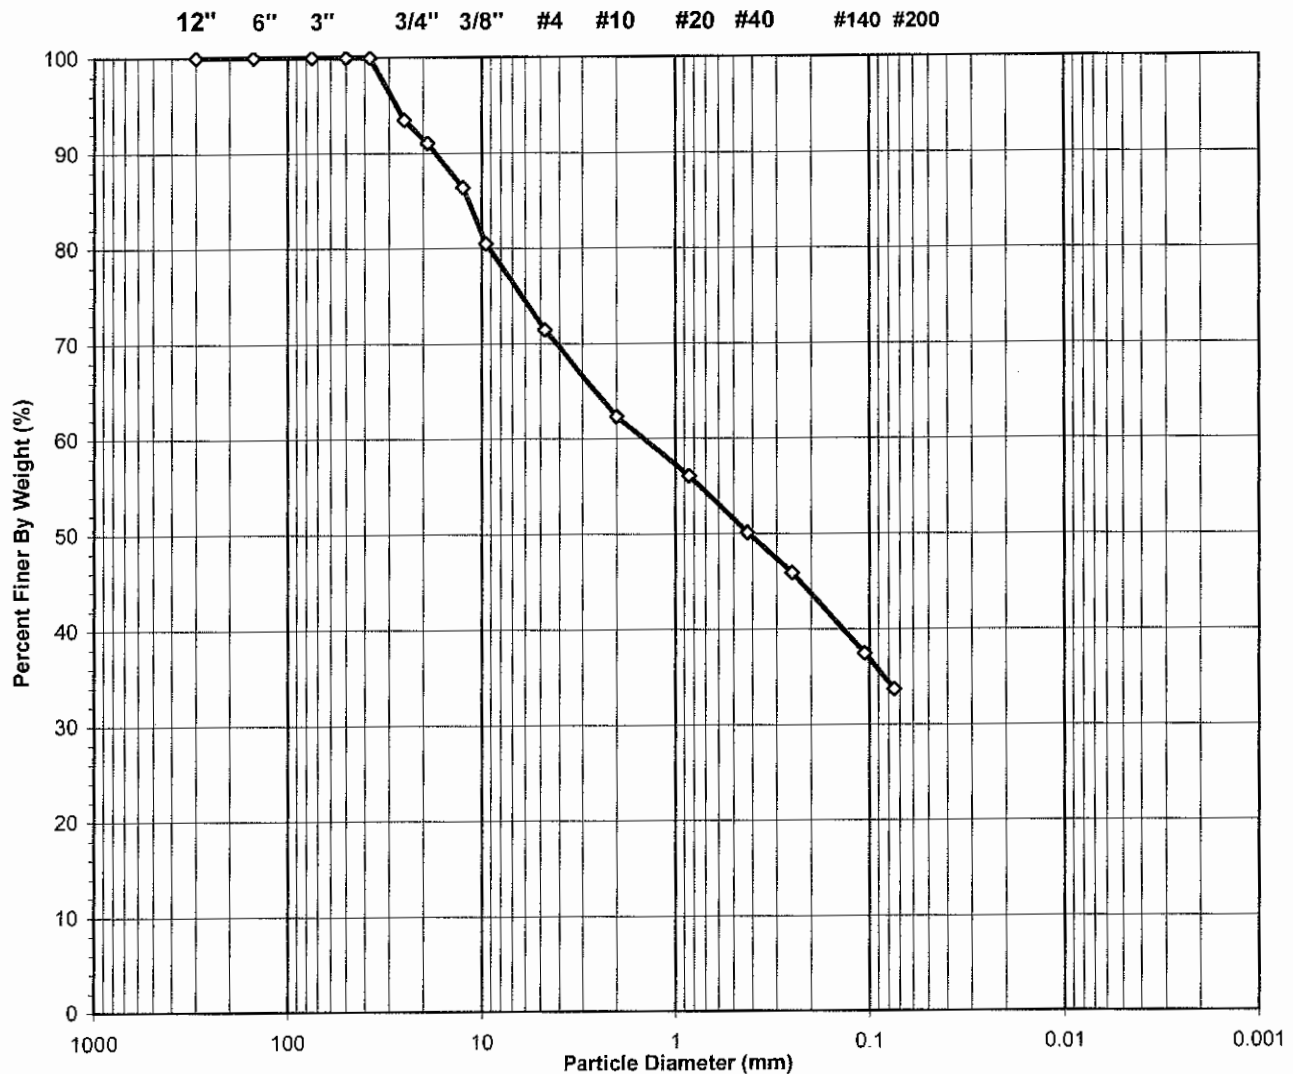
USCS Symbol: *sc, ASSUMED*

USCS Classification: *CLAYEY SAND WITH GRAVEL*

A sub-sample of SB-10 was collected from the Shelby tube at 10.1 to 11.0 feet bgs for analysis. Analytical results indicated the organic matter content of the sample was 2.6% from the loss-on-ignition processes. To determine the fraction of organic carbon (f_{oc}) from soil organic matter, a correction factor of 58% was utilized as recommended by the Indiana Department of Environmental Management (IDEM, 2010). Therefore, the f_{oc} for the SB-10 sample was approximately 1.51%. The average specific gravity and porosity were 2.65 and 0.36, respectively. Sieve analysis classified the soil as clayey sand with gravel (SC).
