**Re: Site Characterization Report
United Refining Company of Pennsylvania
Kwik Fill M-90
1322 South 2nd Street
Clearfield, PA 16830
PADEP Facility ID #17-14821/PAUSTIF Claim #2015-0004(I)**

SITE CHARACTERIZATION REPORT

PADEP Facility ID #17-14821
PAUSTIF Claim #2015-0004(I)

Kwik Fill M-90
1322 South 2nd Street
Clearfield, PA 16830

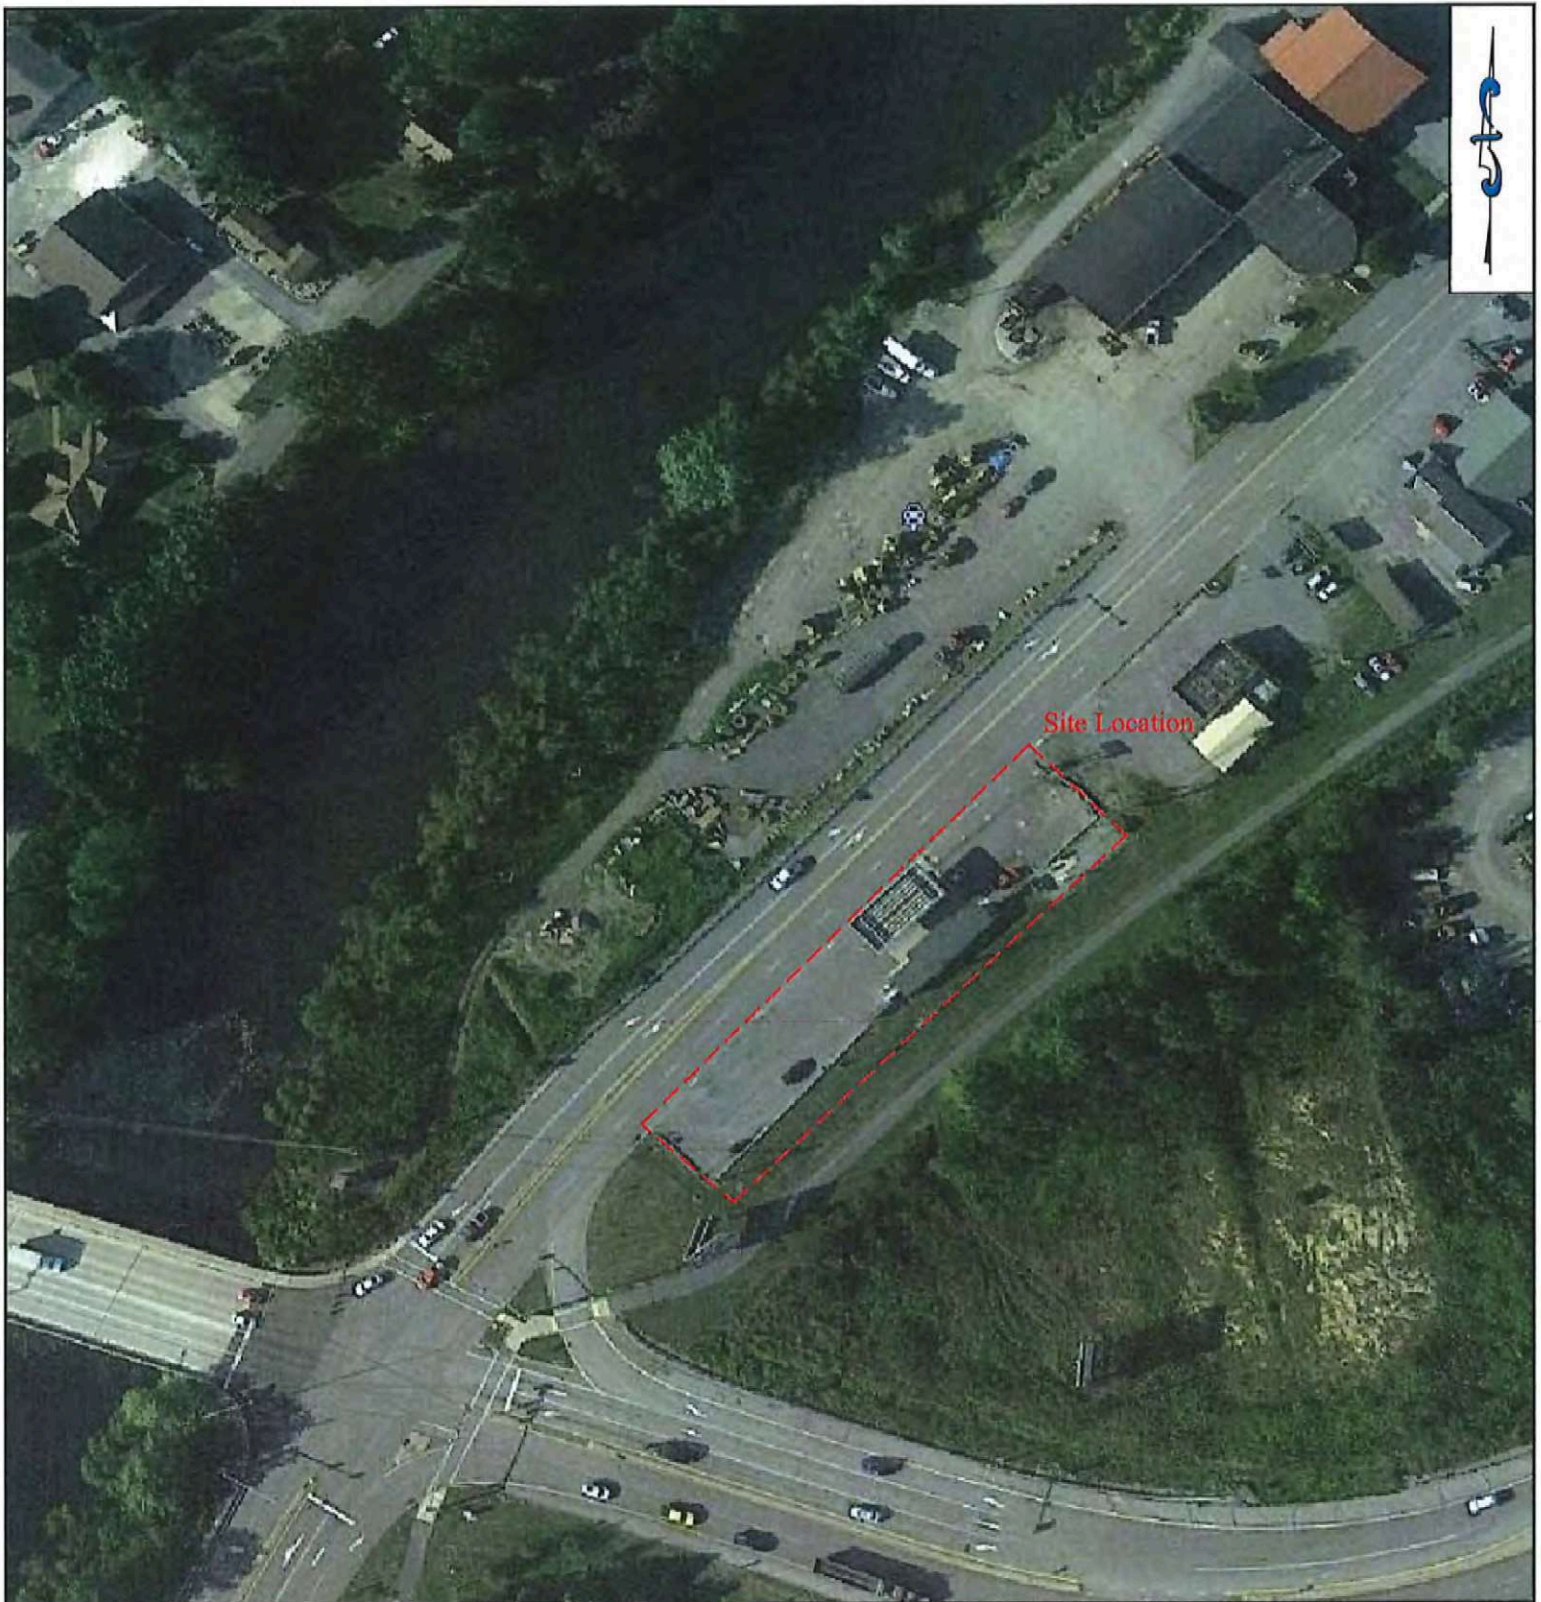
Letterle & Associates</p> <p>2022 Axemann Road, Suite 201 Bellefonte, PA 16823 P: 814-355-2241 F: 814-355-2410 www.letterleassociates.com</p>
<i>Title:</i>	<i>Scale (feet):</i>	
<p>Figure 2 Site Aerial Map</p>	<p>Scale: 1" = 100'</p>

Reference: Aerial Image dated March 26, 2015 taken from Google Earth Program.

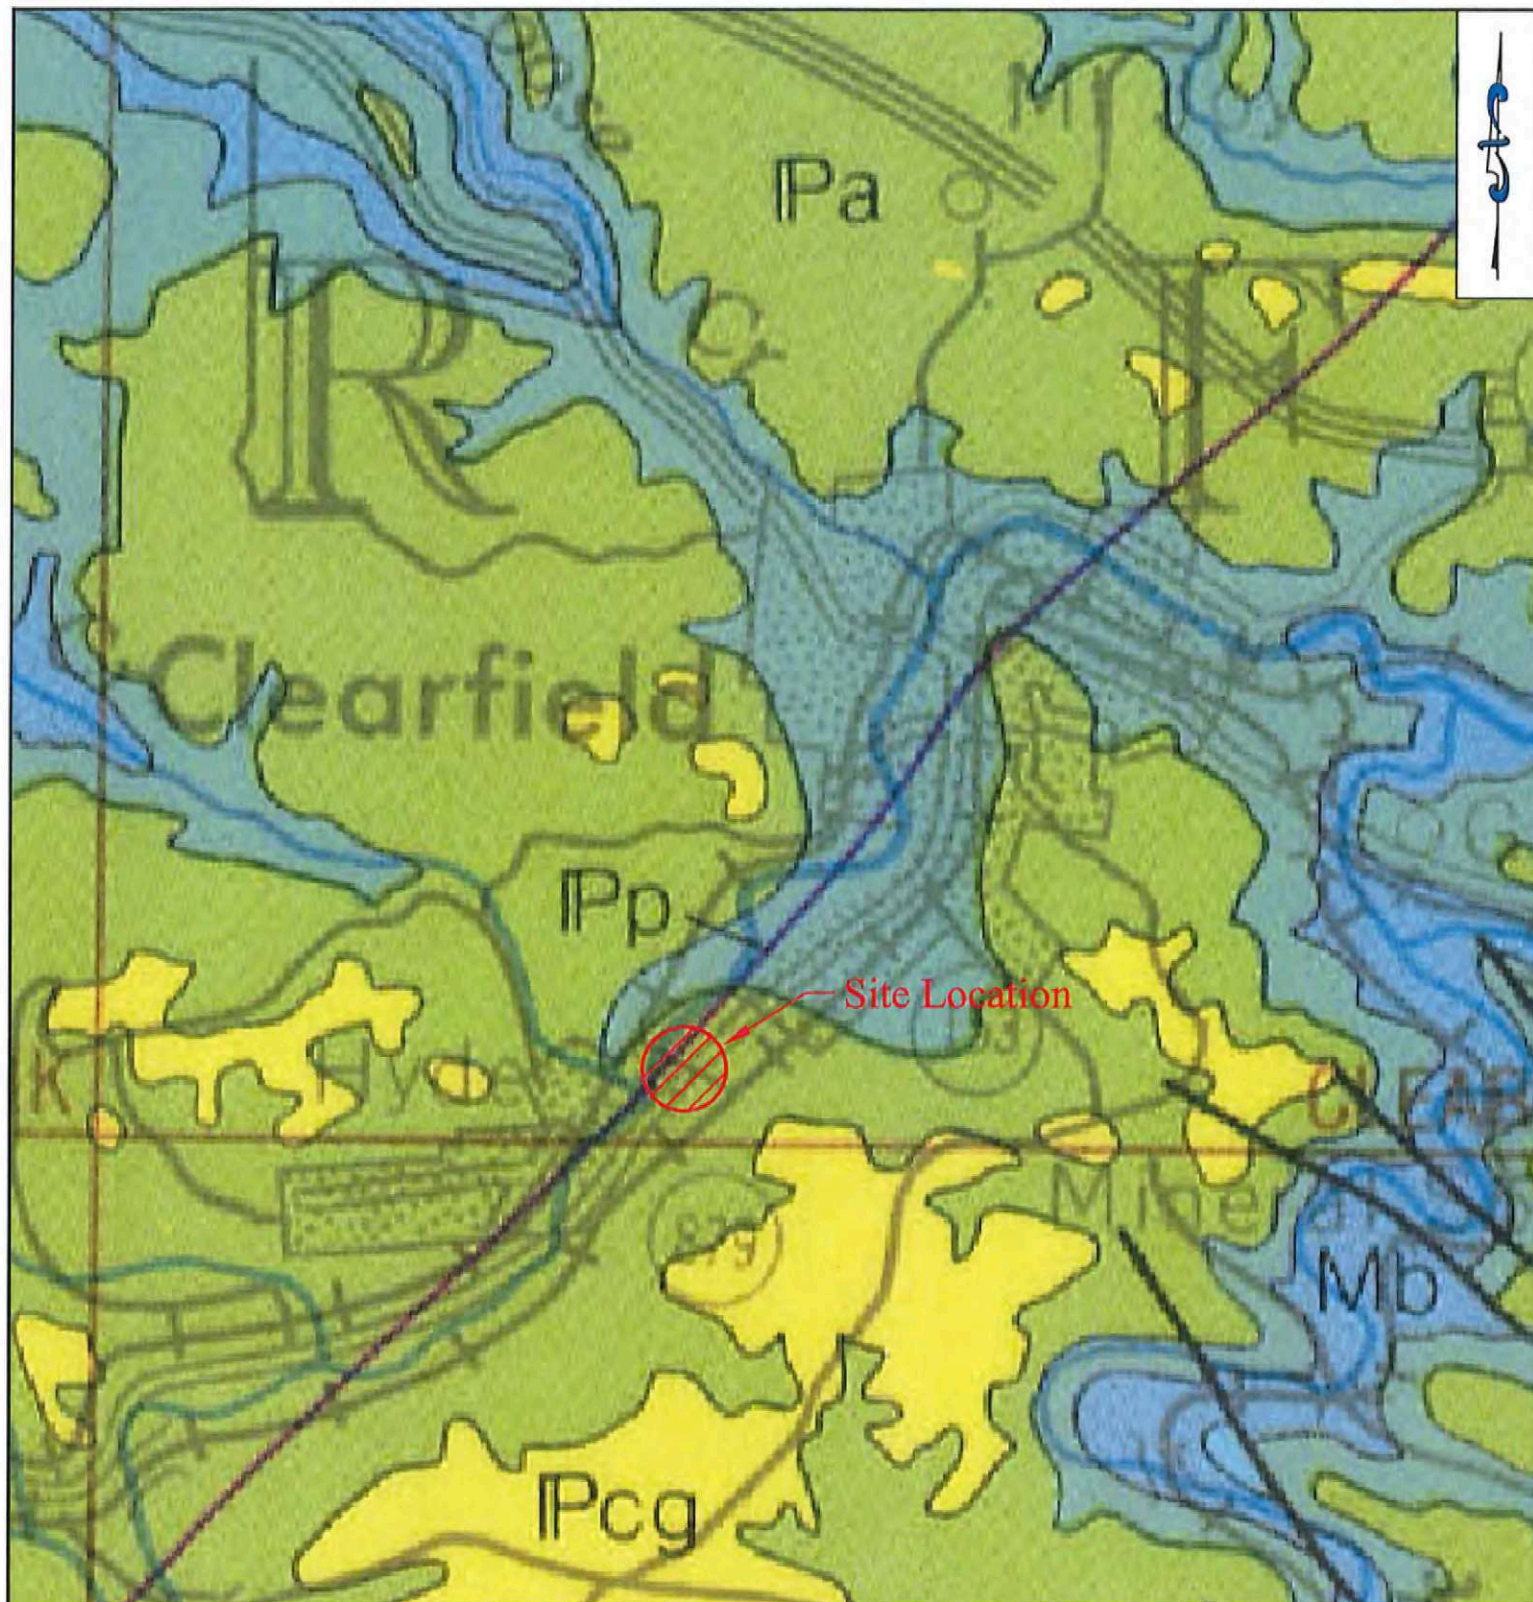
Letterle & Associates 2022 Axemann Road, Suite 201 Bellefonte, PA 16823 P: 814-355-2241 F: 814-355-2410 www.letterleassociates.com
<i>Title:</i>	<i>Scale (feet):</i>	
Figure 4A Preliminary Bedrock Geologic Map	NOT TO SCALE

Reference: Commonwealth of Pennsylvania, Department of Environmental Resources, Bureau of Topographic and Geologic Survey, Geologic Map of Pennsylvania 1980.

Only preliminary geologic mapping of the area has been completed and no published information was available to approximate the basic local structural orientation (local strike and dip) of the underlying bedrock formation. Additionally, no bedrock outcrops were observed during site characterization activities.
