**FIRST QUARTER 2018
REMEDIAL ACTION PROGRESS REPORT
PAUSTIF CLAIM NO. 2011-0082(S)
FORMER ROSEMERGY'S GARAGE/STORE
PROPERTY
NOW THE MARKET AT WOODLOCH
1623 STATE ROUTE 590
LACKAWAXEN TWP., PIKE COUNTY,
PENNSYLVANIA**

APRIL 2018

Project Number: 11-17788-03

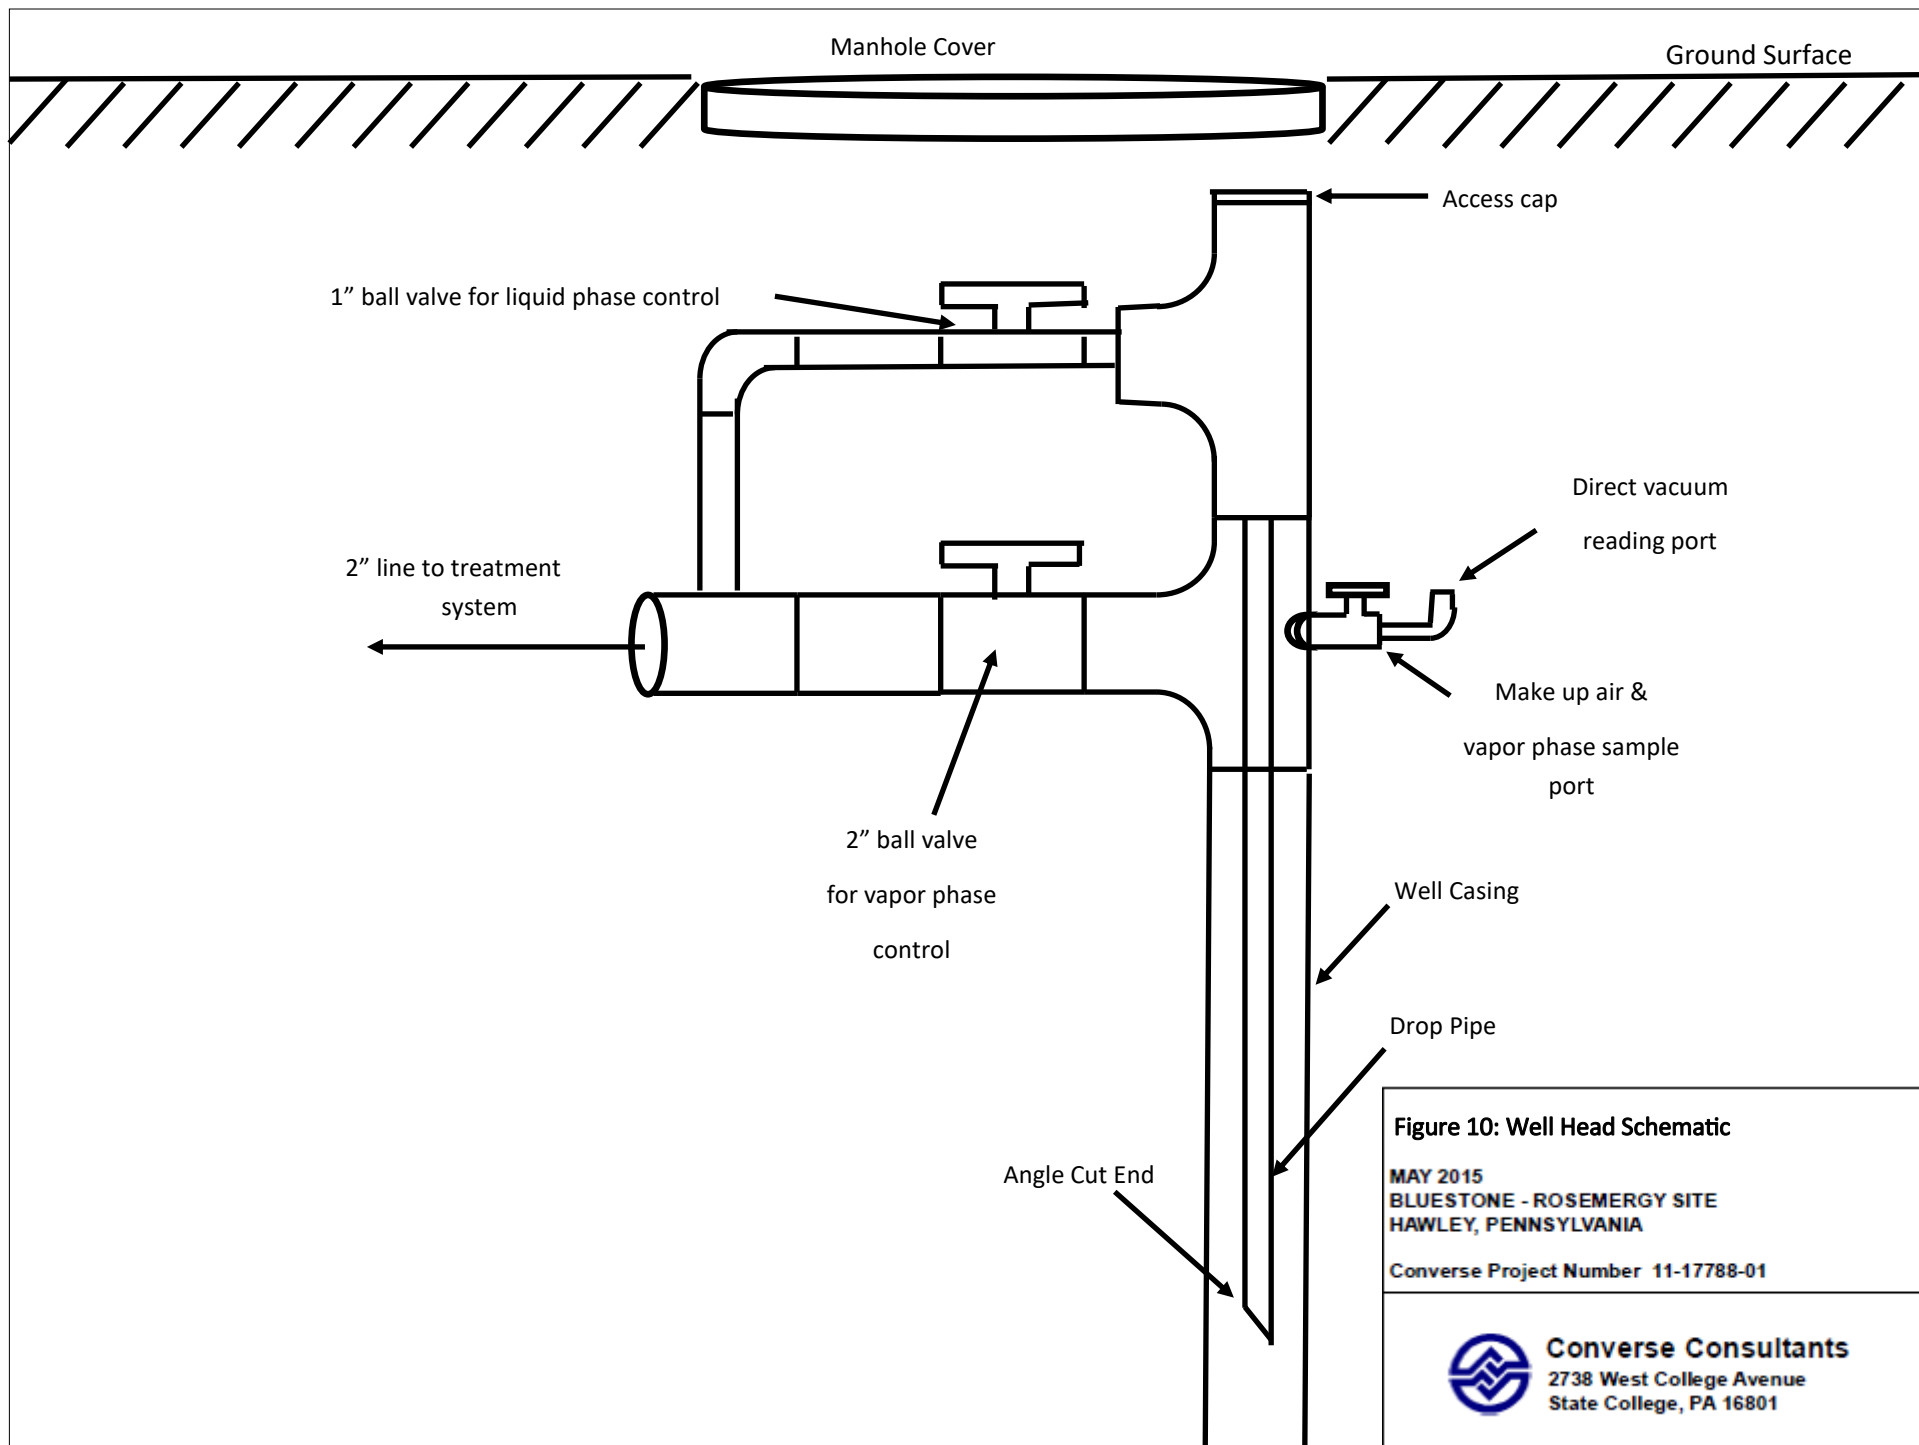
FIGURE 11 - DPE TREATMENT SYSTEM SCHEMATIC
FORMER ROSEMERGY'S PROPERTY
LACKAWAXEN TWP., PIKE CO., PENNSYLVANIA
 CONVERSE PROJECT NUMBER 11-17788-03

Extracted vapors are treated with activated vapor carbon and then discharged to the ambient air above the roofline of the treatment shed. Extracted groundwater is treated with activated carbon prior to being discharged to the storm water infiltration gallery located behind the building on the property. The reconfigured DPE treatment system was restarted November 30, 2017. Refer to **Appendix A: Figure 9** for locations of the DPE extraction wells, **Figure 10** for the treatment system schematic, and **Figure 11** for a schematic of the DPE well heads.

- Transfer pump replaced January 10, 2018. The transfer pump froze and failed due to power outage December 28, 2017.
- Broken belts between the blower and motor replaced January 24, 2018.
- Failed blower replaced February 27, 2018. The blower failed due to the intake of water caused by failed high-high float.
- Failed motor replaced March 12, 2018. The failed motor was identified during system restart on February 27, 2018, after the blower was replaced
- Vapor carbons drained of water and frozen piping in treatment shed replaced March 14, 2018.
- System restarted March 15, 2018.

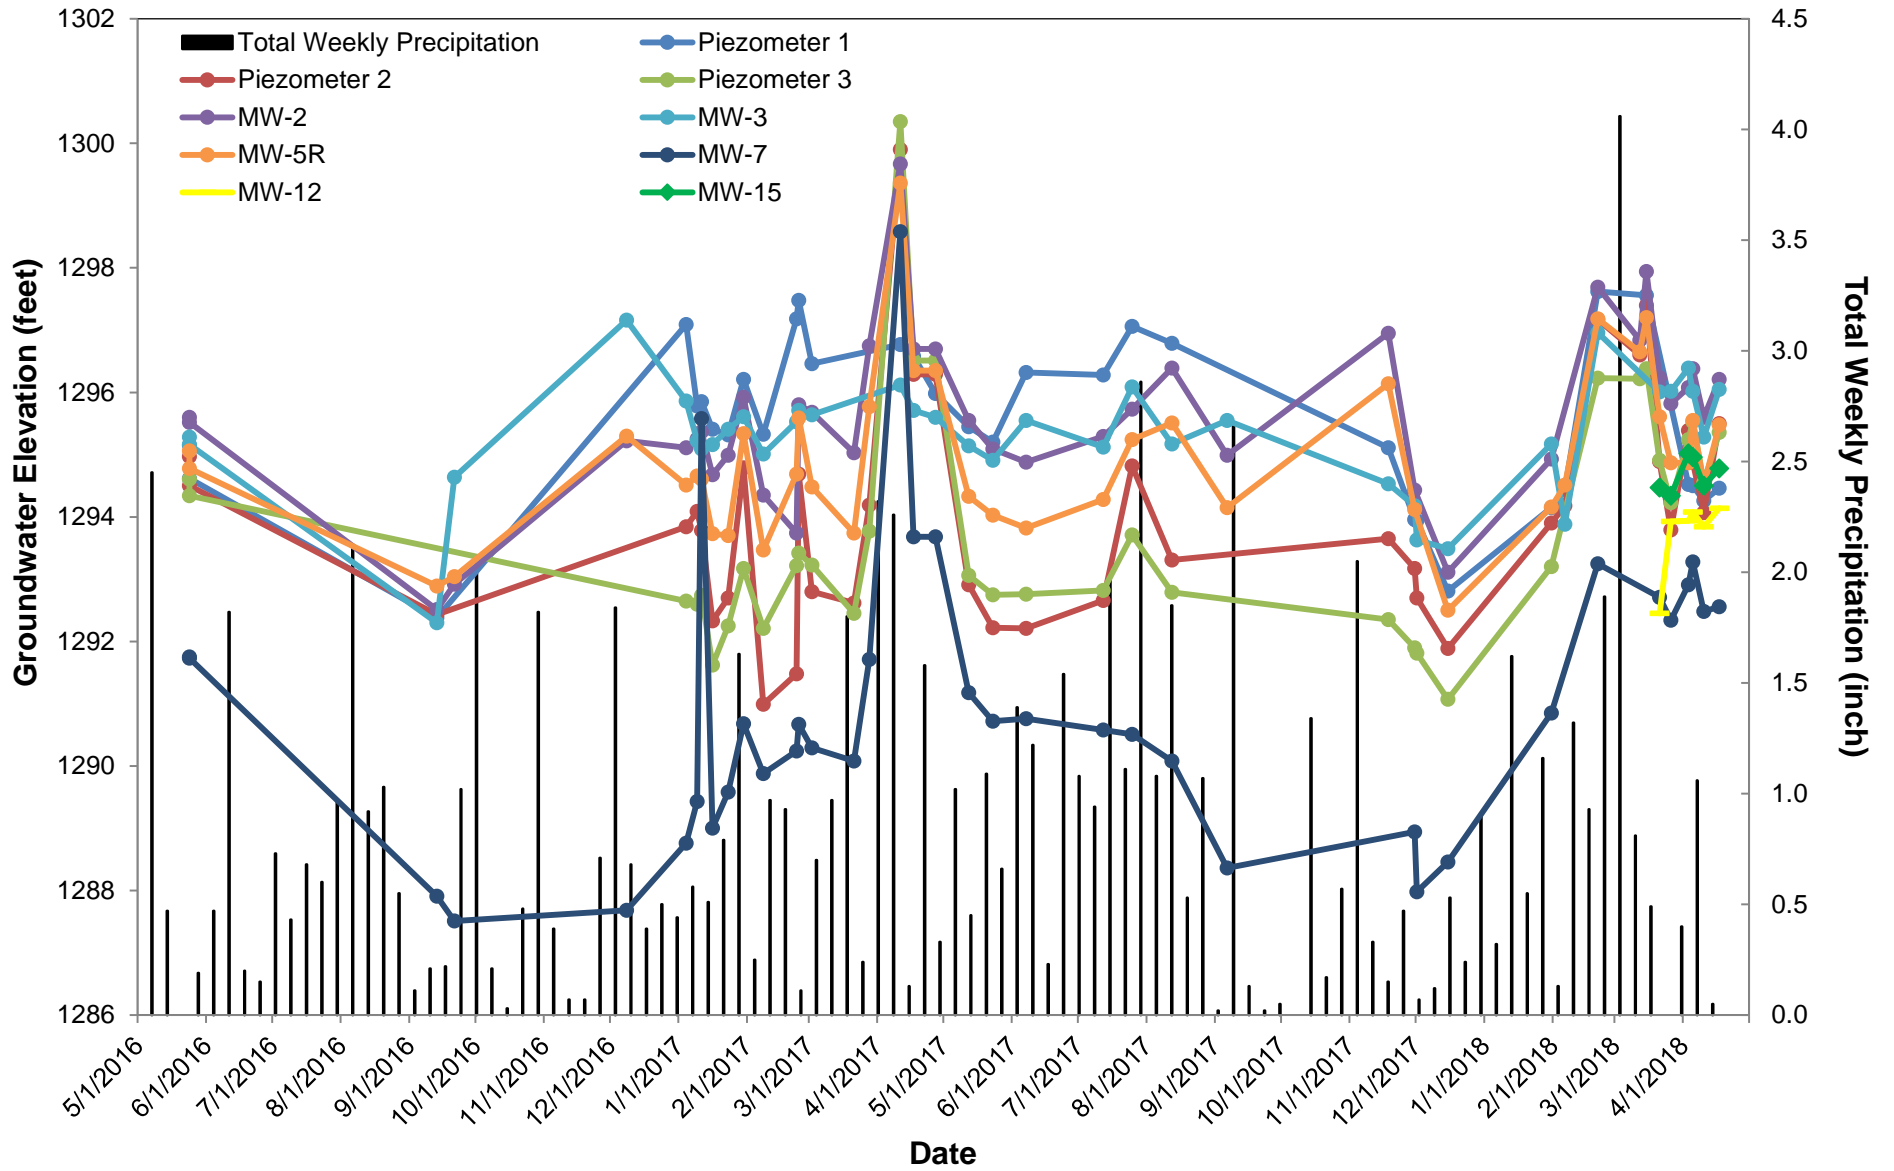
Water Levels vs. Precipitation

Groundwater elevations are compared to weekly precipitation measurements in **Appendix C**. In general, there appears to be a direct relationship between precipitation events and groundwater elevations. The interpretation that atmospheric water infiltration affects groundwater elevations is supported by the increased water extracted by the remediation system during and directly after precipitation events.
